INVESTIGATING THE CAUSAL LINK BETWEEN LIGHTNING STRIKES, CSST AND FIRE

Mark Goodson PE
Mark Hergenrether, MSME

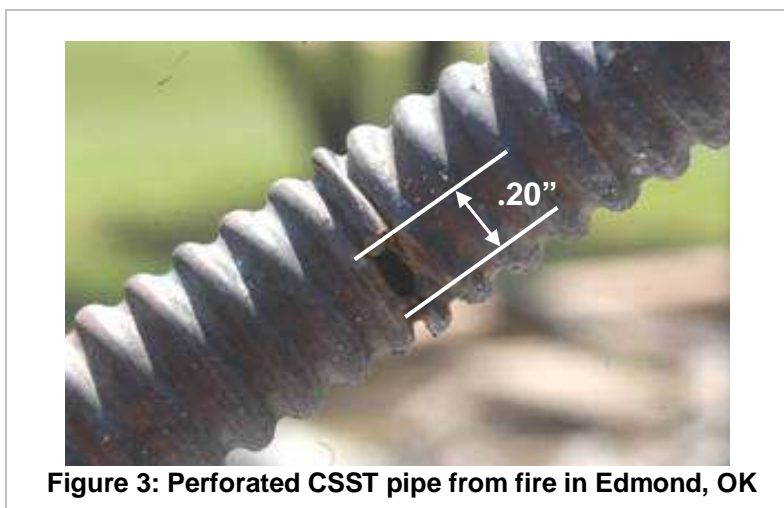
The fire occurred in a two story house under construction, plumbed with approximately 95% black pipe with a value in excess of \$1,000,000. Two runs of CSST, each serving a metal chimney, comprised the CSST piping in the house. A perforation with its major axis measuring approximately 200 mils was found in the CSST; this is shown in Figure 3. A positive lightning report was obtained, showing 11 strikes within 0.5 mile. Figure 4 shows the failed CSST run to the fireplace.

Figure 3: Perforated CSST pipe from fire in Edmond, OK

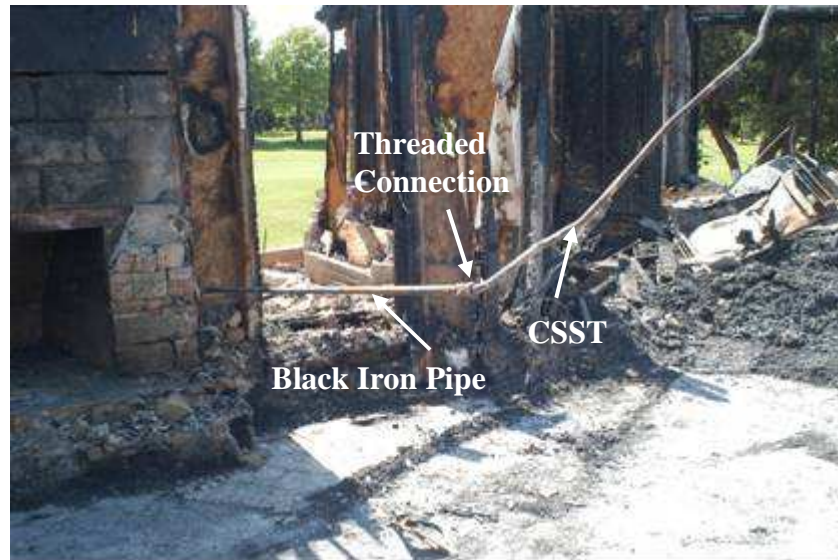
Figure 4: CSST tied to Black Iron pipe from fireplace

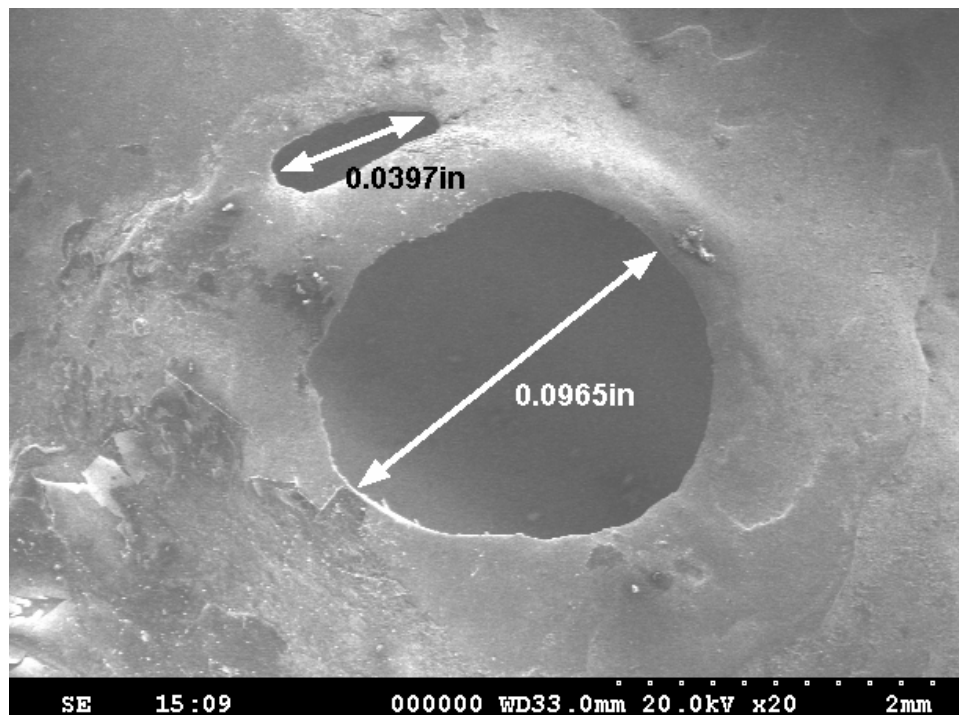
Figure 6: Arc holes in CSST @ 20X induced by lightning

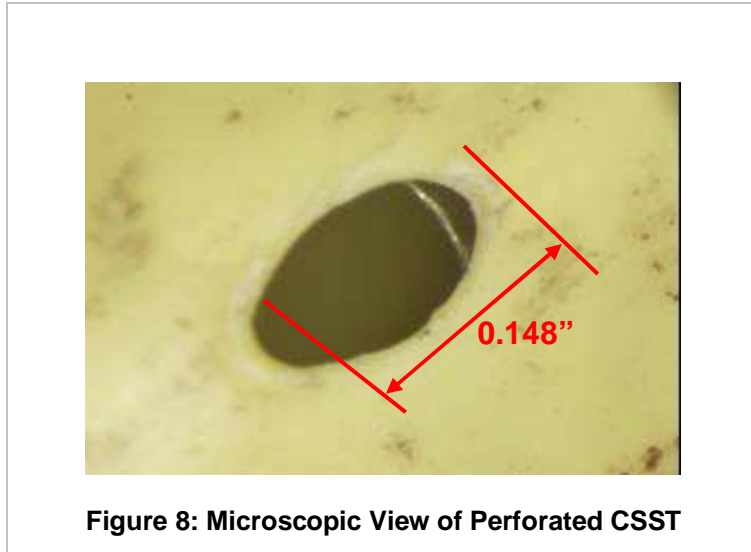
Figure 8: Microscopic View of Perforated CSST

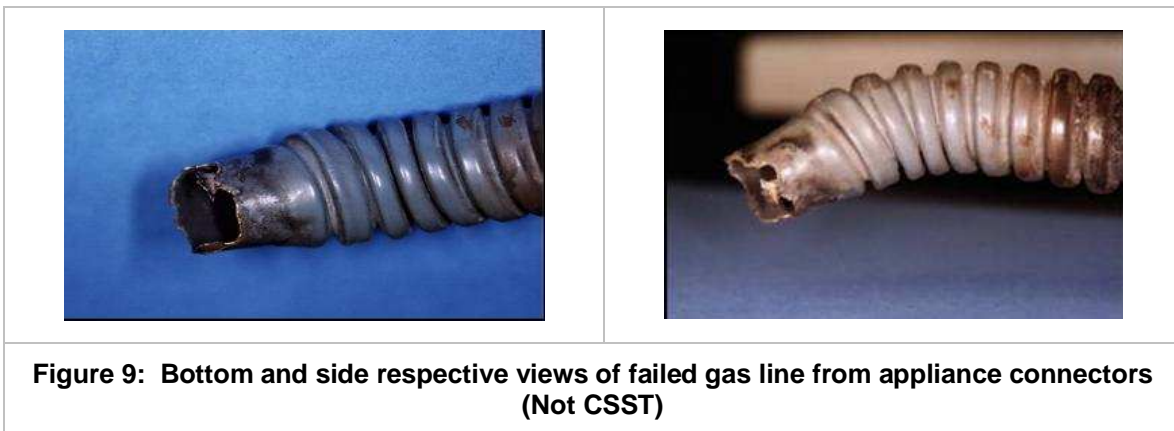
The Frisco Fire Department Report lists escaping gas from the end connectors during lightning events as also being possible sources of ignition. In a previous article written by one of the authors (MEG), this very phenomenon was described on appliance connectors. [19] The fact that a gas line fails at a connection is no surprise, in that gas lines are chosen for mechanical integrity at their junctions, and not necessarily electrical conductivity. Figure 9 shows the end of a failed appliance connector that has arced and caused a fire due to electrical current flow. We might expect to see similar manifestations with CSST at its connectors.

Figure 9: Bottom and side respective views of failed gas line from appliance connectors (Not CSST)
