PROPERTY INSPECTION REPORT

Concerning: 1234 Final Lane
(Address or Other Identification of Inspected Property)

By: Aaron D. Miller, ACI, CEI, CMI, CRI, MTI, RCI
Certified Master Inspector,
ICC Residential Combination Inspector R-5,
ICC Residential Building Inspector B-1,
ICC Residential Electrical Inspector E-1,
ICC Residential Mechanical Inspector M-1,
ICC Residential Plumbing Inspector P-1,
HUD 203K Consultant D0981
PTI Level 1 PT Installer 320054833
TREC Professional Inspector 4336
TDA SPCS 11379/40247 Certified Applicator
TRCC Registered Builder 16229
TRCC Dispute Resolution Inspector 1350
ASHI Certified Inspector 203652

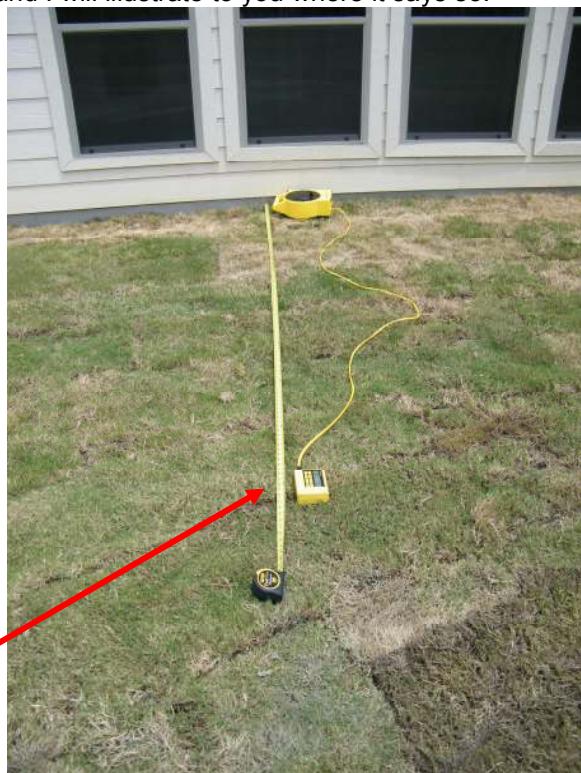
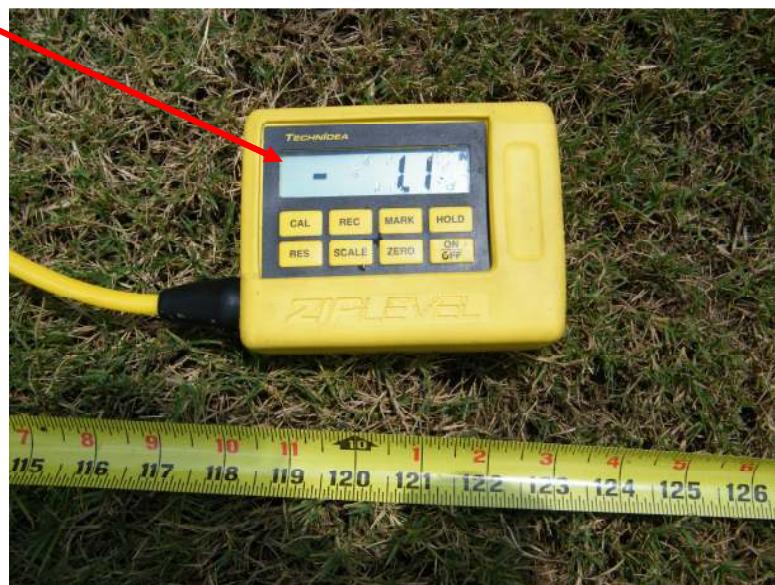
Grading specifications are spelled out clearly in International Residential Code (IRC) R401.3, "Surface drainage shall be diverted to a storm sewer or other approved point of collection so as to not create a hazard. Lots shall be graded so as to drain surface water away from foundation walls. The grade away from foundation walls shall fall a minimum of 6 inches (152 mm) within the first 10 feet (3048)". **FAILURE TO MAKE THESE IMPROVEMENTS VOIDS YOUR FOUNDATION WARRANTY!** If your builder denies this, send me a copy of your warranty and I will illustrate to you where it says so.

Grading not code compliant.

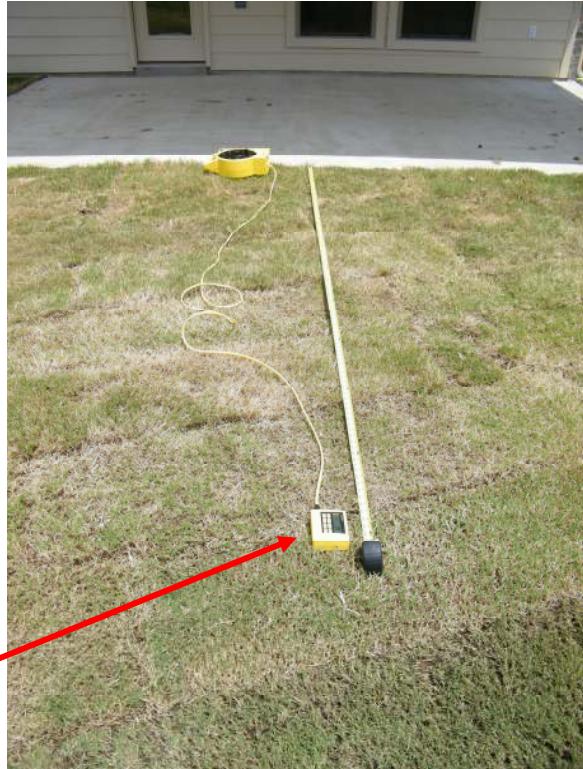
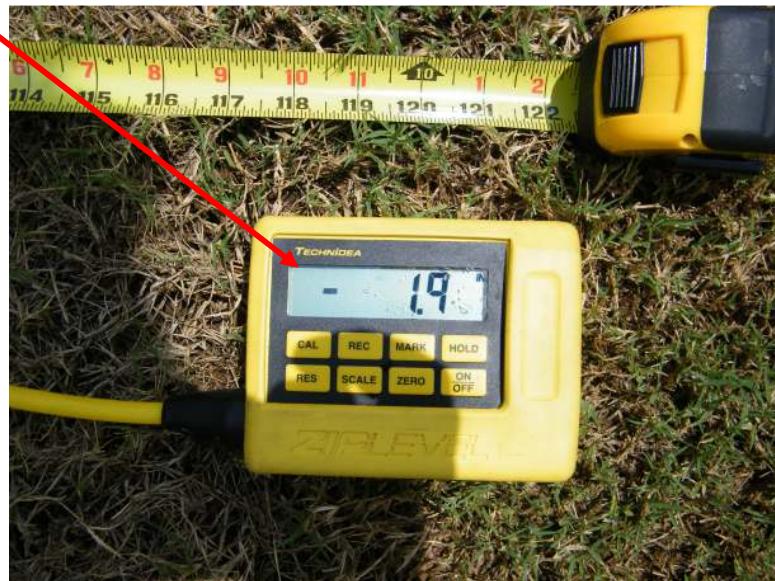
Grading not
code
compliant.

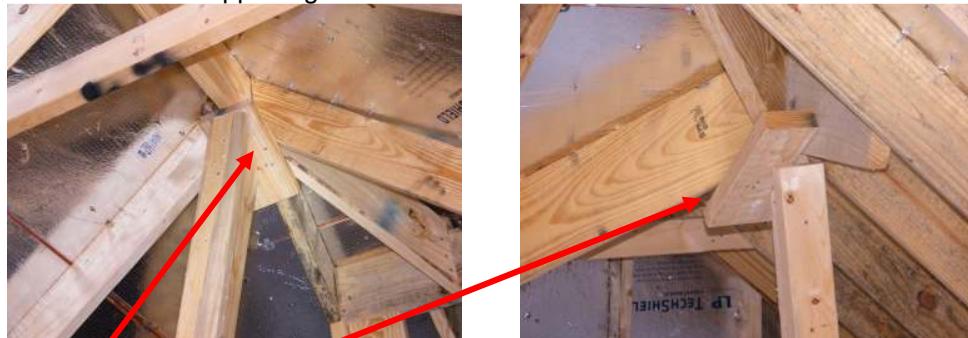
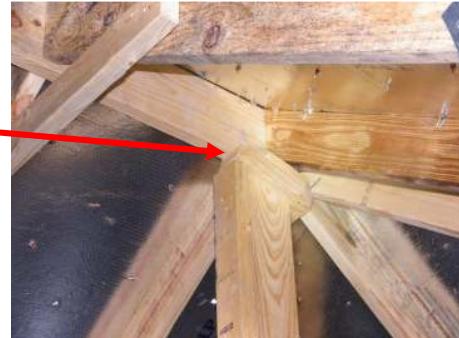
The ridge and hip, and/or valley rafters being supported by "palm braces" are not in compliance with IRC 801.2 Requirements. Roof and ceiling construction shall be capable of accommodating all loads imposed according to Section R301 and of transmitting the resulting loads to the supporting structural elements.

Engineer approval letter required for palm braces.

Additionally, this installation is not in compliance with IRC R802.3 Framing details. Rafters shall be framed to ridge board or to each other with a gusset plate as a tie. Ridge board shall

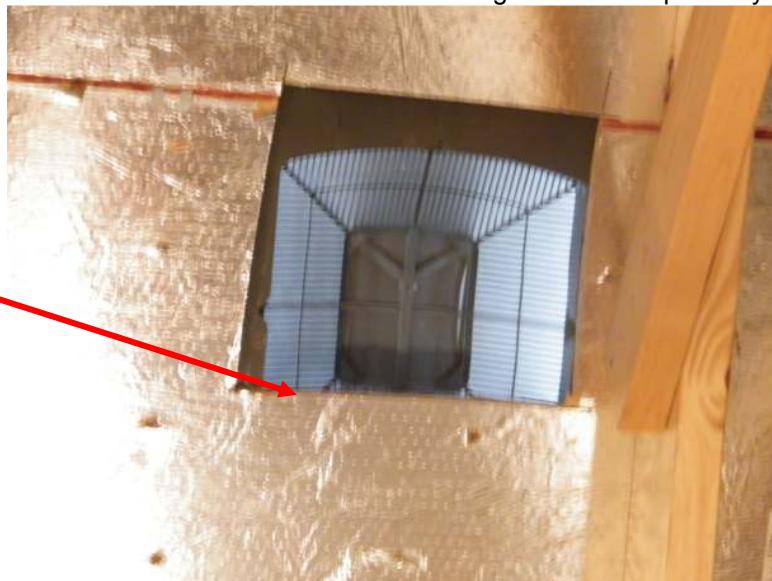
The roof decking has not been cut out to completely accommodate the sizing of the roof vents installed. This obstructs the flow of air through the attic required by IRC R806.2.

Roof deck cut out undersized.

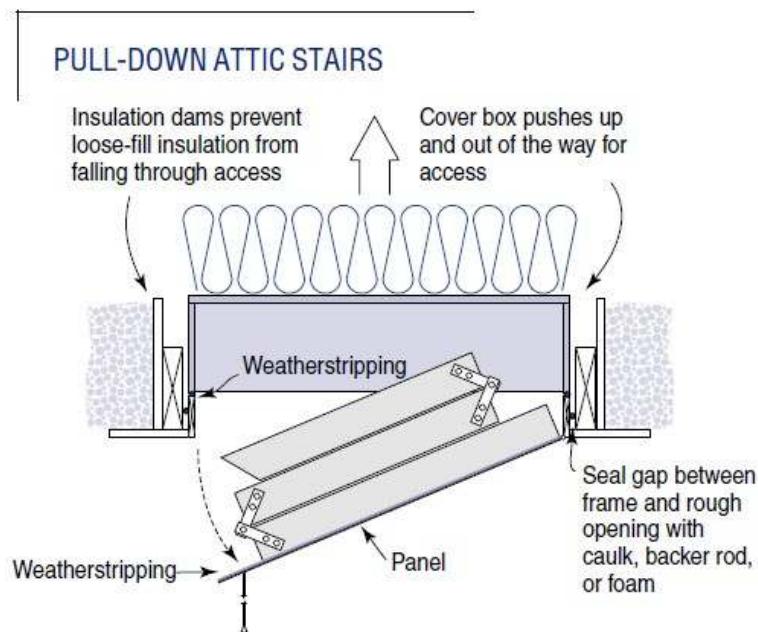
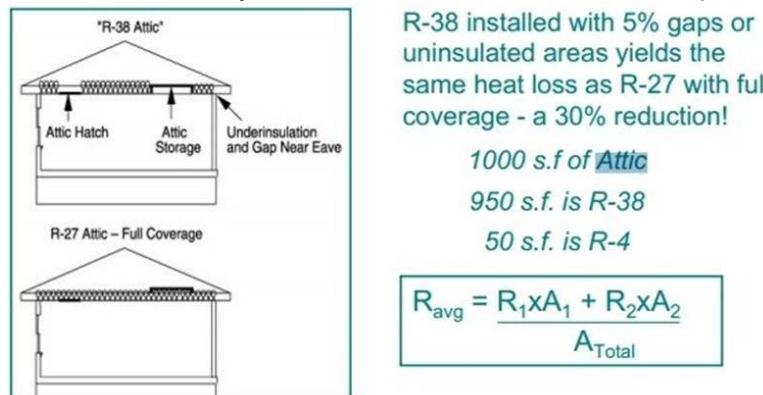
The attic stairs in the 2nd floor hallway must be insulated and gasketed as per N1102.2.3 Access hatches and doors. Access doors from conditioned spaces to unconditioned spaces (e.g., attics and crawl spaces) shall be weatherstripped and insulated to a level equivalent to the insulation on the surrounding surfaces. Access shall be provided to all equipment which prevents damaging or compressing the insulation. A wood framed or equivalent baffle or retainer is required to be provided when loose fill insulation is installed, the purpose of which is to prevent the loose fill insulation from spilling into the living space when the attic access is

Recent research by the U.S. Department of Energy shows that the lack of insulation in these places effectively decreases the R-value of the entire attic by as much as 30%. So this attic R-value is now effectively R-26, which is below the standard required by the 2009 IECC.

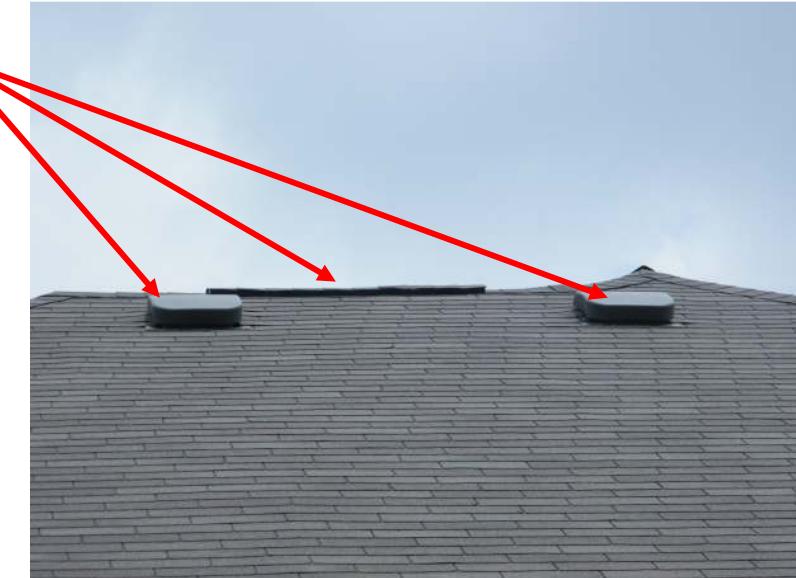
The placement of ridge vents and static roof vents near the ridge defeats the purpose of having soffit vents and drastically decreases the ventilation in the attic. The reason is simple. The attic is ventilated by means of a convection current where cooler air enters through the soffit vents and exhausts through the upper vents. The upper vents will draw air from the closest source. In this case the ridge vents will draw air from the upper static vents and not from the lower soffit vents. Additionally, if there is more net-free opening in the combined static vents than in the combined ridge vents air can actually be drawn into the ridge vents. During a rain storm this will cause leaks.

Ridge vents
should not be
placed adjacent
to static roof
vents.

The optimal situation is where the temperature in the attic is not more than 10° higher than that of the ambient exterior air. In this attic the temperature is > 20° higher. This is further proof that the attic is improperly vented.

You are strongly urged to have either the ridge or upper static roof vents removed whichever has the smaller net-free opening area. In this case the ridge vents should be removed.

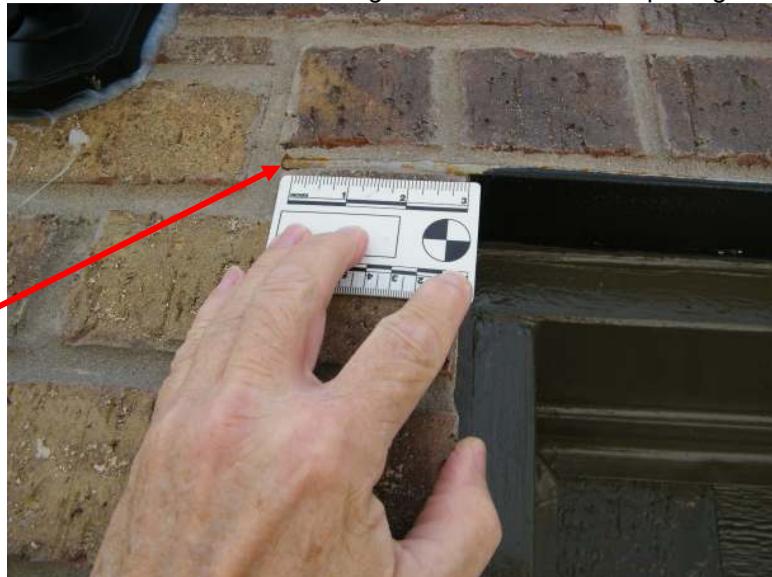
The lintel at the east side of the east garage door does not bear sufficiently on the brick veneer. All lintels over openings in the brick veneer are required by IRC R703.7.3 to have a minimum of four inches 4" bearing on either side of the openings.

Insufficient
lintel
bearing.

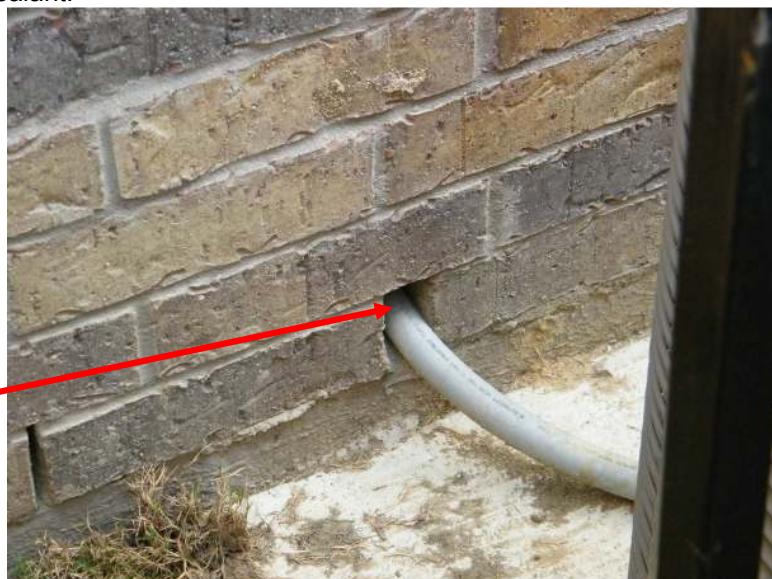
All utility penetrations of the exterior walls require sealing with a high quality low modulus sealant.

Sealant
required.

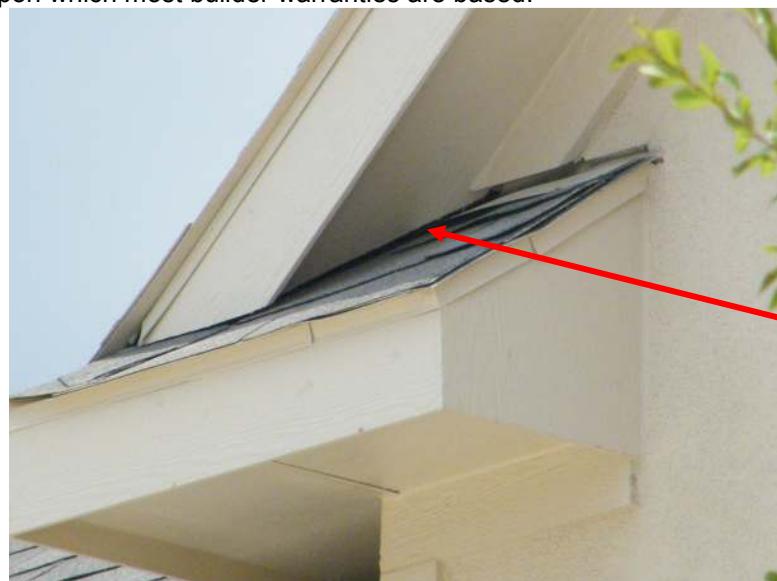
Openings in the eave returns (areas where the soffit meets an adjoining roof surface) shall not be large enough to allow entry by pests as per industry standards. Eave returns, truss blocks, attic vents and roof vent openings shall not allow rodents, birds, and other similar pests into home or attic space. If an eave return, truss block, attic vent or roof vent opening that allows rodents, birds, and other similar pests into home or attic space, the builder shall take such action as is necessary to bring the variance within the standard state in this section. The industry standard is 5-6-1 of the NAHB Residential Construction Performance Guidelines, upon which most builder warranties are based.

Vermin
entry point
not allowed.

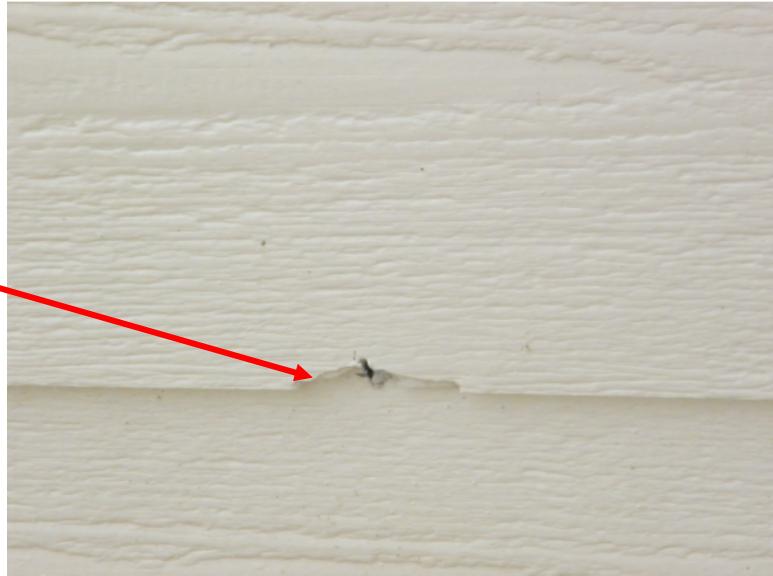
The siding is damaged to the west of the patio and in need of replacement.

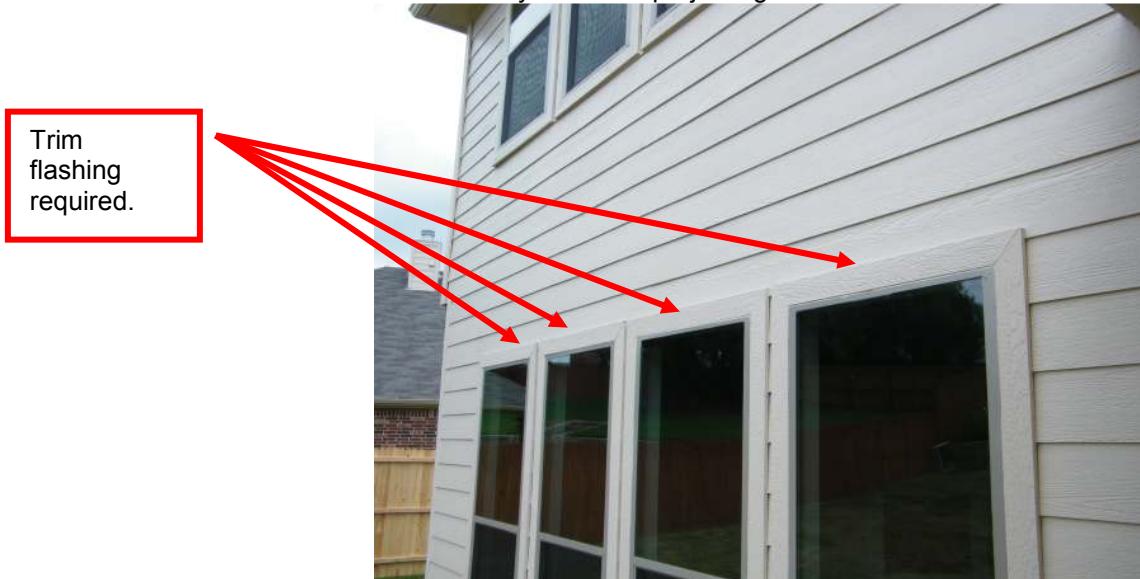
The soffit to the immediate east of the front porch is damaged and requires replacement.

Flashing is required atop all window and door trim.

IRC R703.8 Flashing. Approved corrosion-resistant flashing shall be provided in the exterior wall envelope in such a manner as to prevent entry of water into the wall cavity or penetration of water to the building structural framing components. The flashing shall extend to the surface of the exterior wall finish and shall be installed to prevent water from reentering the exterior wall envelope. Approved corrosion resistant flashings shall be installed at all of the following locations:

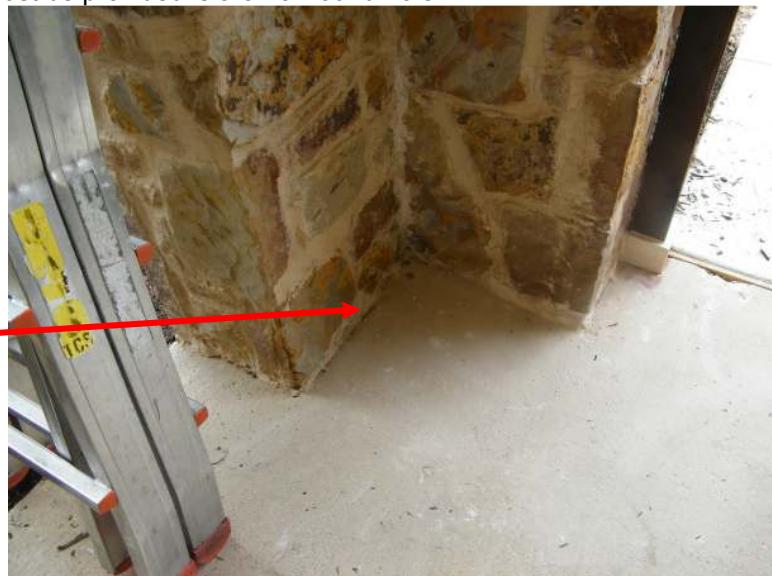
Blocked weep holes (openings in the mortar joints, typically found at foundation level) in the brick veneer wall structure must be cleared at the front porch and other locations where they are either closed or only partially opened as per International Residential, sections R703.7.5 and R703.7.6 and numerous other industry standards. The minimum size of weep hole that must be provided is a 3/16" round hole.

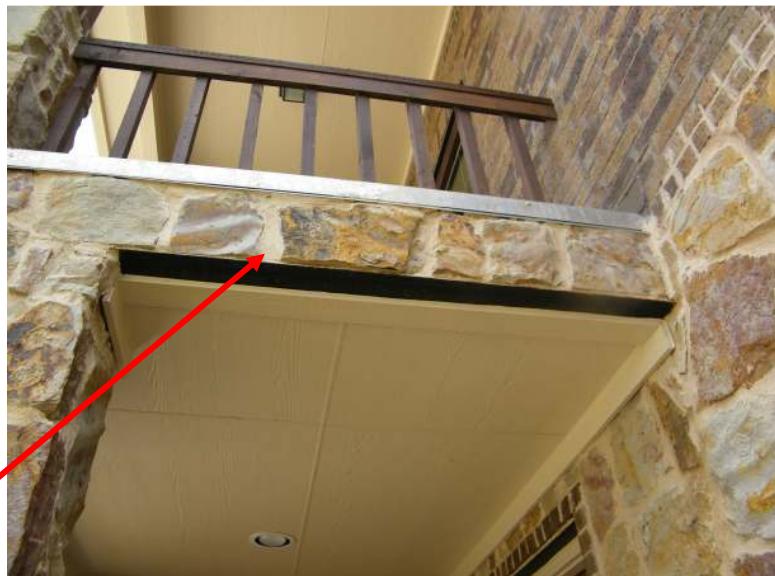
Weep holes and flashing material are required above and below all windows and above all doors with lintel-supported brick or stone veneer. International Residential Code sections R703.7.5 and R703.7.6 requires this detail not only on the first course of masonry above finish grade, but also at the tops and bottoms of windows and doors and above knee wall flashings where the brick is supported by a roof structure.

Weep holes
required @
33" o.c.

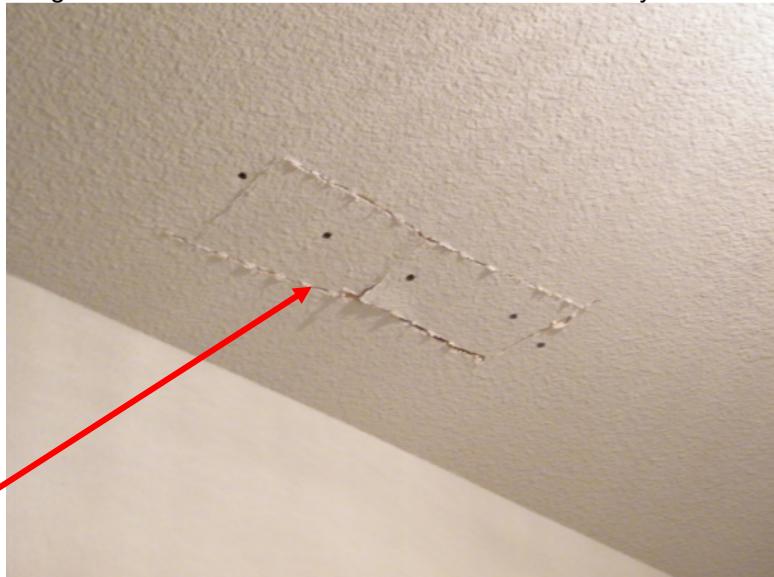
Damage to the interior finish was observed in the laundry room and should be repaired.

Drywall
repair
required.

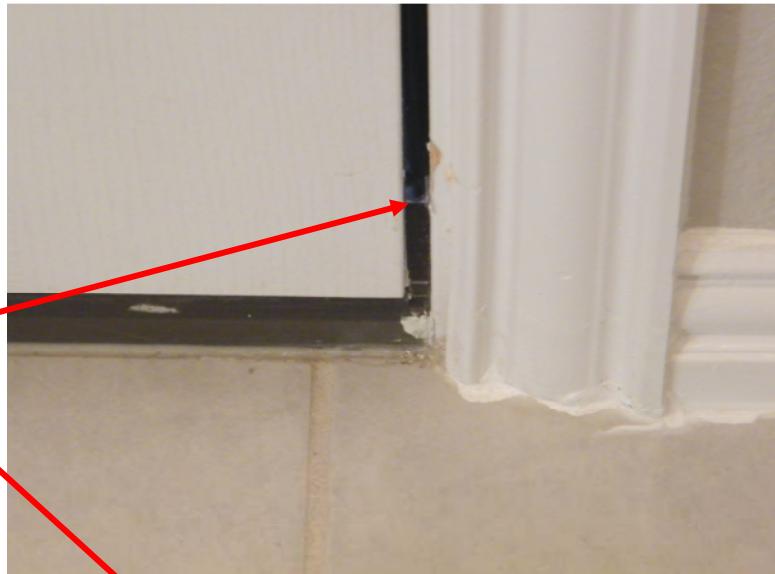
Light visible
due to no
seal pad.

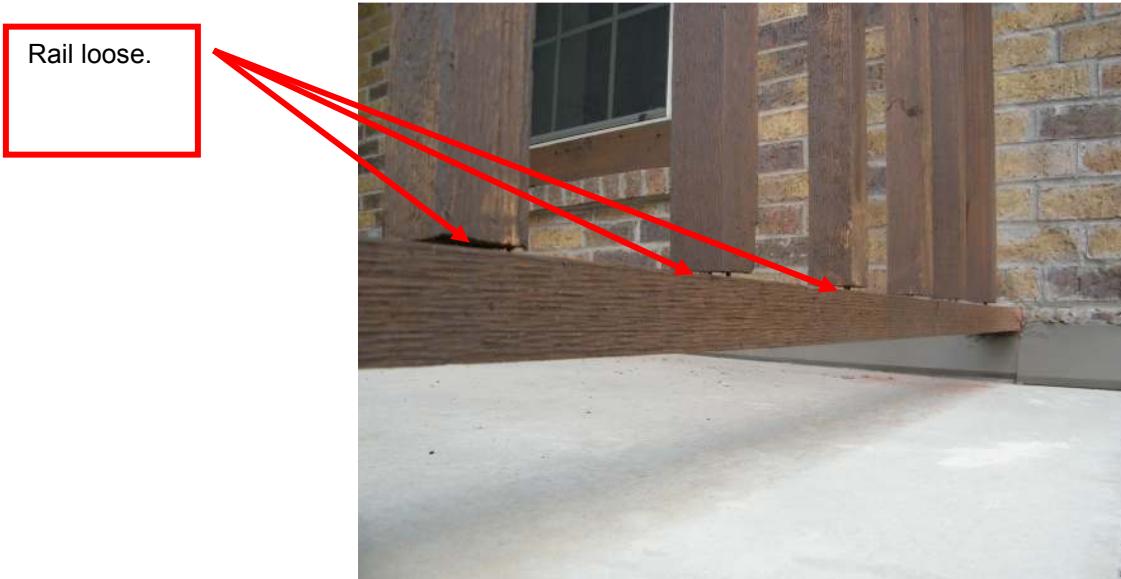
The bottom rail of the west balcony guard (handrail) is loose and requires improvement.

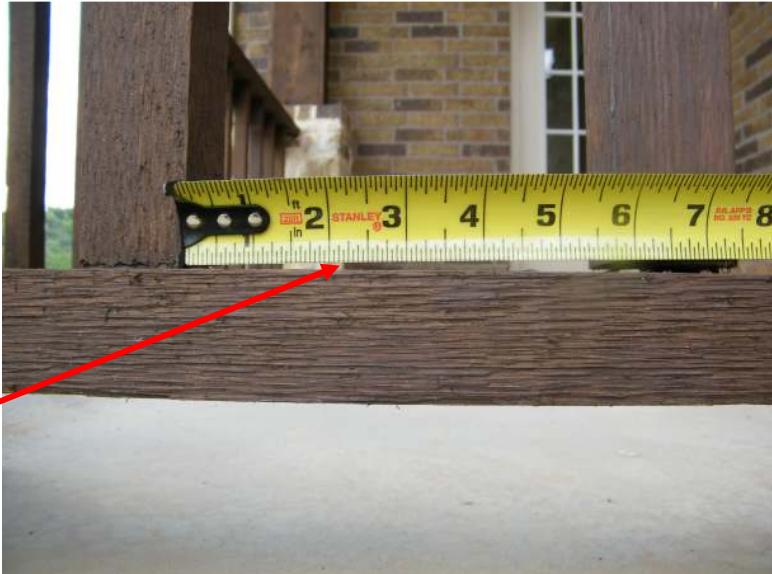
The openings in the balcony railing are large enough to allow an object larger than four inches to fall through. It is required that this condition be repaired for improved safety as per IRC 316.2.

Baluster
openings not
code
compliant.

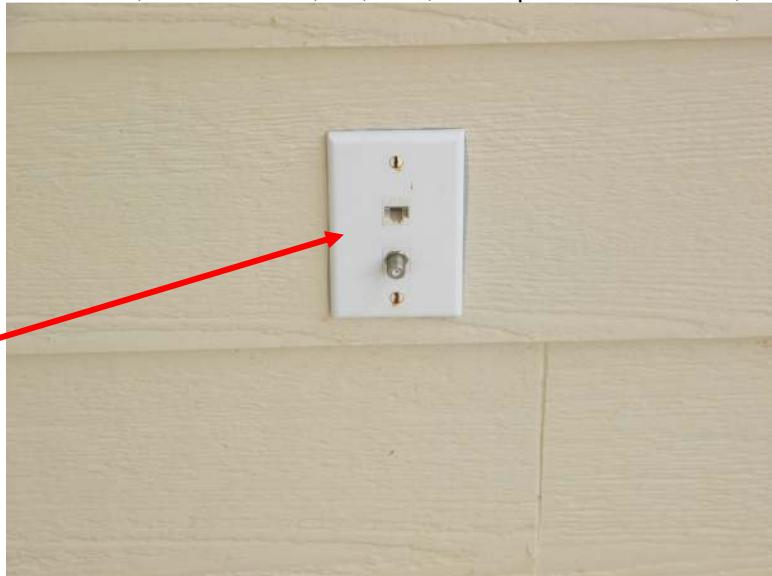
Must be listed and labeled for damp or wet use.

Additionally, the interior listed blank junction box cover plates being used are not UV resistant plastic and are not intended for use in damp or wet locations.
