# TEXAS INSPECTOR

## PROPERTY INSPECTION REPORT

### A. Foundations

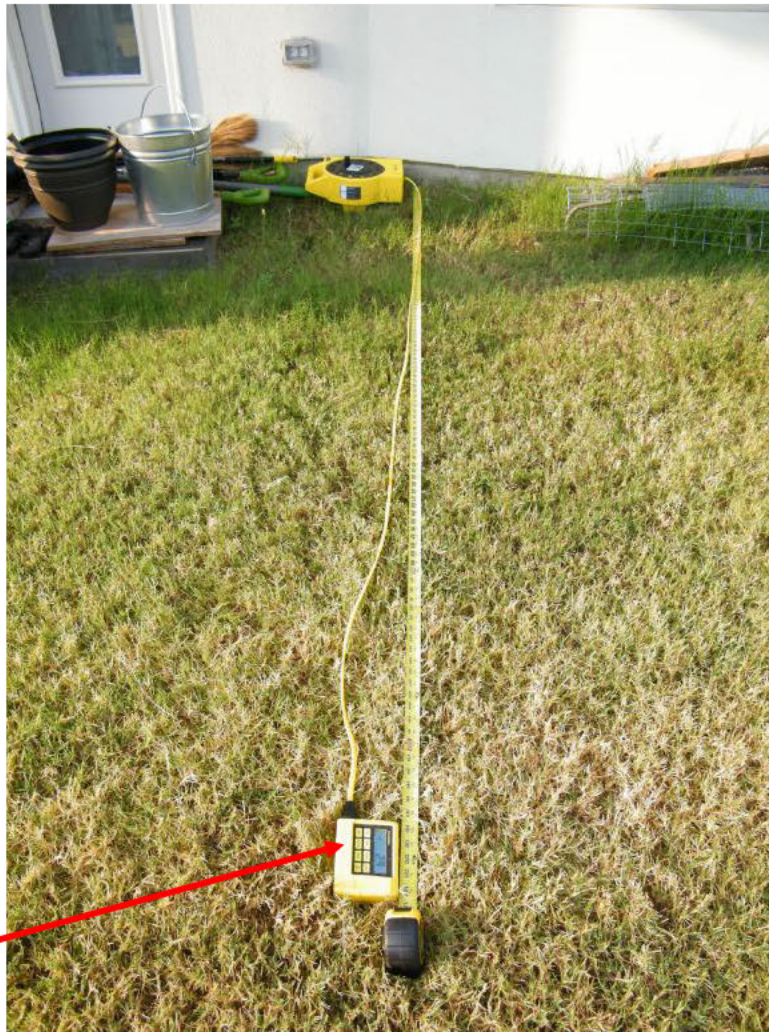
Grading  
west of  
patio is not  
code

The grading around the perimeter of the foundation must be improved to promote the flow of storm water away from the house. Grading specifications are spelled out clearly in International Residential Code (IRC) R401.3, "*Surface drainage shall be diverted to a storm sewer or other approved point of collection so as to not create a hazard. Lots shall be graded so as to drain surface water away from foundation walls. The grade away from foundation walls shall fall a minimum of 6 inches (152 mm) within the first 10 feet (3048)".* This is equivalent to the 5% grade required by the foundation design firm's engineer. **FAILURE TO MAKE THESE IMPROVEMENTS MAY EFFECTIVELY VOID YOUR FOUNDATION WARRANTY!**

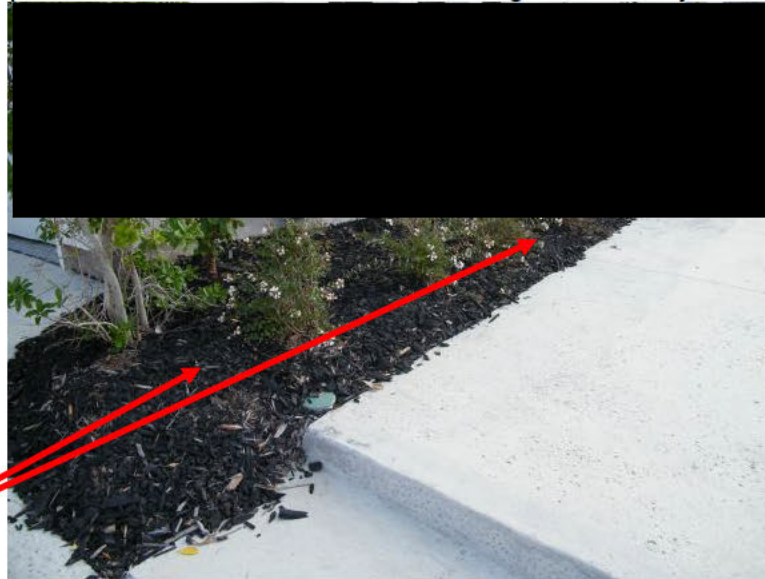
The builder has installed a perched drainage plane where water draining will be trapped between the approach sidewalk, driveway, and the foundation. This must be improved in order to prevent excess moisture from accumulating in the soil adjacent to the foundation.

Perched  
drainage  
plane.

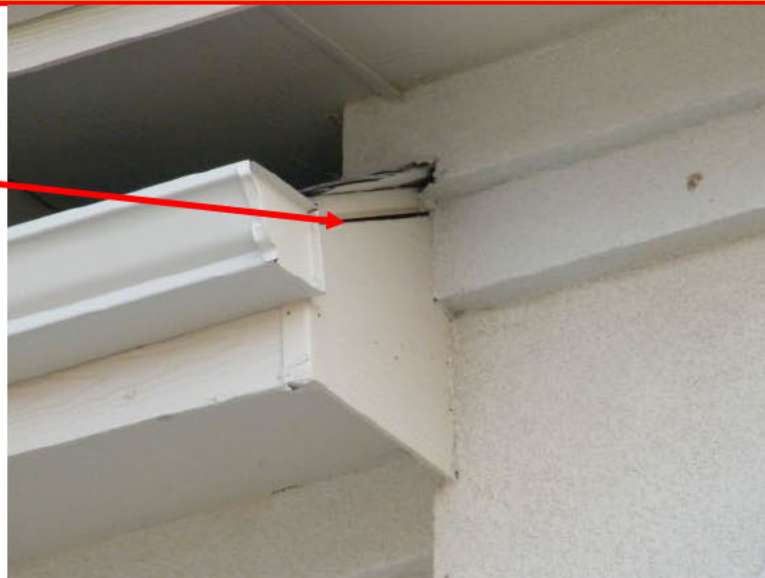
Drip edge does not cover top of fascia.

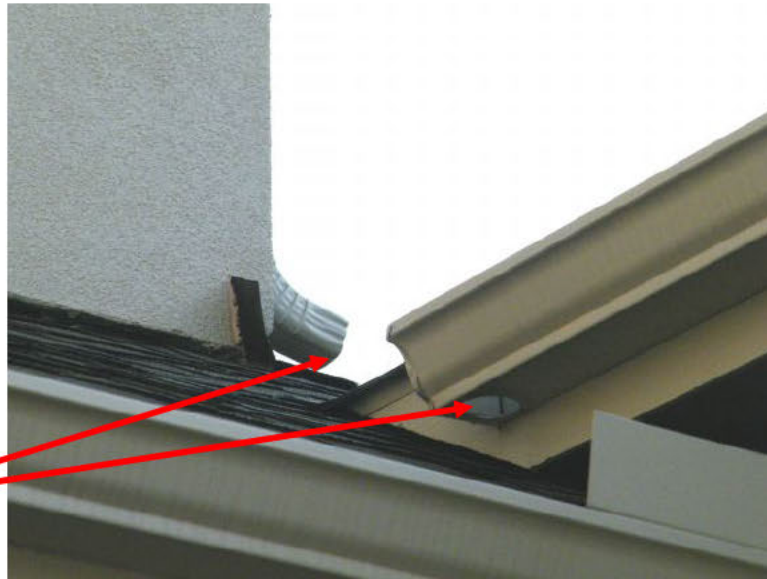
Spouts and gutters must not drain on roof.

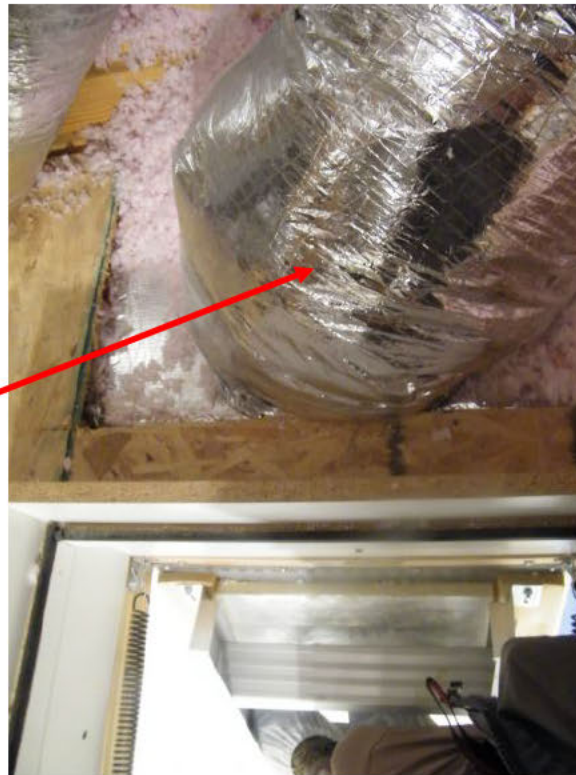
Duct  
obstructs  
access to  
attic.

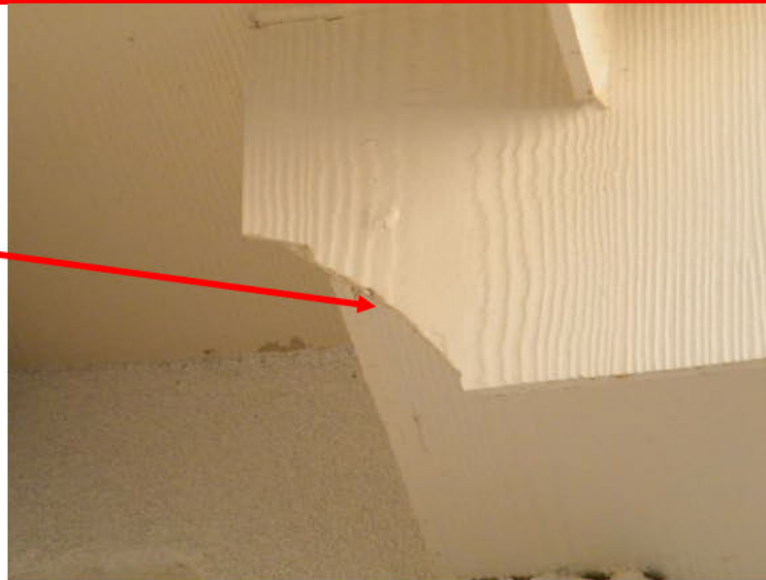
Fascia  
damaged.

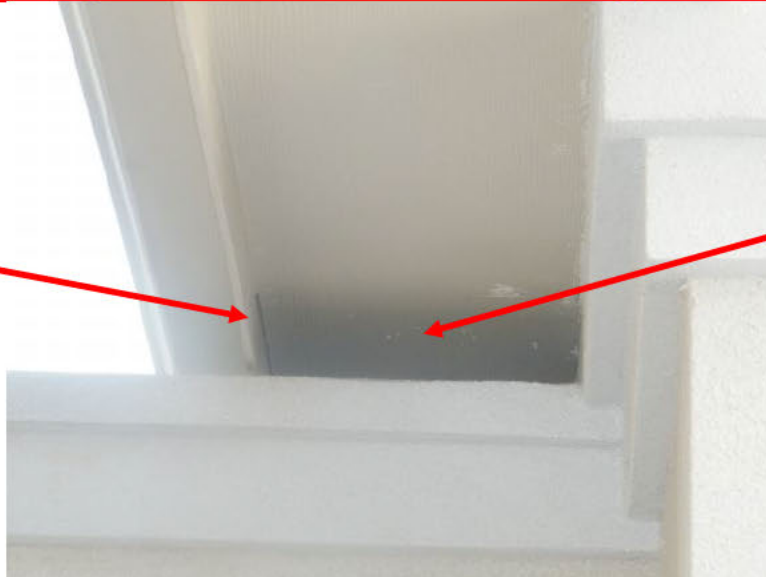
The soffit and fascia above the hinge side of the courtyard gate has not been caulked or painted as required by the materials manufacturer, IRC 102.4 and 703.1, and 703.10.1. From the builder's warranty:

Caulk  
missing.

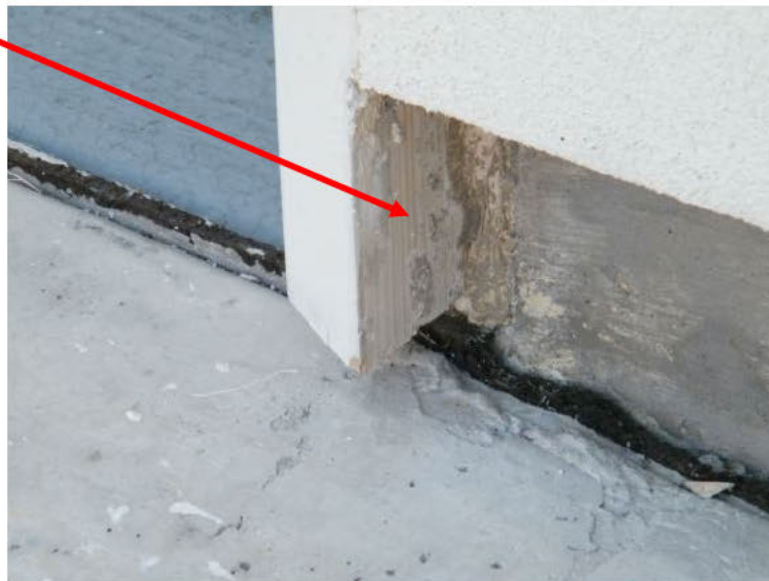
Paint  
doorjamb.

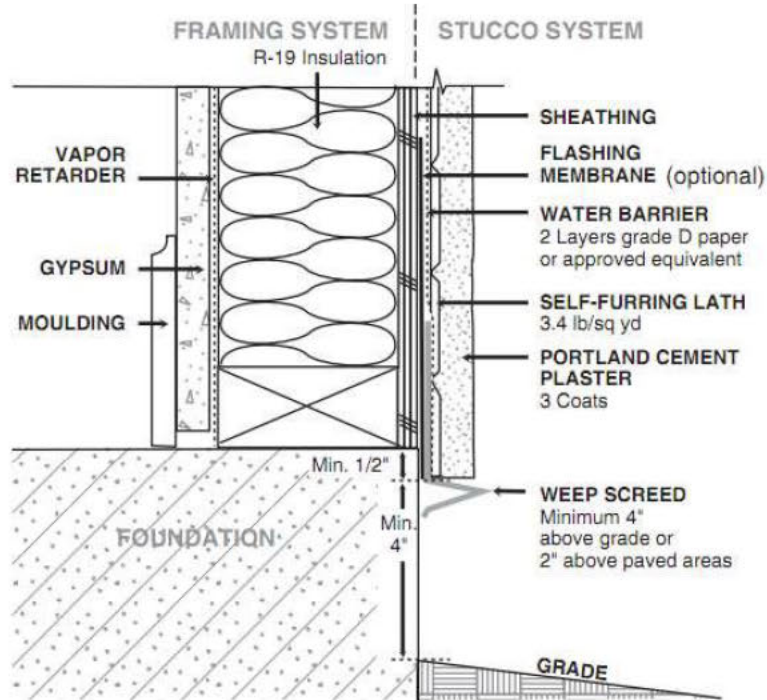
The stucco system at the courtyard and patio is installed too close to grade and flatwork as per IRC R703.6.2.1. This requires repair so that a minimum clearance is achieved of 4" above grade and 2" above paving. From the builder's warranty:

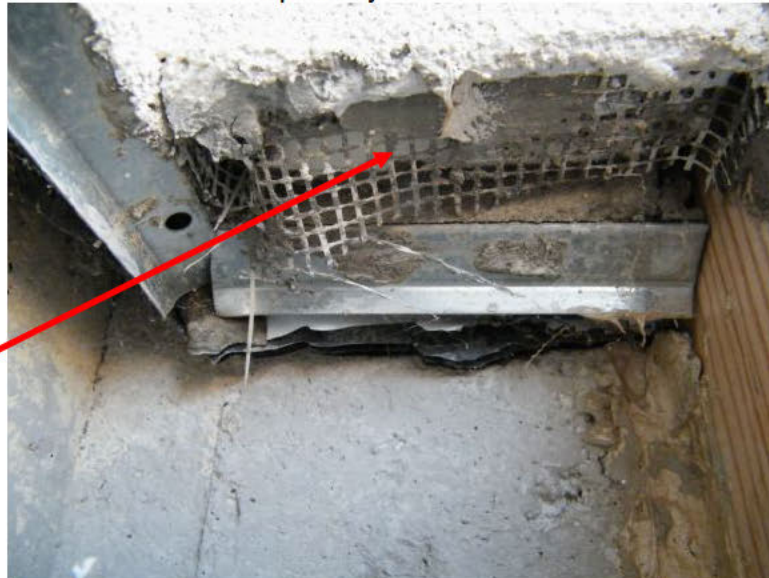
The bottom edges of the expanded polystyrene door trim on the north side jamb of the single garage overhead door must be backwrapped with mesh and coated with the stucco finish coat in all locations. This is required by IRC 703.6.

Trim not  
back  
wrapped.

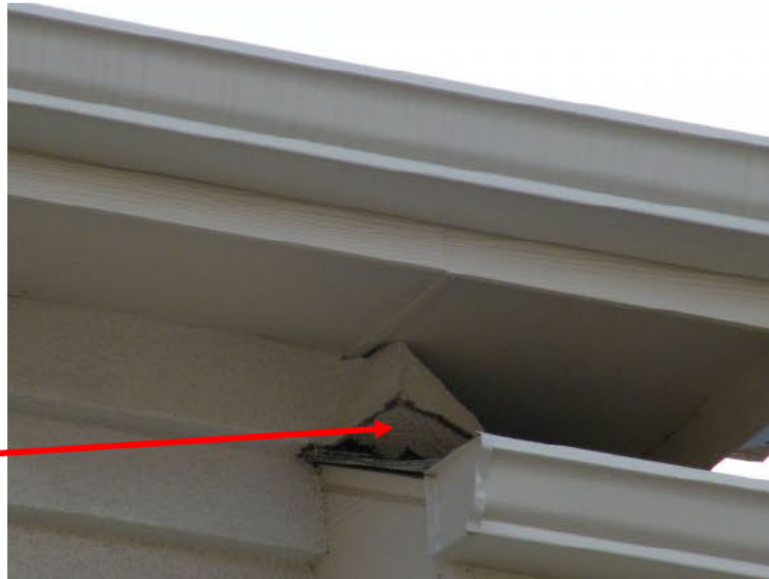
The EPS trim is damaged at the top of the wall above the single garage. Repair is required.  
From the builder's warranty:

EPS trim  
loose and  
damaged.

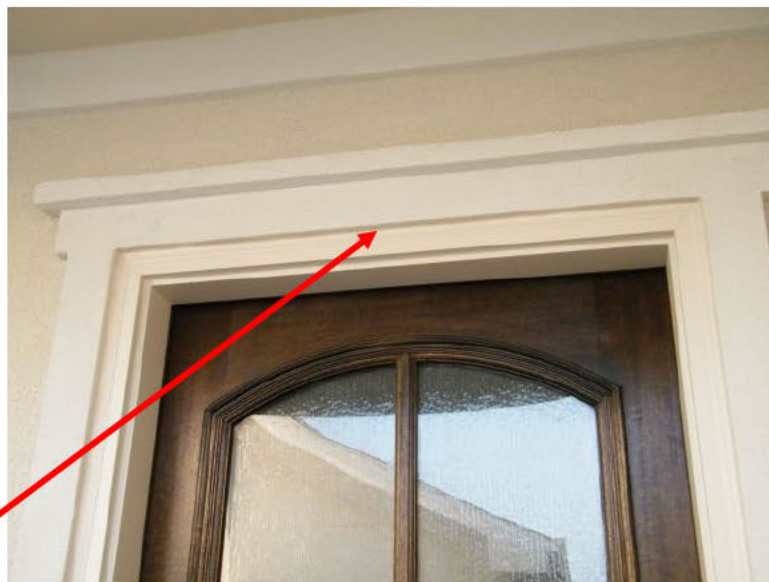
No header flashings are installed above the exterior door openings in the stucco cladding as required by IRC 703.8, ASTM E-2112, and AAMA 2400.

Header  
flashing  
required.

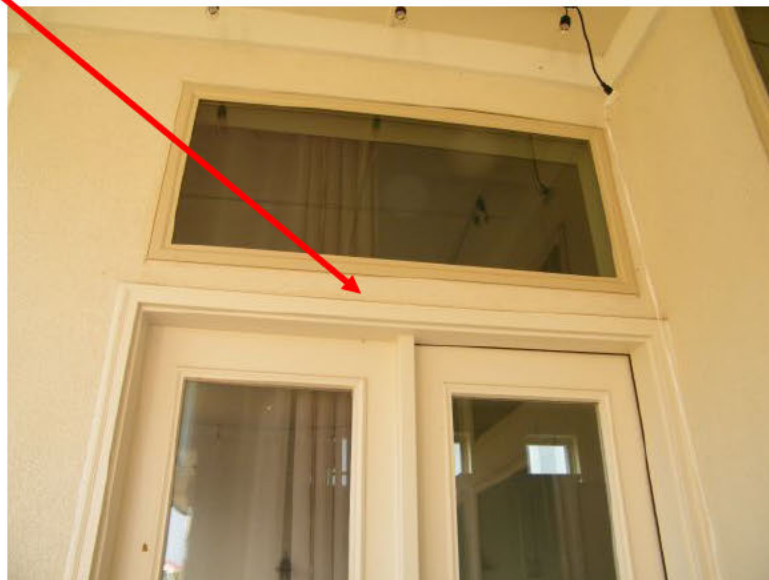
Header  
flashing  
required.

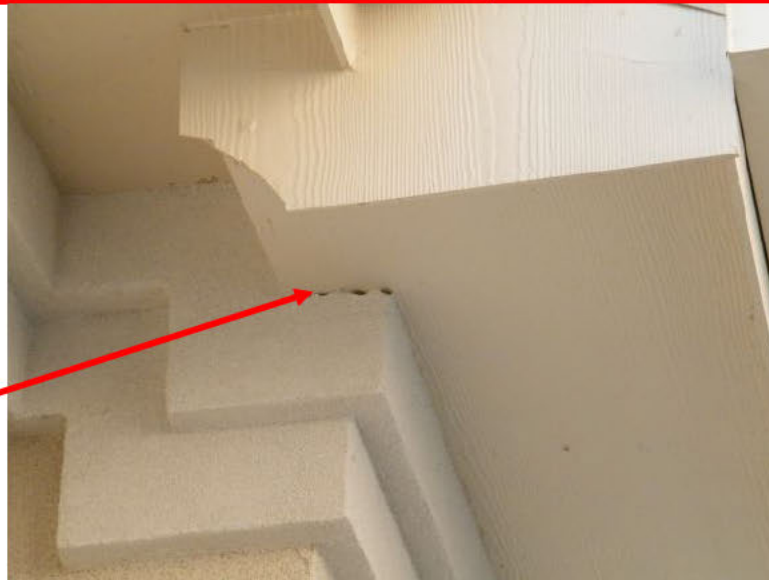
Sealant missing.

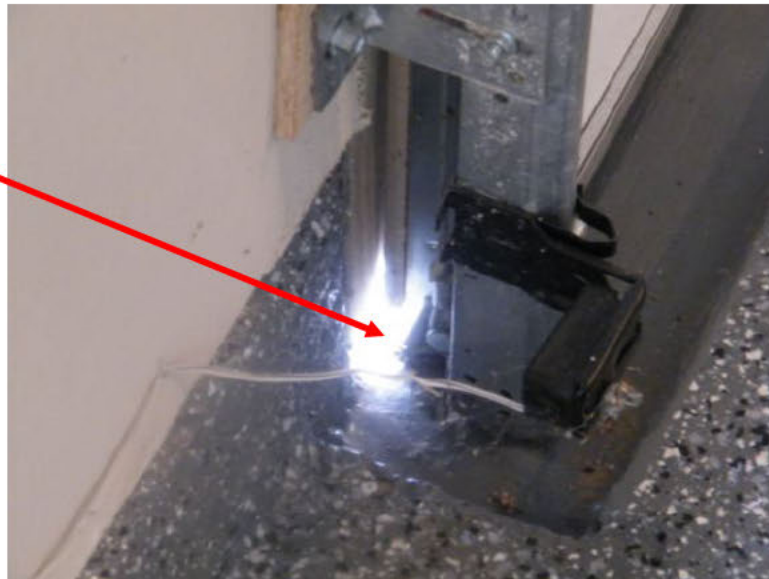
Vermin  
entry point  
not allowed.

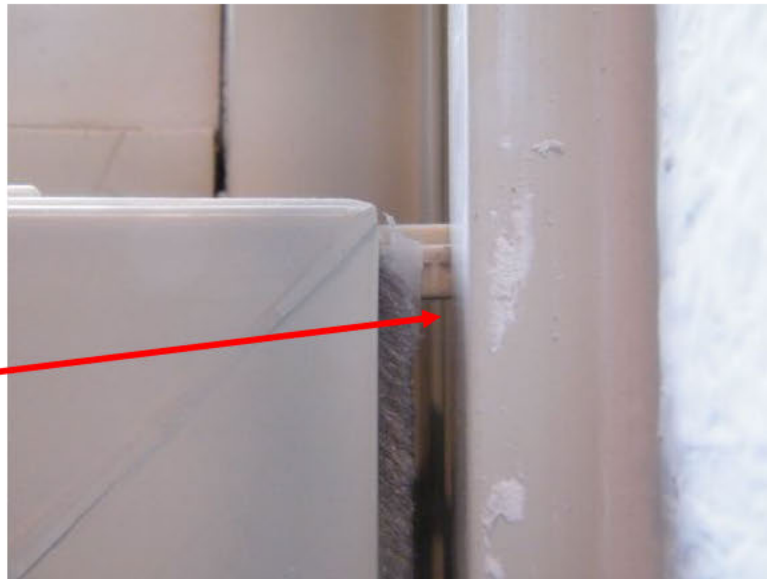
Gap due to  
splayed  
frame.

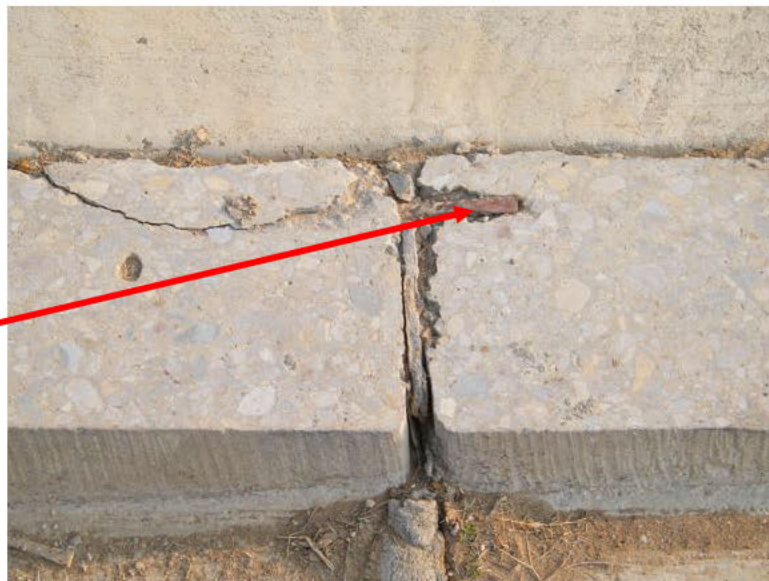
Rebar  
exposed in  
driveway.

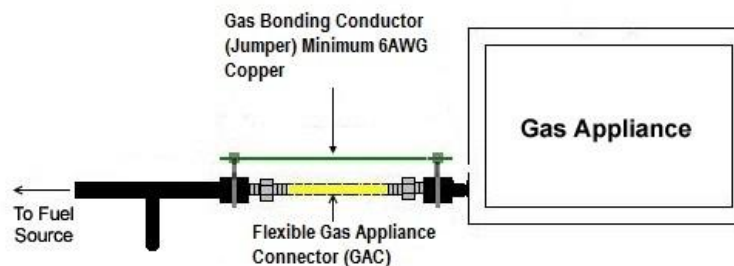
Solid copper bond jumpers from threaded steel gas piping to threaded steel gas piping at the cooktop(s), furnace(s) and water heater(s), et al., were not installed. The flexible gas appliance connectors are not designed or intended to be ground pathways and are not protected from “electrically induced fires”. A gas pipe shall not be used for grounding or as a grounding pathway as per NEC 250.104(B) and NEC 250.52(B). Flexible gas appliance connectors are similar in thickness and design to corrugated stainless steel tubing (CSST) gas piping material which is prone to damage from nearby (non-direct) lightning strikes which perforate the pipe and exacerbate fires. See “Google” - CSST litigation. See also “Electrically Induced Fires”, Fire Arson Investigator, July 1999 - [http://goodsonengineering.com/wp-content/uploads/2011/08/ElectricallyInducedFuelGasFires\\_web.pdf](http://goodsonengineering.com/wp-content/uploads/2011/08/ElectricallyInducedFuelGasFires_web.pdf)

##### **This is a fire and explosion hazard which requires immediate improvement!**

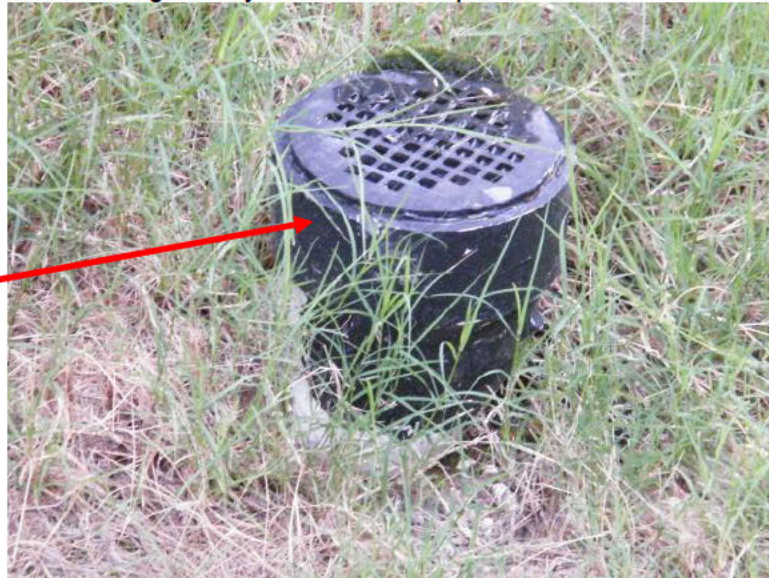
The purpose for the PVC pipe protruding from the ground near the gas meter is unknown. Further investigation by the builder is required.

Determine purpose of this.

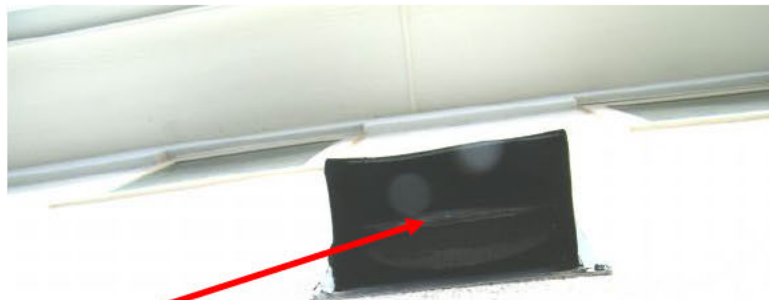
Damper  
does not  
close.

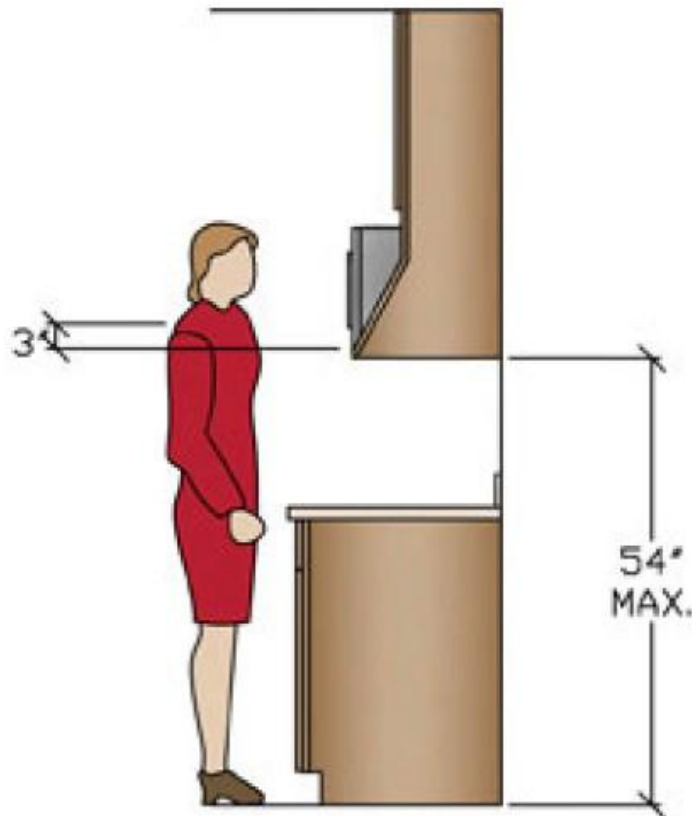
The microwave oven is located too high above the floor for safe use as per the Kitchen and Bath Association. 54" is the optimal maximum height from the floor to the bottom of the door.

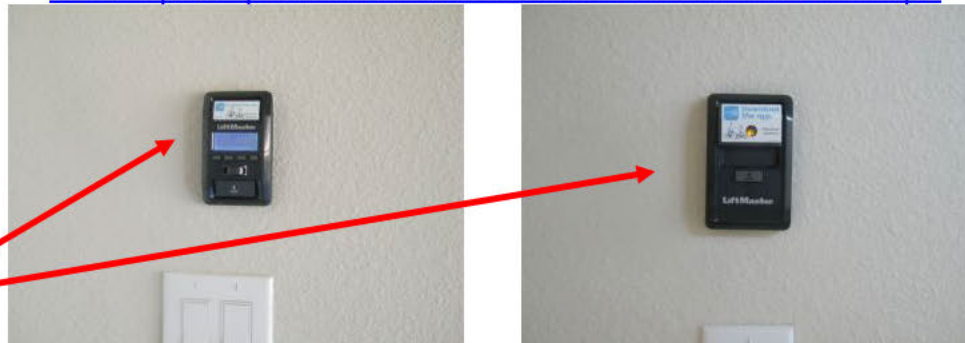
The DASMA-required warning labels and tags were not posted as required. This is hazardous and posting of the labels prior to the end of any time periods associated with the purchase of this home is strongly urged. See: <https://www.dasma.com/wp-content/uploads/pubs/TechDataSheets/CommercialResidential/TDS172.pdf>

DASMA  
signage  
missing.
