# TEXAS INSPECTOR

## PROPERTY INSPECTION REPORT

**By:** Aaron D. Miller, ACI, CEI, CMI, CPI, CRI, MTI, RCI [REDACTED]

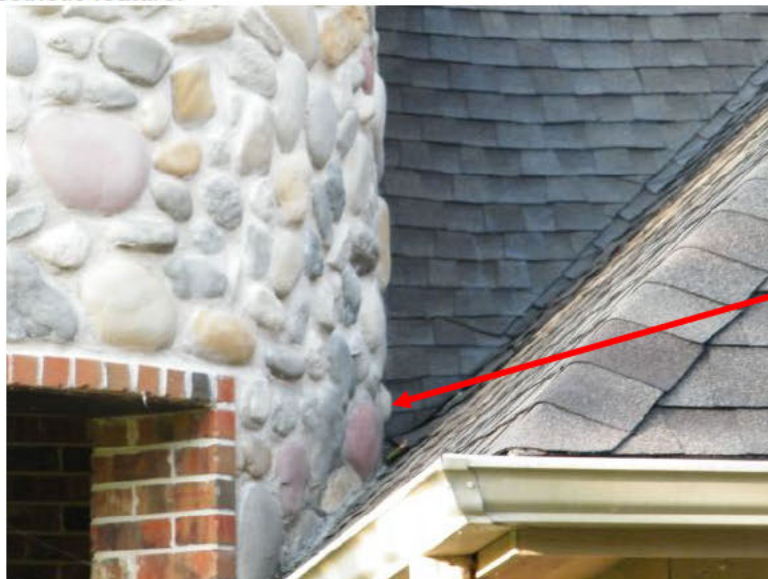
There is a flat valley at the east end of the balcony and a dead valley at the west side of the turret in the front of the house. The term "dead (flat) valley" is used to indicate a valley on a pitched roof that terminates into a flat or low slope area. This low slope allows water to pool and can lead to leaks even if it is underlaid properly. Building a flat roof valley is no different than a plumber installing a drainpipe that is flat for a few feet just to accommodate some aesthetic feature.

Dead valley.

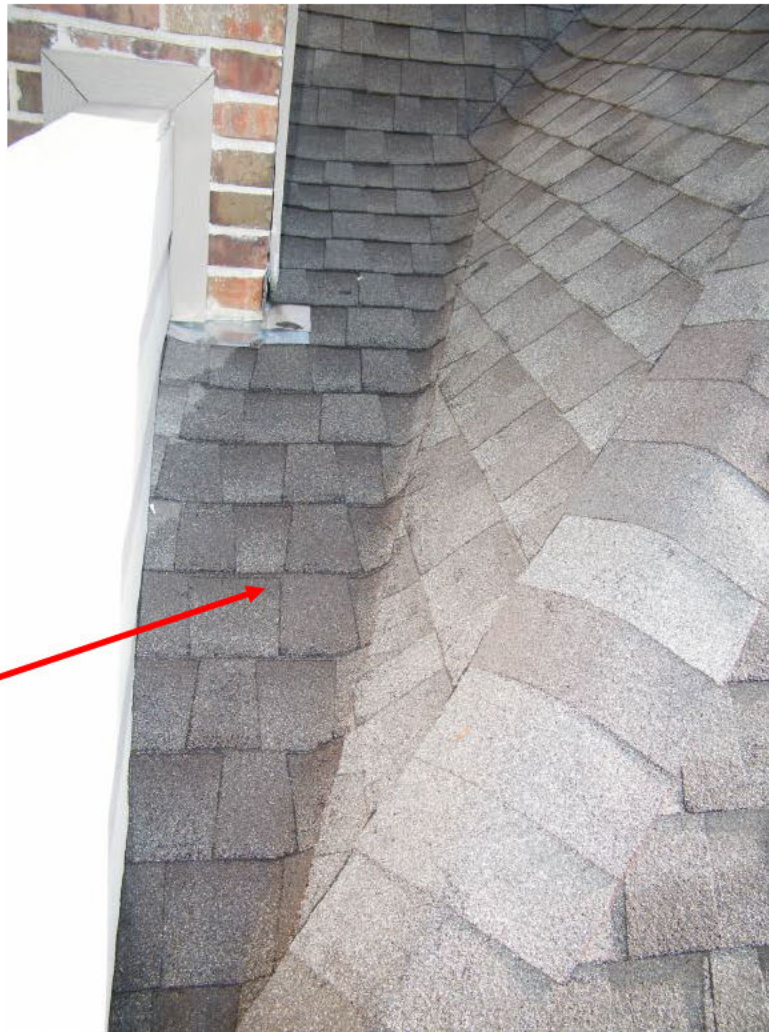
Flat valley.

Dead valleys are flat valleys that terminate at a knee wall. All valleys must be designed to have a clear drainage channel off of the roof –i.e. no dead valleys. This is a violation of IRC R903.1 General. Roof decks shall be covered with approved roof coverings secured to the building or structure in accordance with the provisions of this chapter. Roof assemblies shall be designed and installed in accordance with this code and the approved manufacturer's installation instructions such that the roof assembly shall serve to protect the building or structure. (Commentary) In all cases, a roof must be designed to provide protection from the elements. For the roof to adequately perform this function, it must be designed in accordance with this chapter. This section requires flashing where the roof intersects vertical elements such as walls, chimneys, dormers, plumbing stacks, plumbing vents and other penetrations of the weather-protective barrier.

Roof drainage to remove water from the roof to an approved location is also regulated. This also violates IRC 903.2 Flashing. Flashings shall be installed in a manner that prevents moisture from entering the wall and roof through joints in copings, through moisture permeable materials and at intersections with parapet walls and other penetrations through the roof plane.

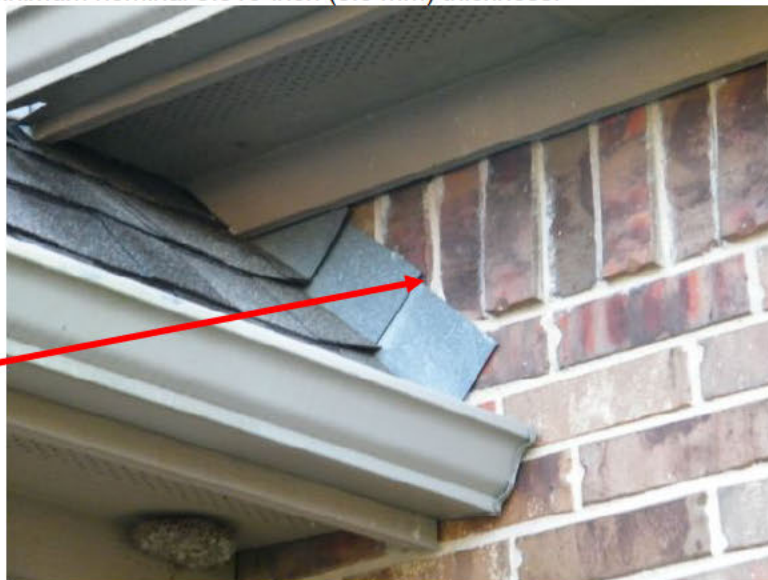
Cap  
flashing  
missing.

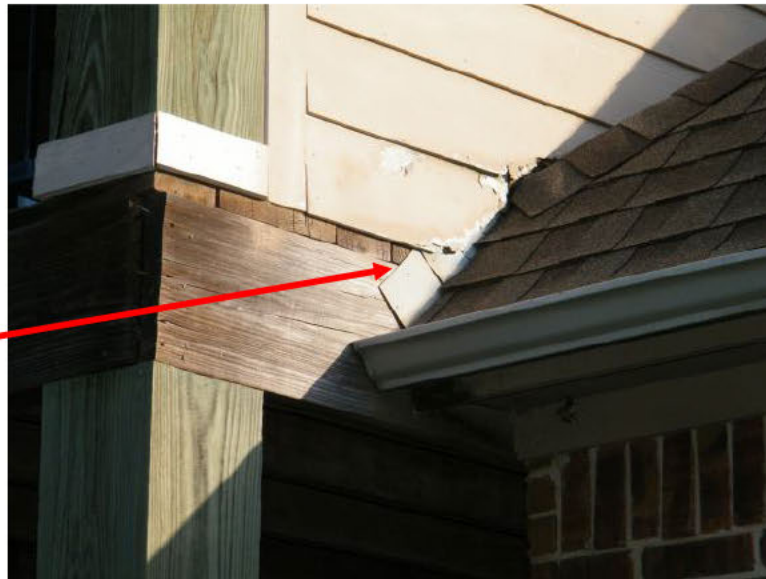
Cap  
flashing  
missing.

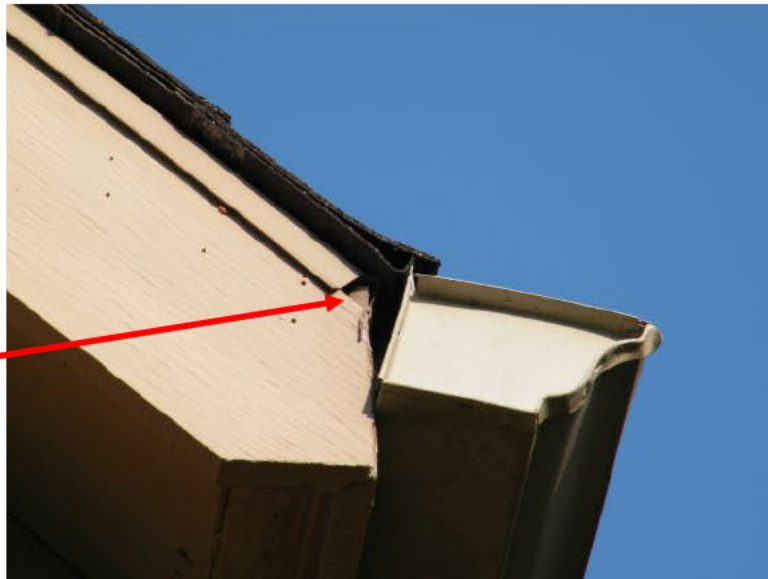
The drip edge flashing is improperly cut at an outside corner near the northeast corner of the house. These corners should be formed by making a single cut through one leg of the flashing and then bending the remaining leg at a 90-degree angle. This bend should place the rake portion of the flashing above the eaves portion so that moisture will drain past the overlap. The improper manner in which these cuts have been made negates the effectiveness of the flashing and will lead to water damage in these areas in the near future. This flashing has been installed in violation of the shingle manufacturer's installation instructions, IRC 102.4, 903.1 and 903.2:

Drip edge  
improper.

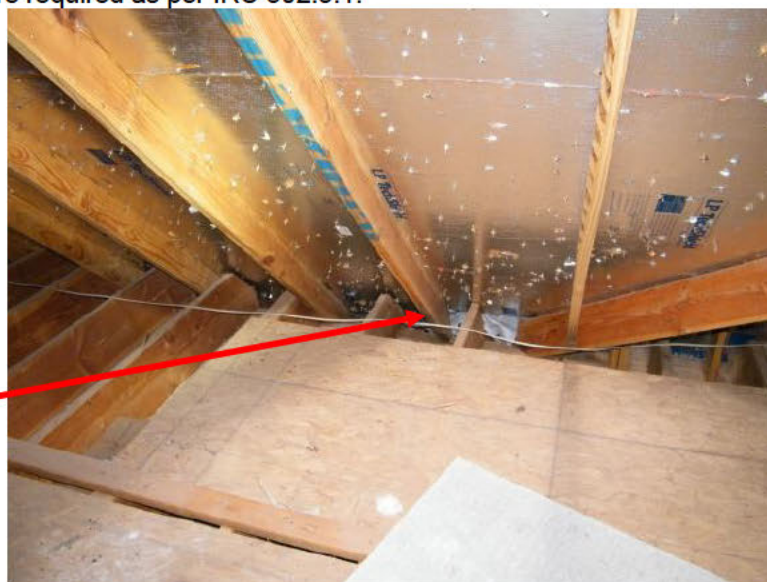
The rafters are not tied together at the top plates with the parallel ceiling joists and rafter ties are required as per IRC 802.3.1.

Rafters not tied to joists.

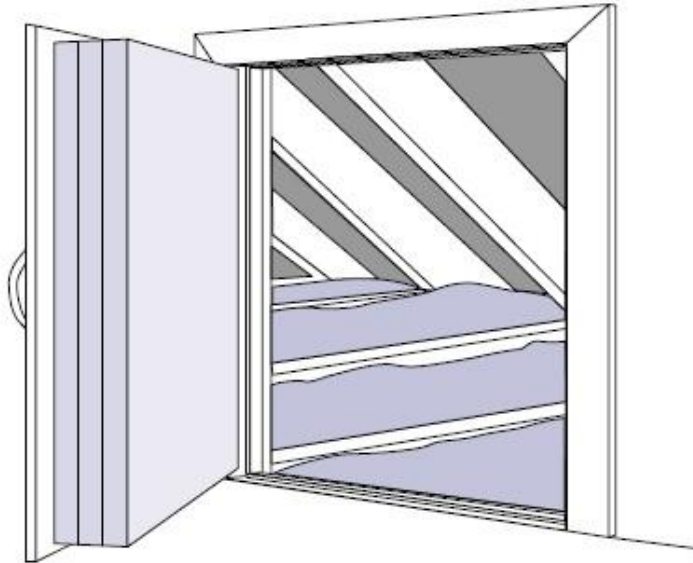
The hollow core side wall door at the second floor attic entrance is rated at R-2.17 while the surrounding walls are insulated to R-13. 2.17 does not equal 13.

*Add R-value to a knee-wall door by adhering rigid insulation boards (sandwiched together with construction adhesive and screws) to the back of the door. Pay special attention to the clearance between the insulation and the door frame and air sealing details.*

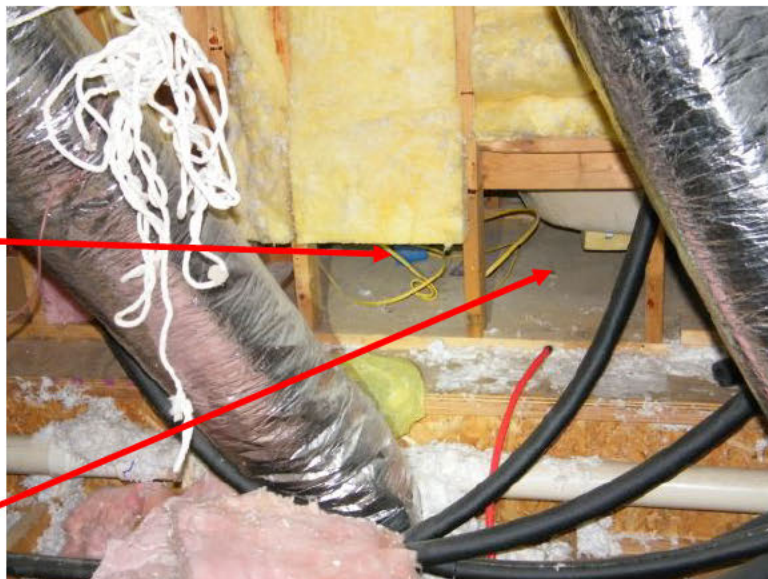
Insulation  
and drywall  
missing.

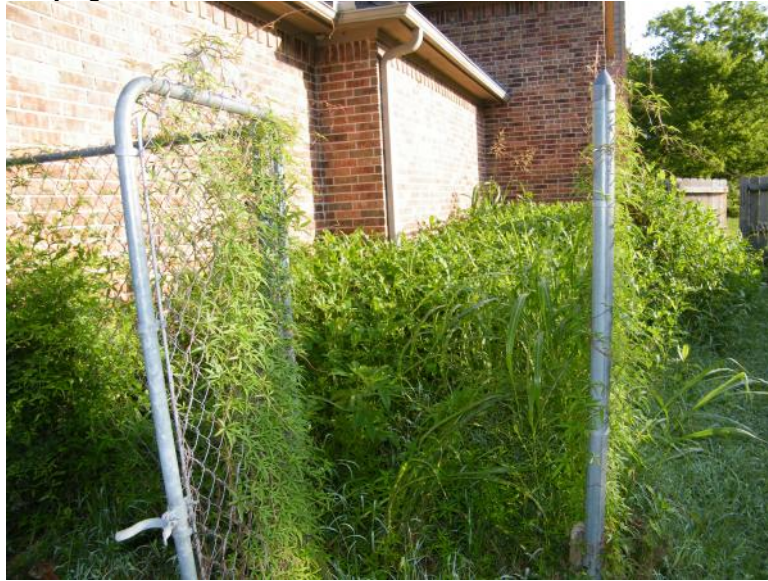
Vines and shrubs should be trimmed away from and not allowed to grow on exterior wall surfaces. Excessive vegetation against exterior walls is conducive to the attraction of wood destroying insects and the collection of excessive moisture on wall surfaces.

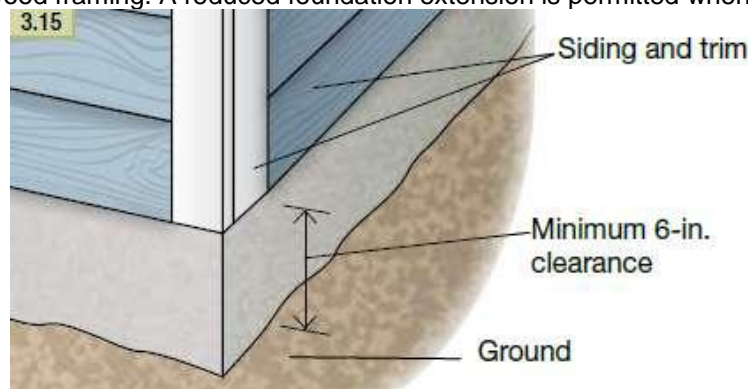
The siding is installed too close to grade at the northeast chimney chase as per the manufacturer's installation instructions (1"-2" to masonry and 6" to grade), and IRC 404.1.6 R404.1.6 Height above finished grade. Concrete and masonry foundation walls shall extend above the finished grade adjacent to the foundation at all points a minimum of 4 inches (102 mm) where masonry veneer is used and a minimum of 6 inches (152 mm) elsewhere. The minimum distance above adjacent grade to which the foundation must be extended provides termite protection and minimizes the chance of decay resulting from moisture migrating to the wood framing. A reduced foundation extension is permitted when masonry veneer is used.

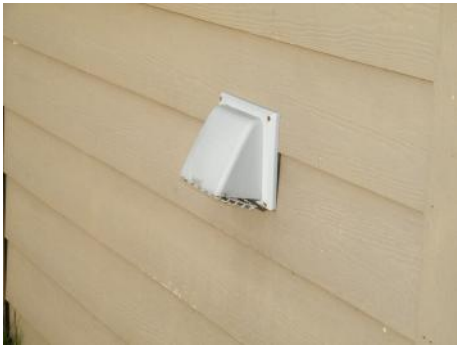
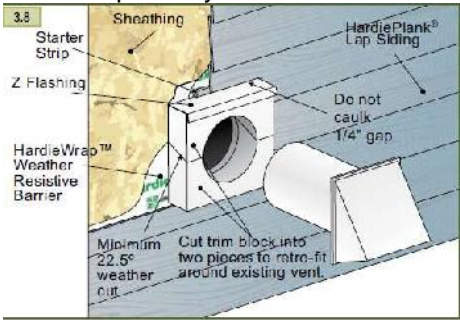
The utility penetrations in the siding have not been flashed as per the siding manufacturer's installation instructions. This is required by IRC 102.4 and 703.10.2.

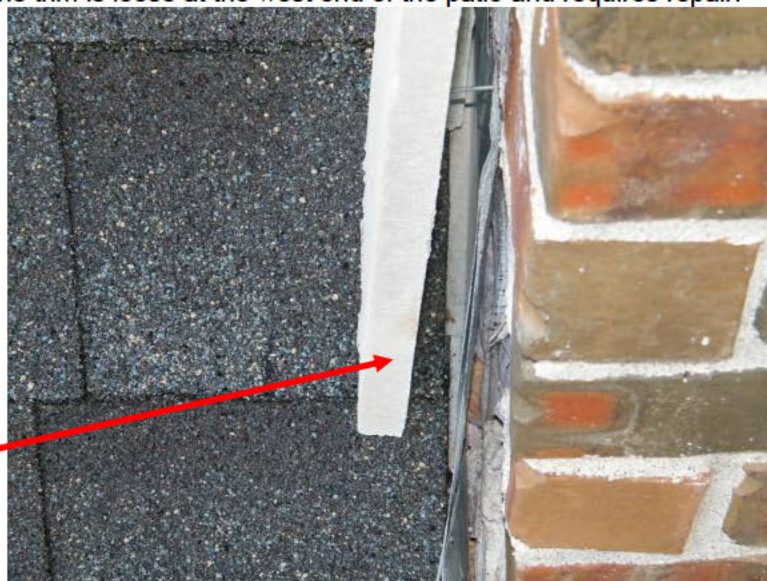
The trim is loose at the west end of the patio and requires repair.

Trim loose.

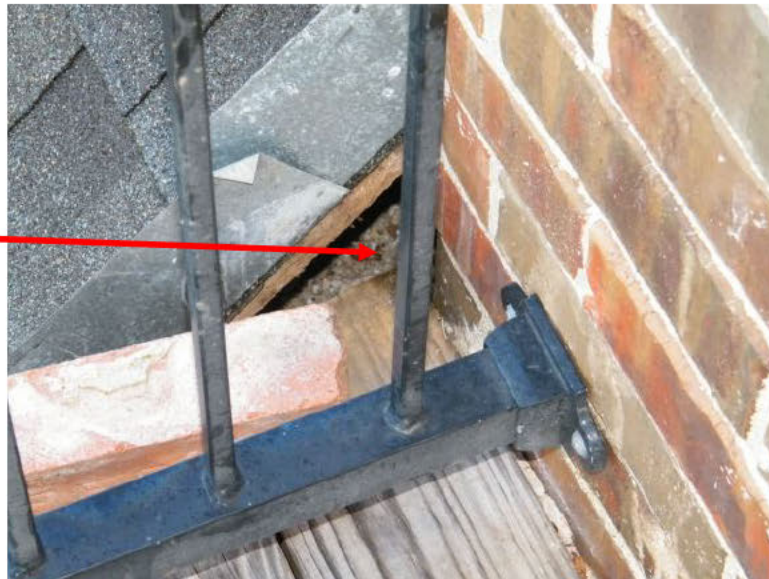
Vermin  
entry point  
in fascia.

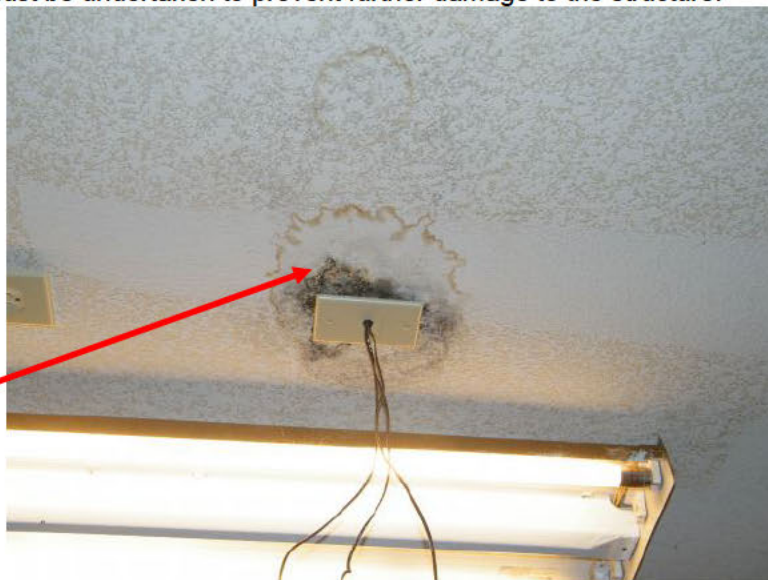
Water damage and mold garage.

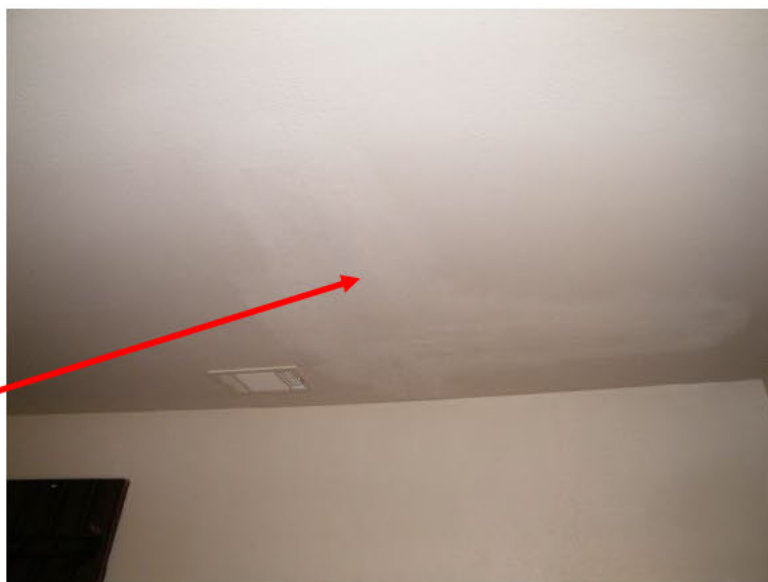
Water damage game room.

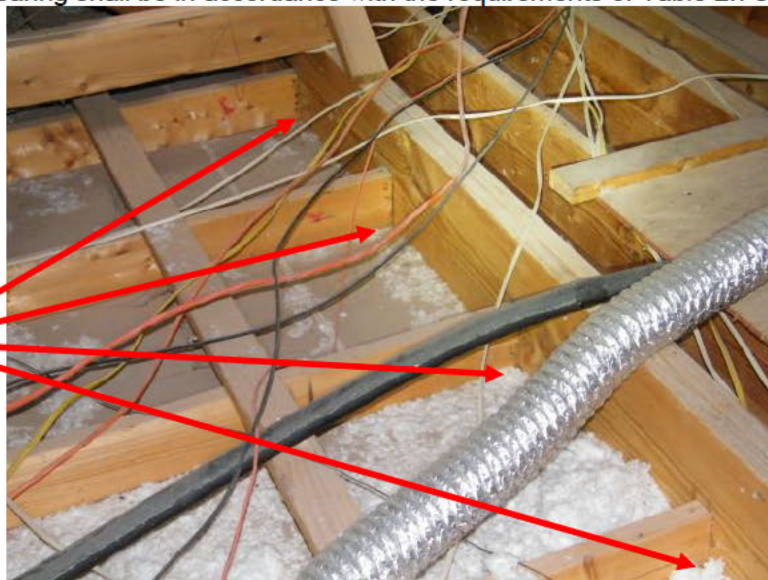
Joist hangers are missing in the attic above the garage. The floor or ceiling joist must be supported on each end by a top plate, ledger strip or joist hanger as per IRC 502.6.2. This is also a requirement in the National Design Standard, which is a referenced standard in the International Residential Code. NDS 2.3.1.2 Bearing Joists shall bear directly on beams, girders, ledgers, or load-bearing walls or be supported by hangers or framing anchors. Joist bearing shall be in accordance with the requirements of Table 2.7C.

Joist  
hangers  
missing.

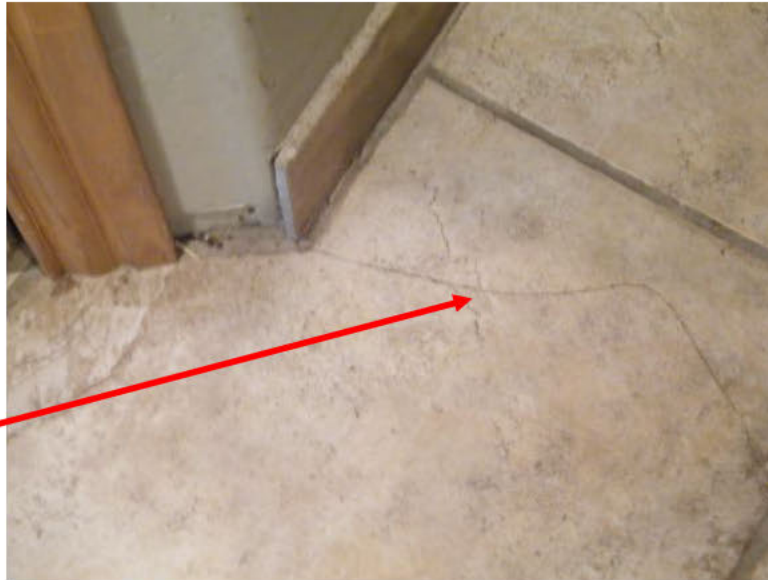
Tile crack  
kitchen.

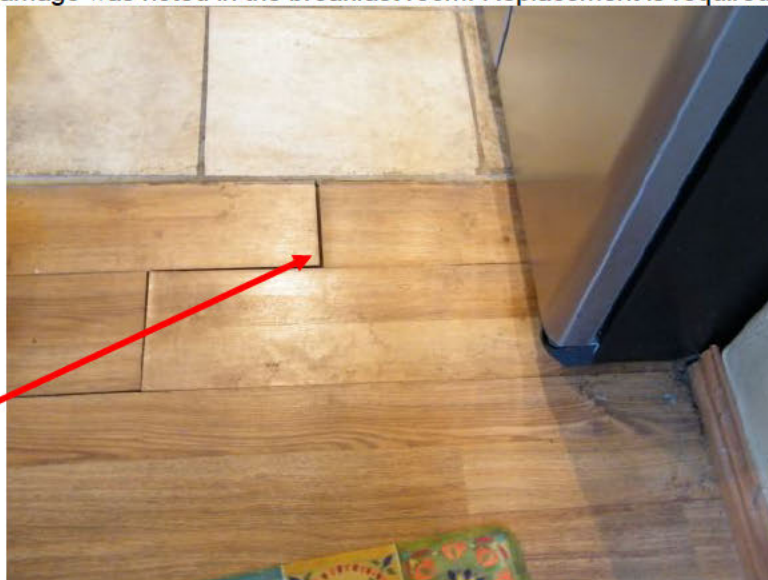
Water  
damage to  
flooring.

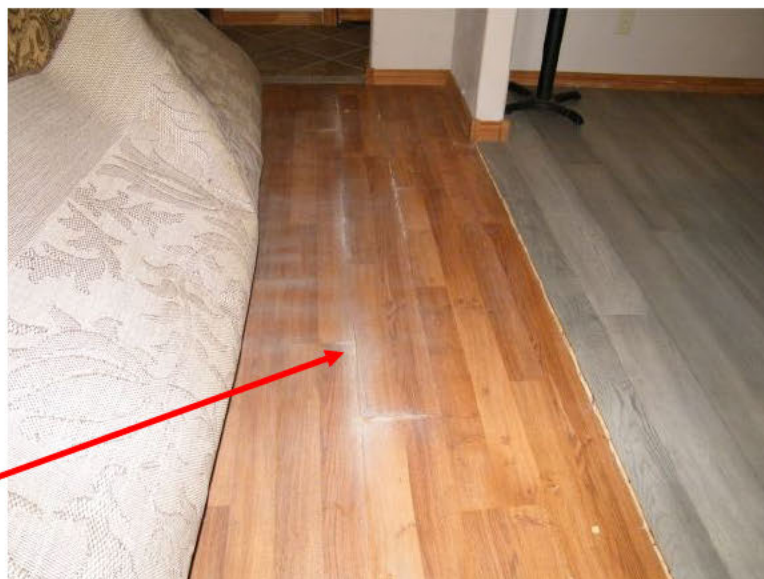
Poor repair in the north side of the family room is evident.

Unsightly  
repair.

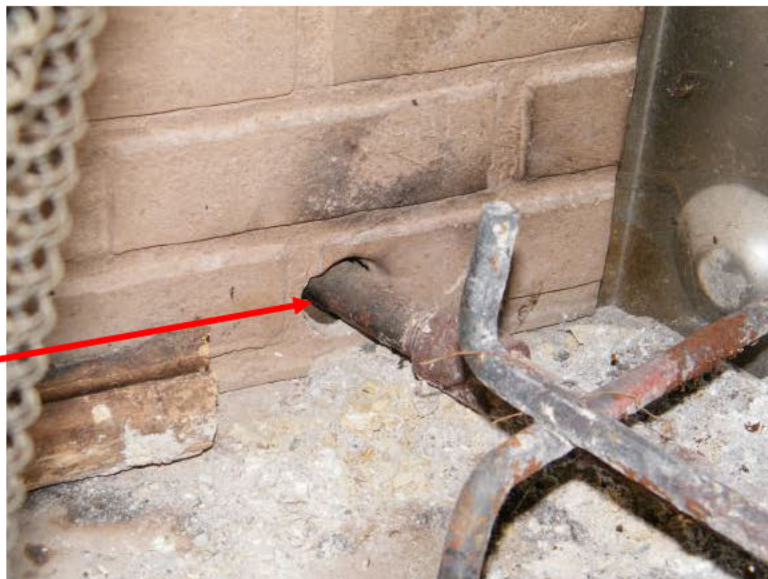
Sealant  
required.

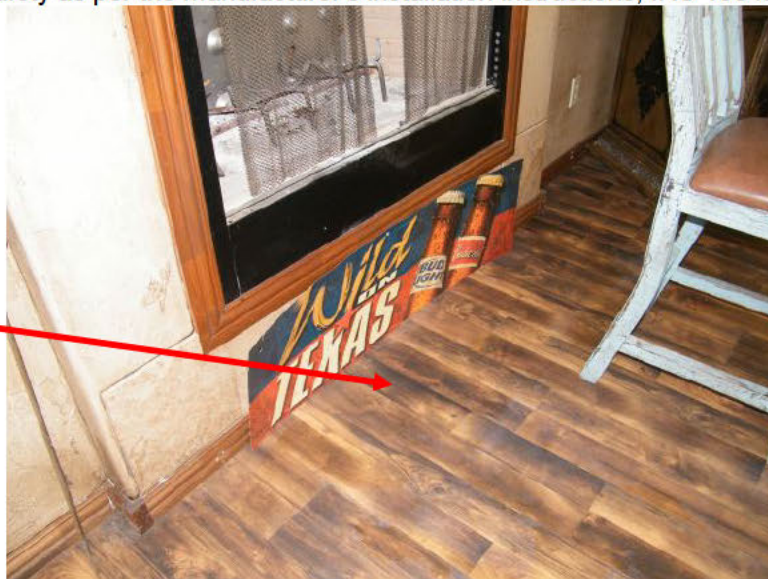
The hearth outside the fireplace is not large enough to reduce the risk of fire, should hot embers manage to escape from the fireplace. This situation must be altered for improved safety as per the manufacturer's installation instructions, IRC 1004.2 and IRC 102.4.

Hearth  
extension  
required.

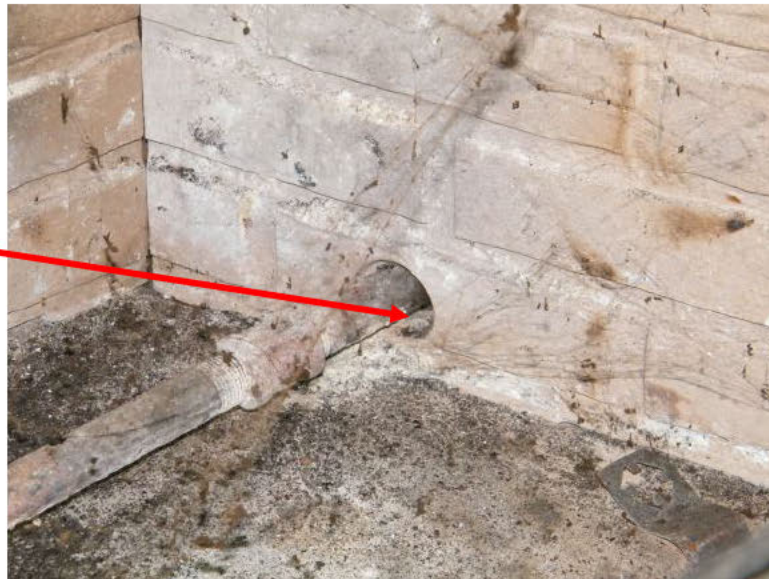
Sealant  
required.

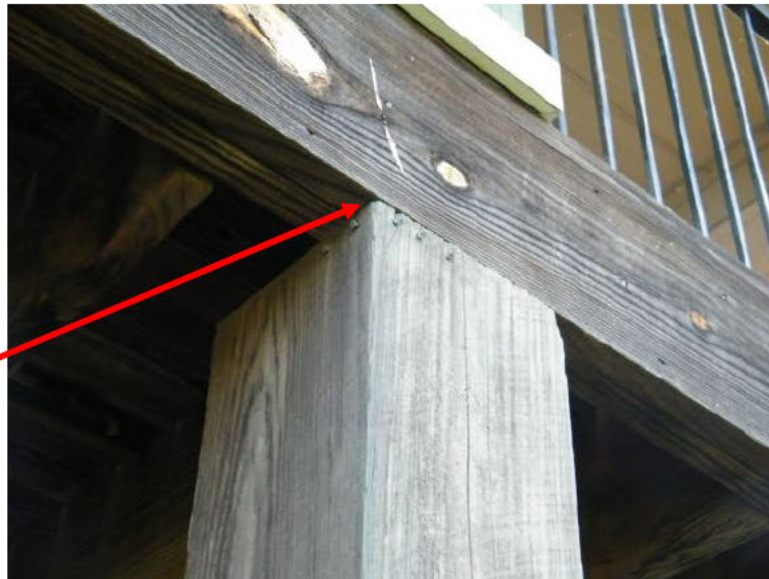
Improper  
post-to-  
beam  
connections

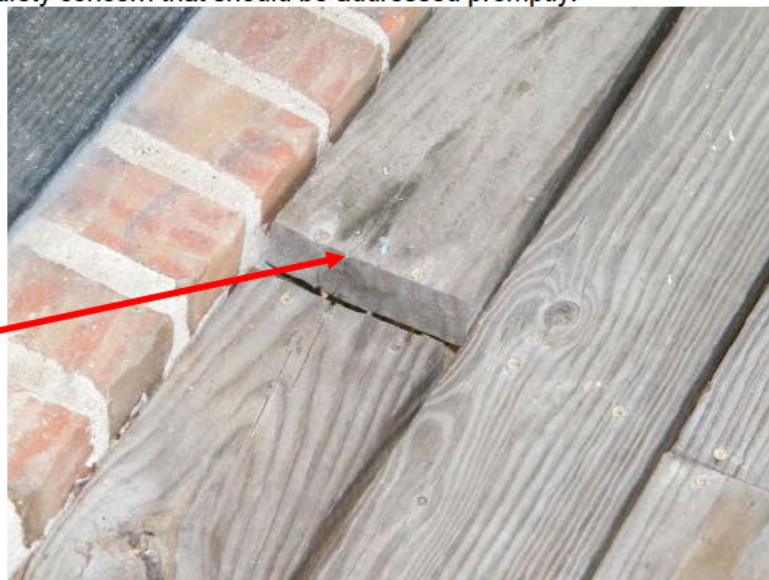
The loose balcony deck boards represent a trip hazard and should be repaired. This is a safety concern that should be addressed promptly.

Loose deck  
board.

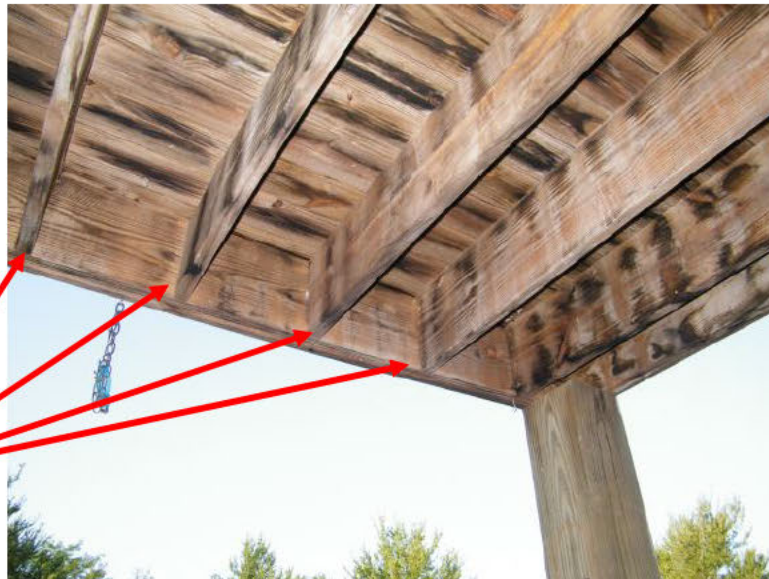
Joist hangers are missing from the joists to beam connections at the south side of the balcony structure. The floor or ceiling joist must be supported on each end by a top plate, ledger strip or joist hanger as per IRC 502.6.2. This is also a requirement in the National Design Standard, which is a referenced standard in the International Residential Code. NDS 2.3.1.2 Bearing Joists shall bear directly on beams, girders, ledgers, or load-bearing walls or be supported by hangers or framing anchors. Joist bearing shall be in accordance with the requirements of Table 2.7C.

Joist hangers missing.

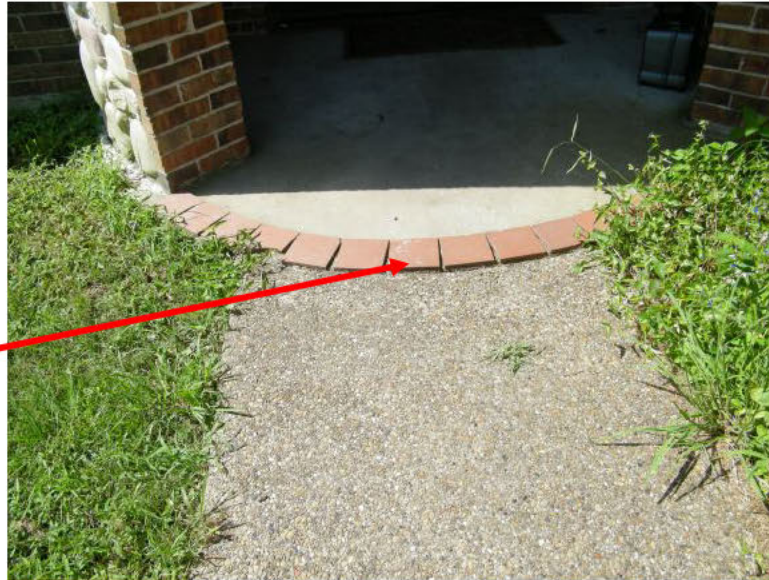
The tile sections appended to the sidewalk/front porch junction protrude from the surface and constitute a very real pedestrian slip and fall hazard for which you, as the owner, will be held liable.

Trip hazard.

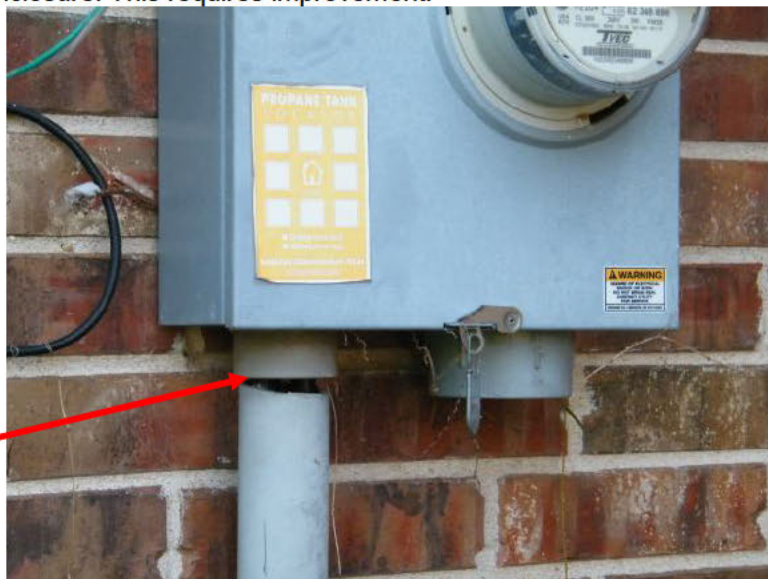
Conduit  
loose.

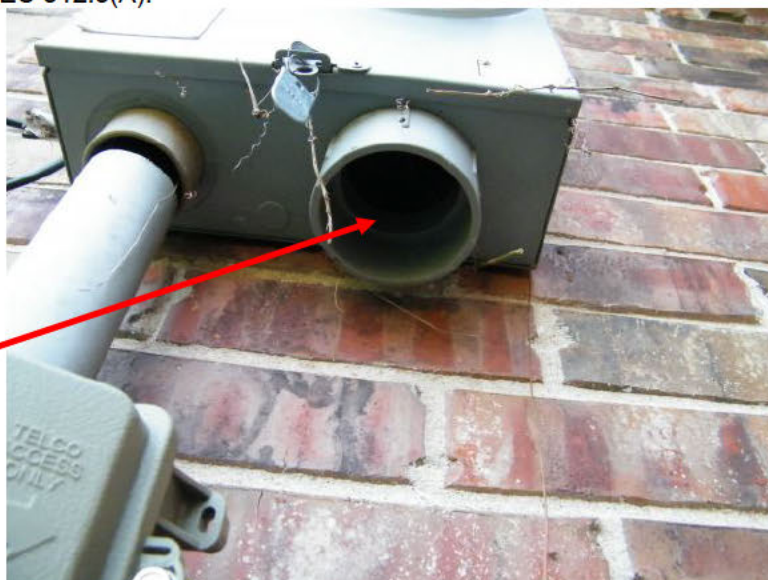
The opening in the bottom right side of the meter socket enclosure must be sealed as per NEC 312.5(A).

Close  
opening.

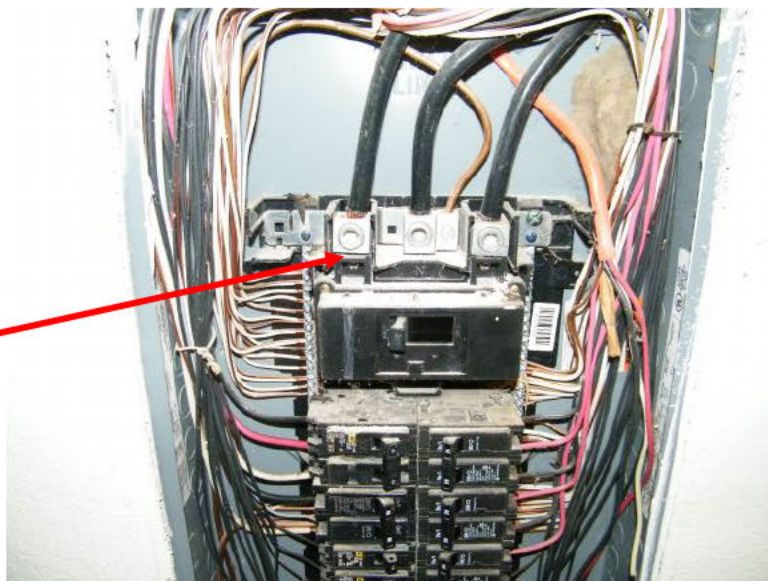
Lug  
protectors  
missing.

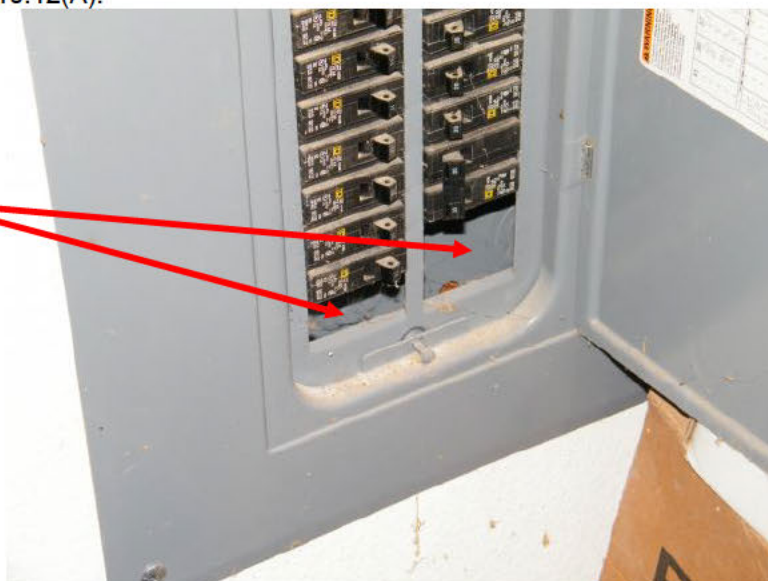
Any unused openings in the main distribution panelboard must be covered as per NEC 110.12(A).

Close  
openings.

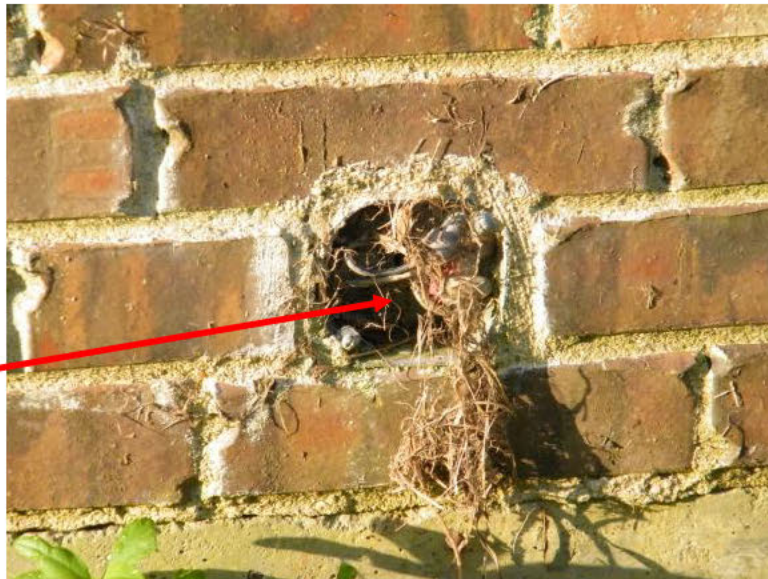
Cover plate  
missing.

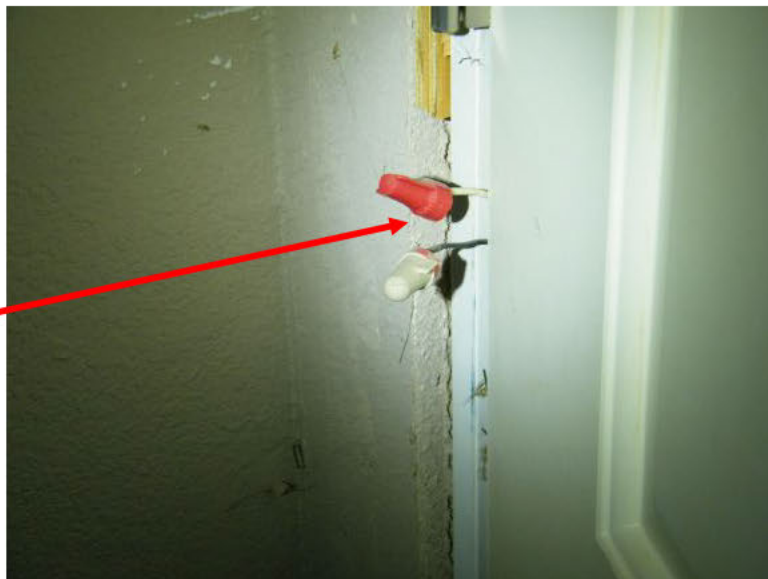
Improper  
connection.

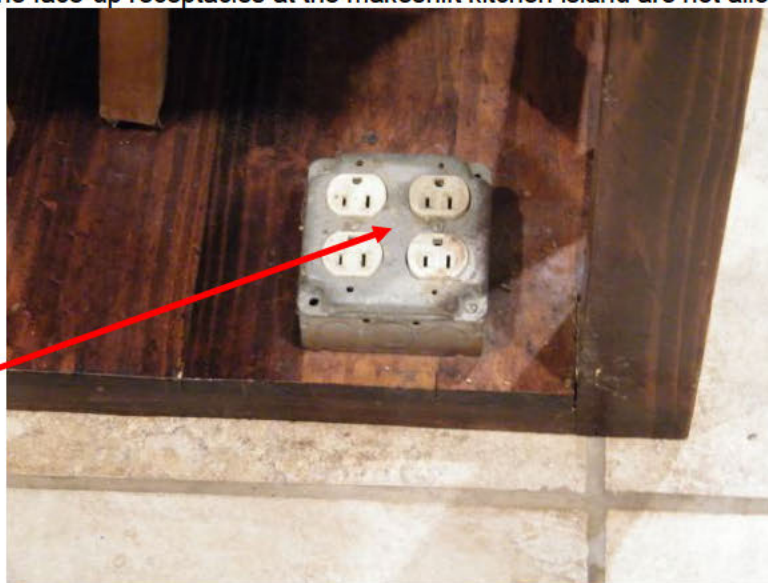
Face-up  
outlets not  
allowed.

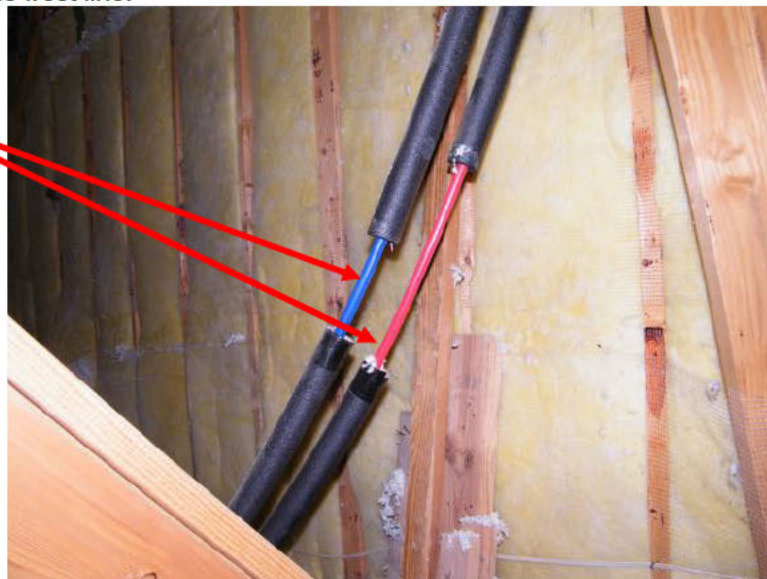
Insulate all  
PEX in attic.

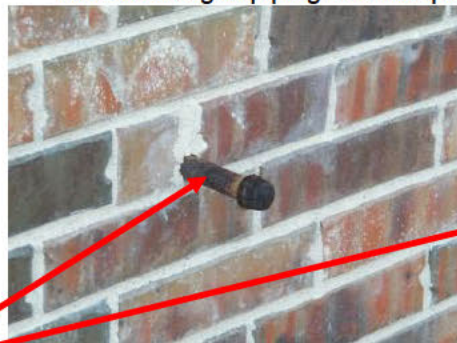
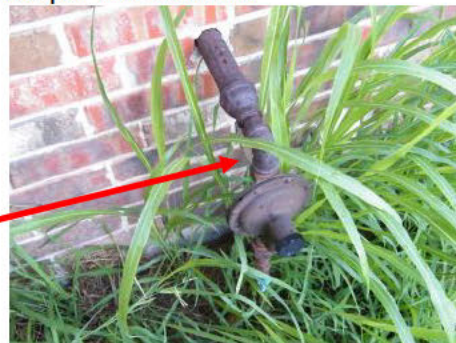
The exterior gas piping must be painted as per IRC G2414.8.

Paint exterior gas piping.

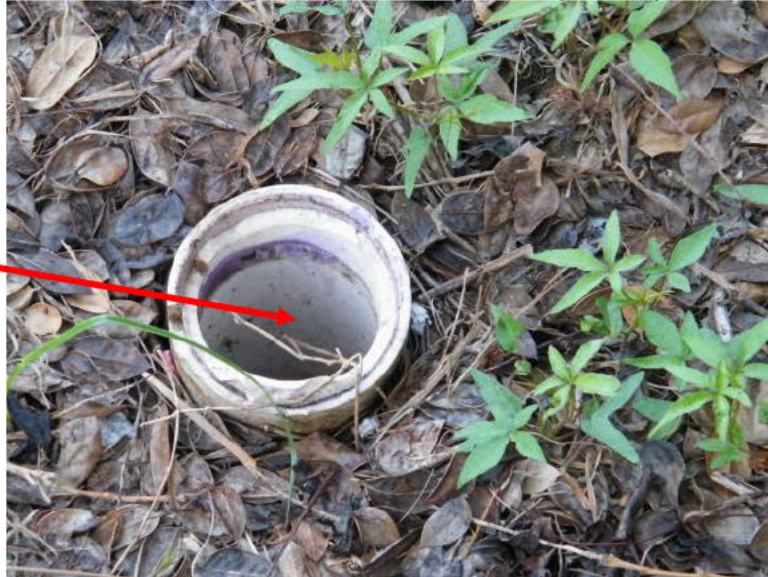
Cleanout  
cover  
missing.

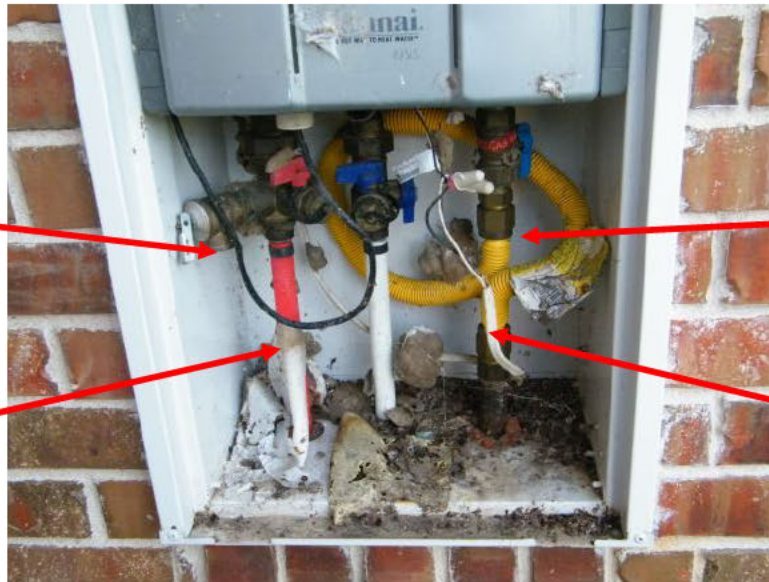
Conduit  
required.

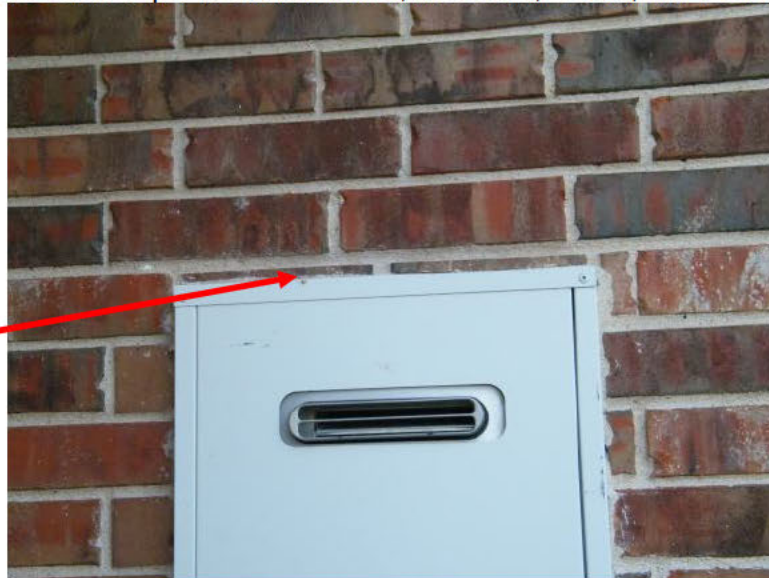
A lintel is required at the opening in the brick veneer wall above the tankless water heater recess box as per the manufacturer, IRC 102.4, 2001.1, and 703.8.3.

Lintel  
required.

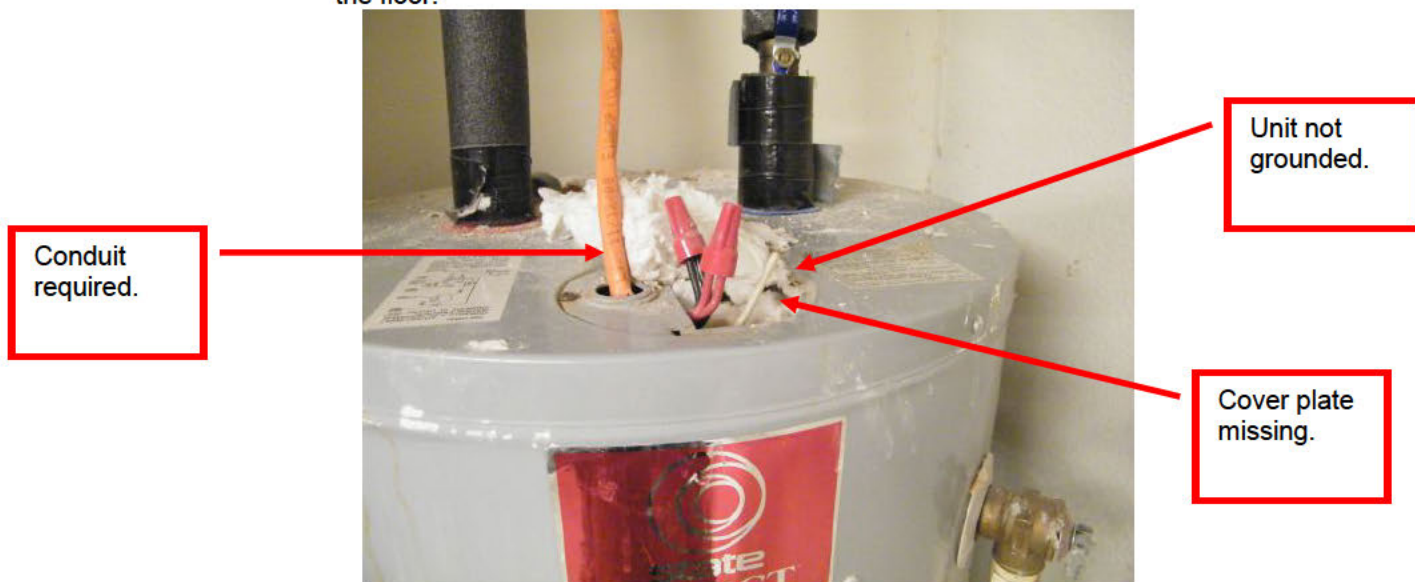
Wiring serving the electric water heater must be protected by a conduit as per NEC 334.15(B): Protection from Physical Damage. Cable shall be protected from physical damage where necessary by rigid metal conduit, intermediate metal conduit, electrical metallic tubing, Schedule 80 PVC conduit, or other approved means. Where passing through a floor, the cable shall be enclosed in rigid metal conduit, intermediate metal conduit, electrical metallic tubing, Schedule 80 PVC conduit, or other approved means extending at least 150 mm (6 in.) above the floor.

The electrical cable splice in this unit is not contained within the internal junction box as required.

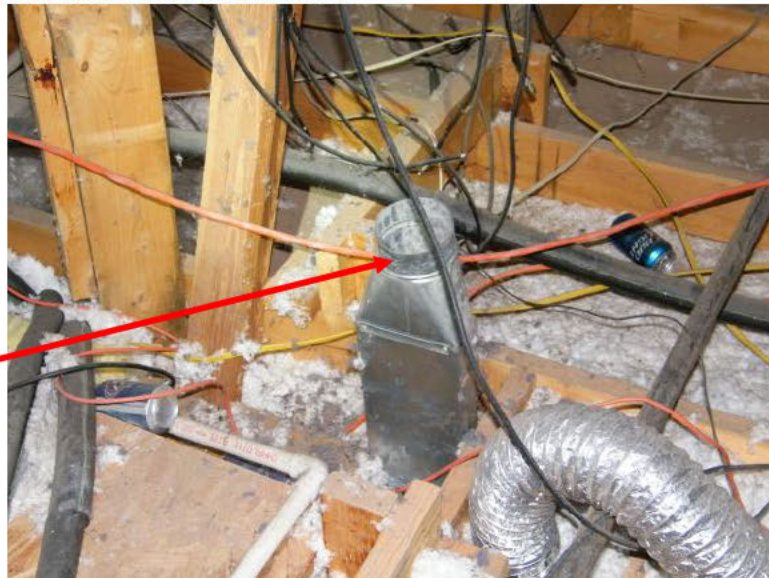
The clothes dryer duct was not observed to be properly terminated as it was vented into the attic. The clothes dryer duct must be vented to the building exterior as per M1502.3 Duct termination. Exhaust ducts shall terminate on the outside of the building. Exhaust duct terminations shall be in accordance with the dryer manufacturer's installation instructions. If the manufacturer's instructions do not specify a termination location, the exhaust duct shall terminate not less than 3 feet (914 mm) in any direction from openings into buildings. Exhaust duct terminations shall be equipped with a backdraft damper. Screens shall not be installed at the duct termination.

Dryer vents  
in attic.
