TEXAS INSPECTOR

PROPERTY INSPECTION REPORT

A. Foundations

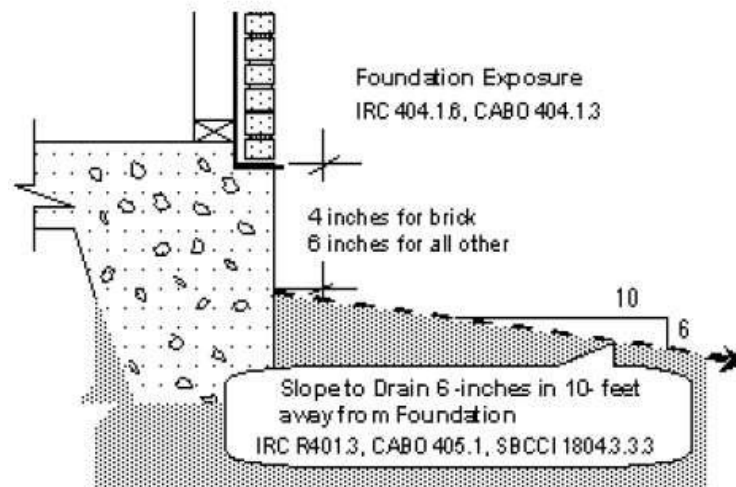
The grading around the perimeter of the foundation must be improved to promote the flow of storm water away from the house. Grading specifications are spelled out clearly in International Residential Code (IRC) R401.3, "Surface drainage shall be diverted to a storm sewer or other approved point of collection so as to not create a hazard. Lots shall be graded so as to drain surface water away from foundation walls. The grade away from foundation walls shall fall a minimum of 6 inches (152 mm) within the first 10 feet (3048)". This is equivalent to the 5% grade required by the foundation design firm's engineer. **FAILURE TO MAKE THESE IMPROVEMENTS MAY EFFECTIVELY VOID YOUR FOUNDATION WARRANTY!**

R 401.3 is not the only place in the code requiring this drainage provision. R506.1, and R 403.1.8 instruct builders slab-on-grade residential buildings on expansive clay soils to adhere to an even stricter commercial building code, that of the International Building Code 1805.8.2, "Slab-on-ground foundations. Slab-on-ground, mat or raft foundations on expansive soils shall be designed and constructed in accordance with WRI/CRSI Design of Slab-on-Ground Foundations or PTI Design and Construction of Post-Tensioned Slabs-On-Ground." PTI Design is the Post-Tensioning Institute of which this inspector is both a member and a Level 1

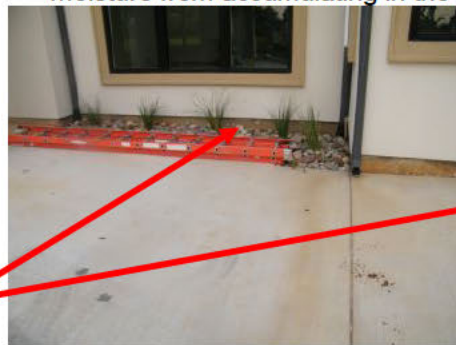
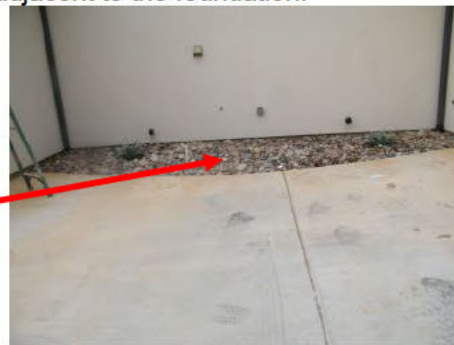
The builder has installed two perched drainage planes where water draining will be trapped between the driveway and the foundation. This must be improved in order to prevent excess moisture from accumulating in the soil adjacent to the foundation.

Perched
drainage
planes.

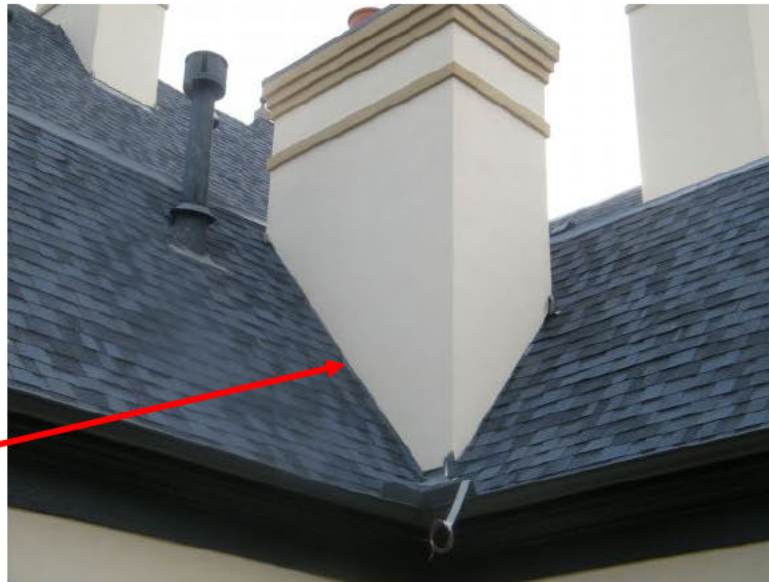
Chimney in
valley.

In the Steep Slope Roofing and Waterproofing Manual published by the National Roofing Contractors Association it states that "A valley is created at the downslope intersection of two sloping roof planes. Water runoff from the portions of roof areas sloping into a valley flows toward and along the valley. Because of the volume of water and the lower slope along a valley line, such an area is especially vulnerable to leakage. A clear, unobstructed drainage path is desired in valleys so the valley can carry water away quickly and perform successfully for the service life of a roof system." And additionally, "To prevent leakage, it is important with all types of valley construction to avoid placing fasteners and penetrations near the center of a valley."

All roofing manufacturers adhere to NRCA recommendations in their installation instructions. The IRC in turn requires that roofing materials be installed in accordance with these instructions in IRC 102.4, 903.1, and 904.1.

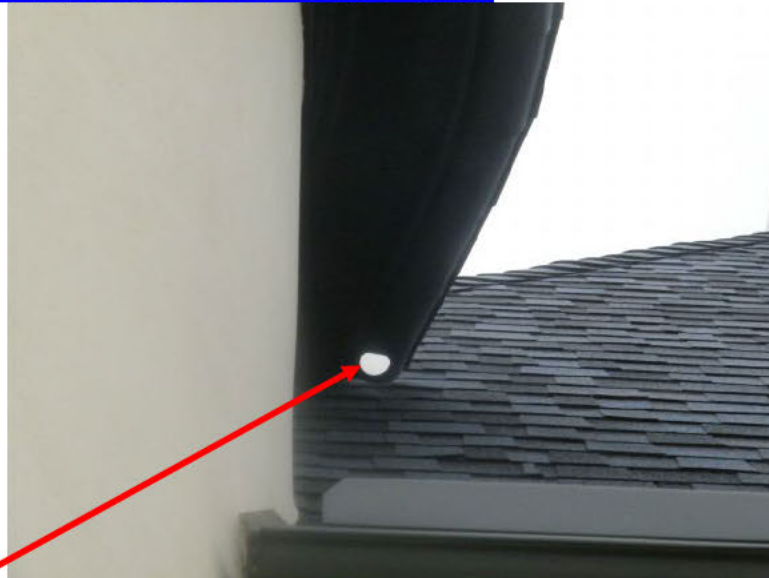
Gutter sections and spouts must not drain on roof.

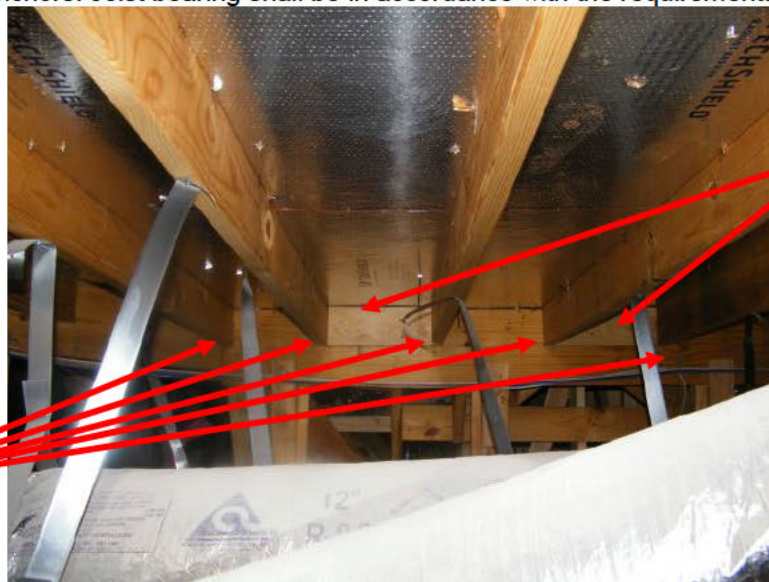
The low slope roof rafters and ceiling joists visible in the lower west and upper northeast attic areas must be supported on each end by a top plate, ledger trip or joist hanger as per IRC 502.6.2. This is also a requirement in the National Design Standard, which is a referenced standard in the International Residential Code. NDS 2.3.1.2 Bearing Joists shall bear directly on beams, girders, ledgers, or load-bearing walls or be supported by hangers or framing anchors. Joist bearing shall be in accordance with the requirements of Table 2.7C.

Joist hangers required.

Pressure blocks not allowed.

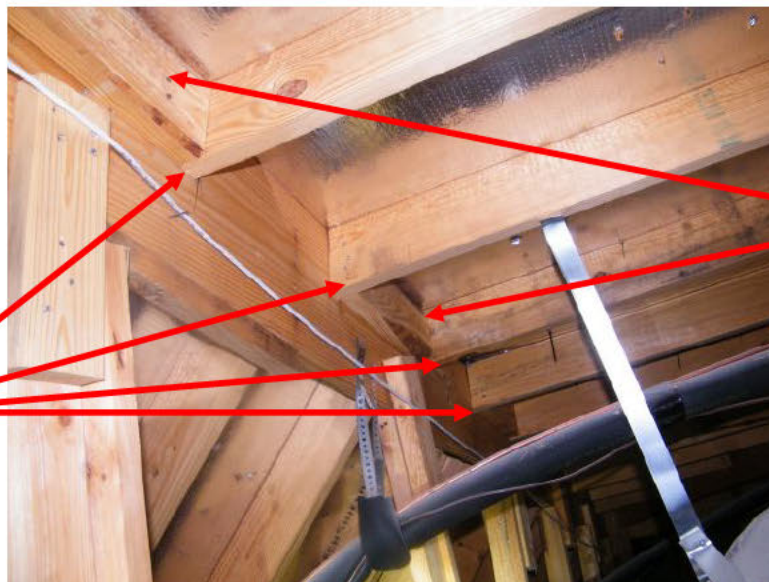
Joist hangers required.

Pressure blocks not allowed.

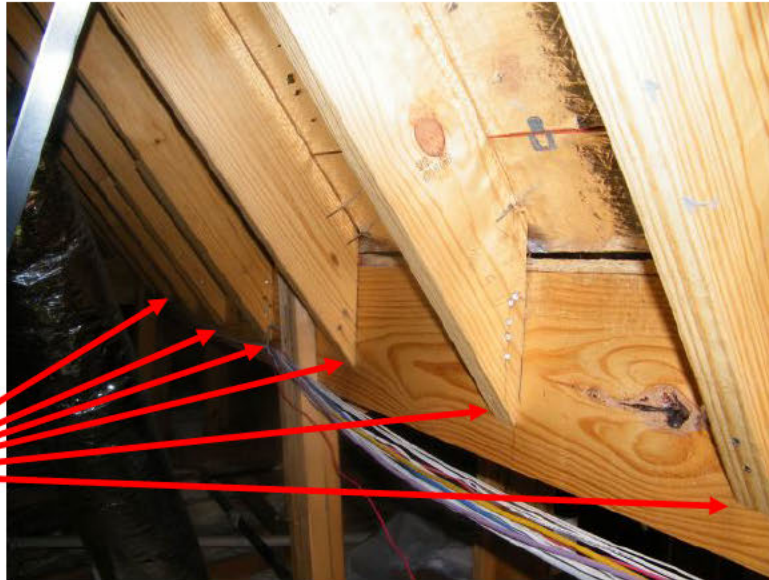
Joist hangers required.

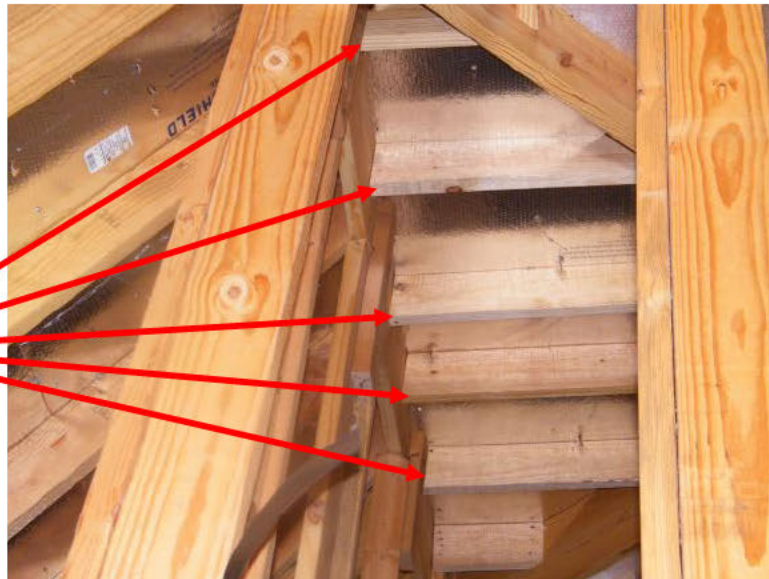
Joist
hangers
required.

If you are told that "pressure blocking" or "power blocking" takes the place of joist hangers, your builder is supplying you with anecdotal information.

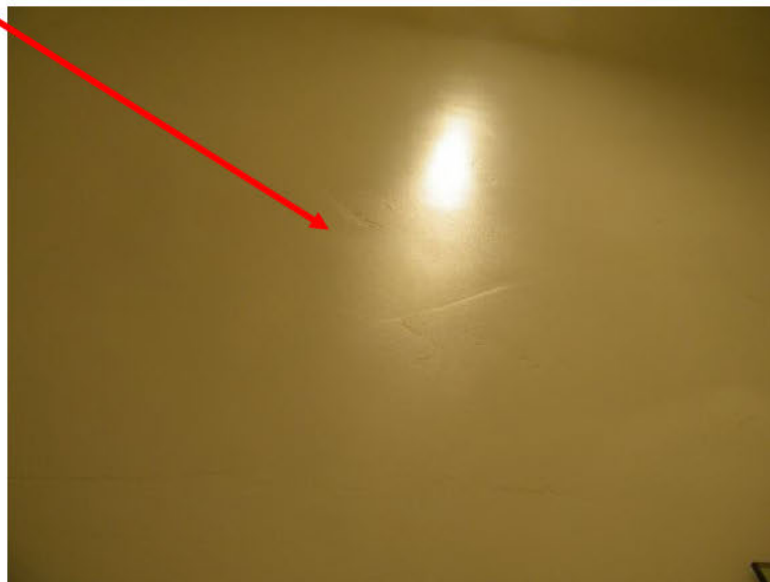
Not level 5 compliant.

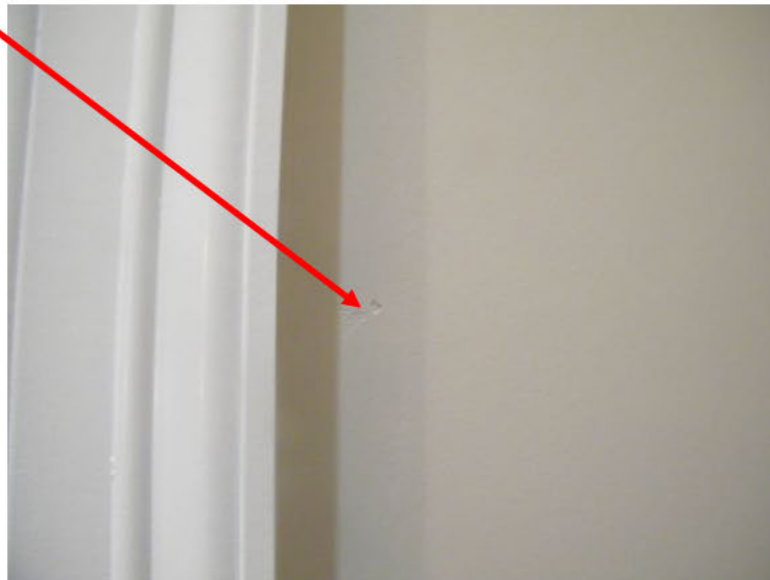
Not level 5 compliant.

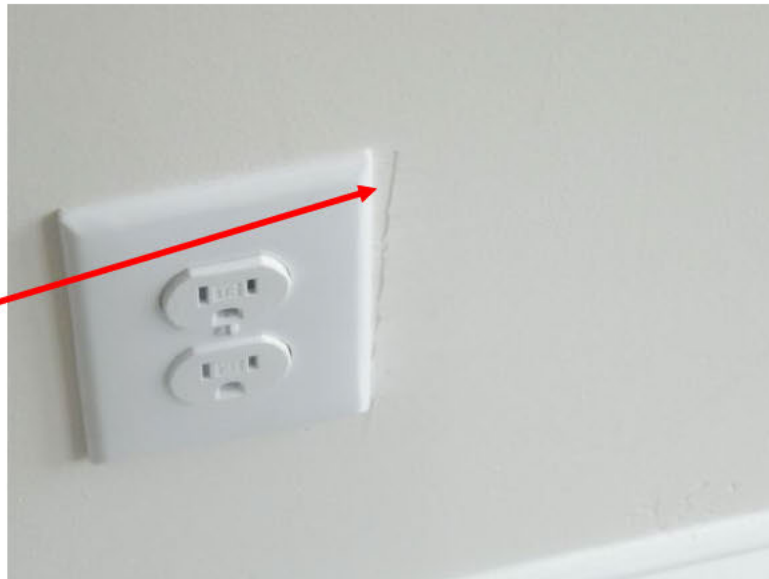
Not level 5
compliant.

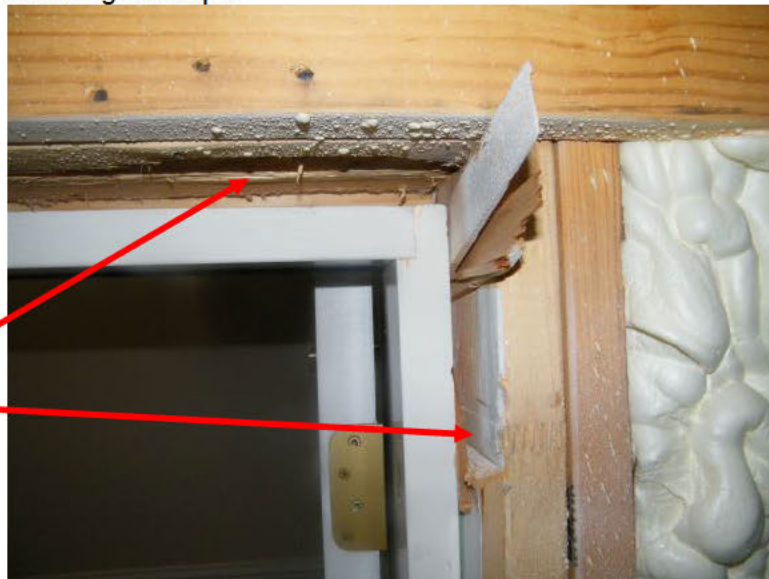
The perimeter of the jamb for the door to the southeast attic must be air sealed. All walls must be air-sealed as per 2018 IECC Table 402.4.1.1. A continuous air barrier shall be installed in the building envelope.

Air seal
frame of
attic doors.

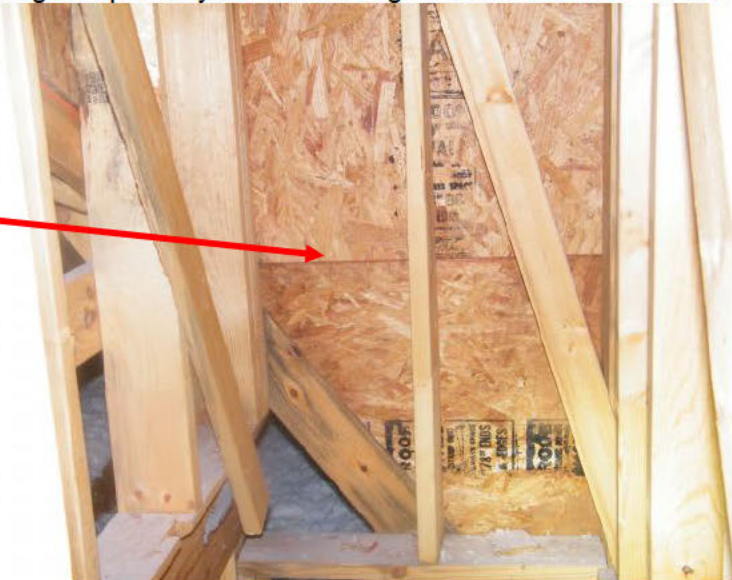
The sheathing panels that are present have not been installed in accordance with the manufacturer's installation instructions and APA standards in that the panels have not been spaced 1/8" apart from one another. This requires improvement as per IRC 102.4 and 604.3.

OSB not spaced 1/8" or supported by framing.

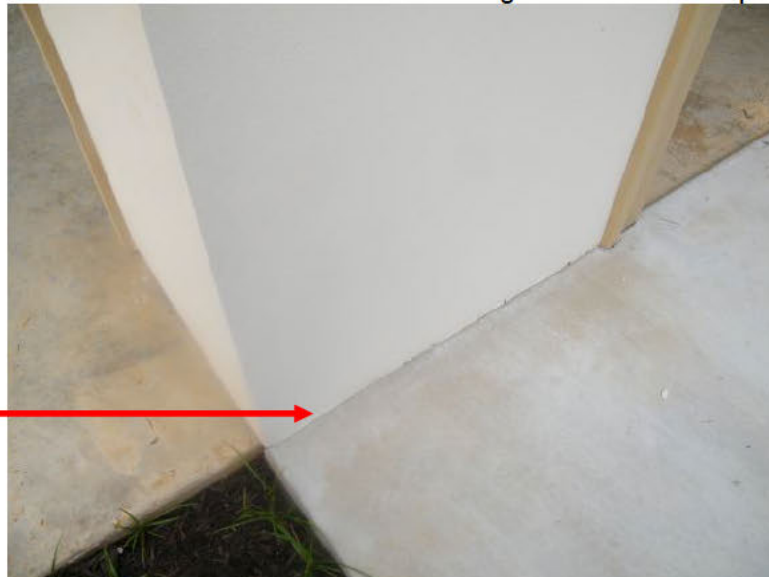
Stucco too close to masonry at front porch.

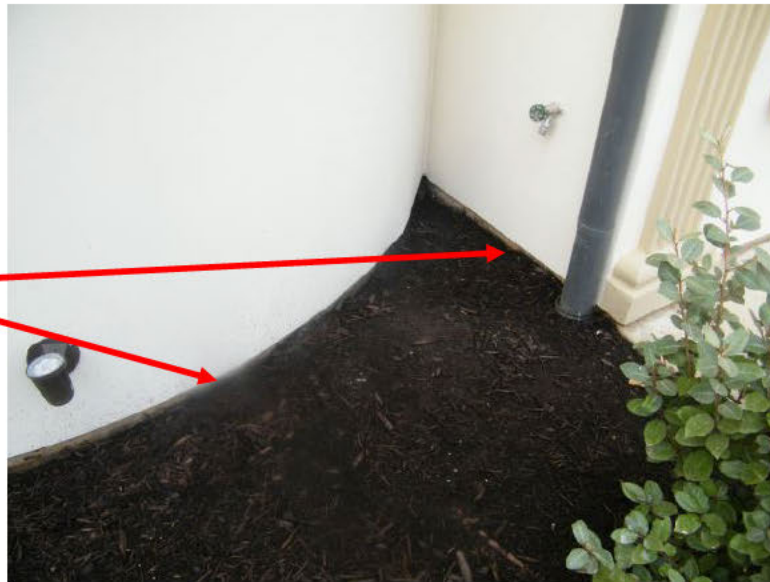
Stucco too close to grade.

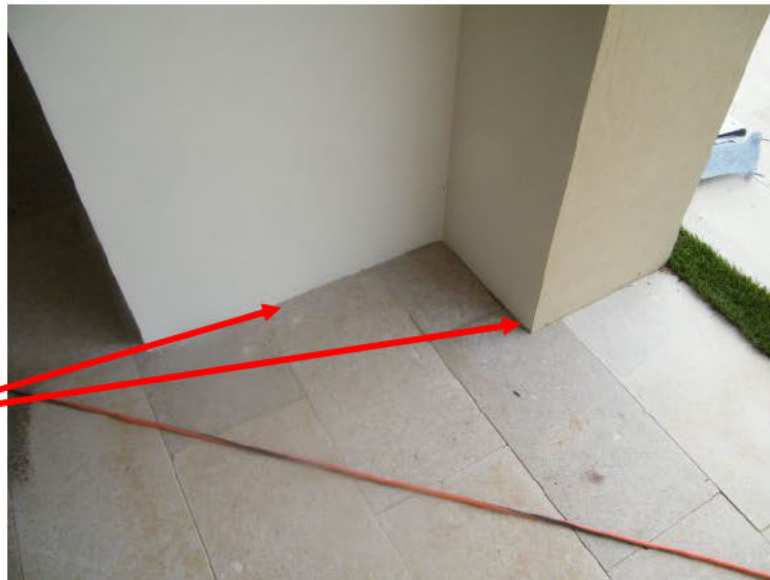
Stucco too close to patio.

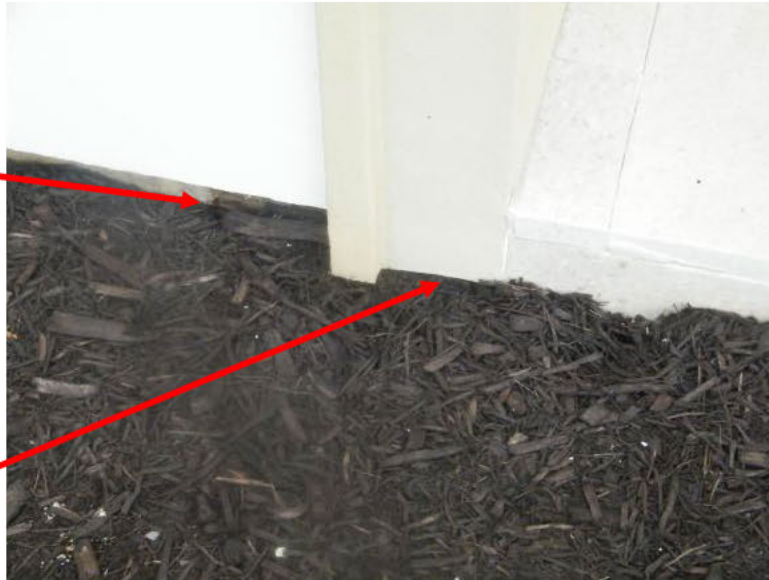
Stucco too close to grade.

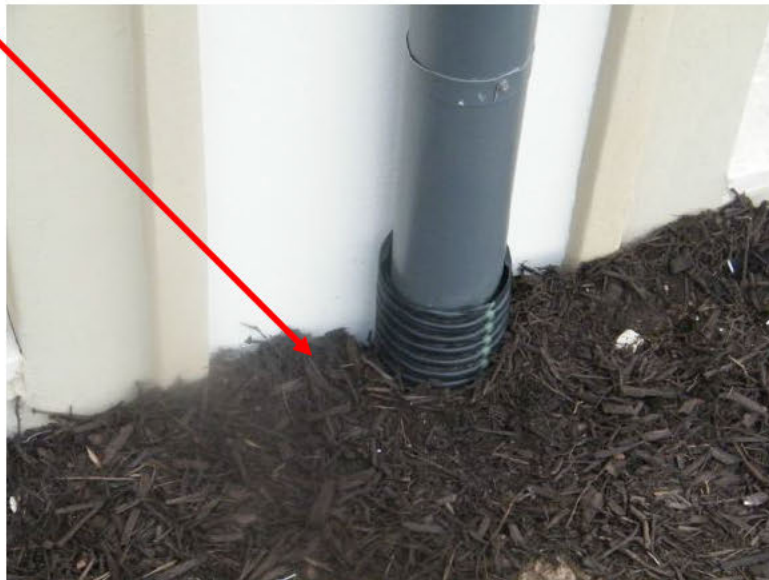
Stucco below grade.

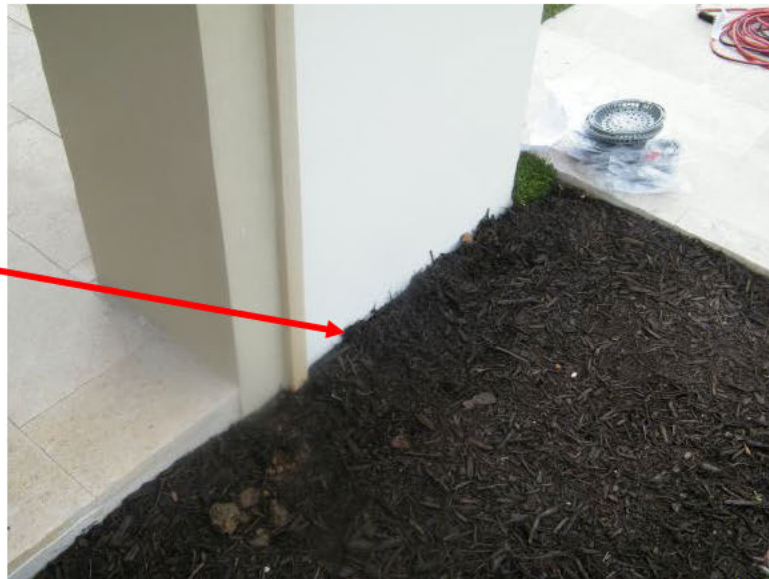
Stucco
below
grade.

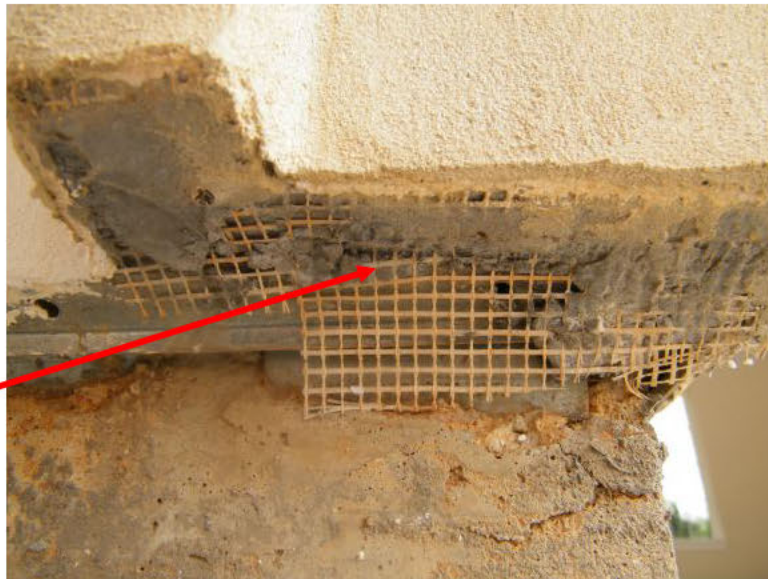
The bottom edges of the expanded polystyrene door trim must be backwrapped with mesh and coated with the stucco finish coat in all locations. This is required by IRC 703.6.

Back wrap
bottoms of
EPS door
trim.

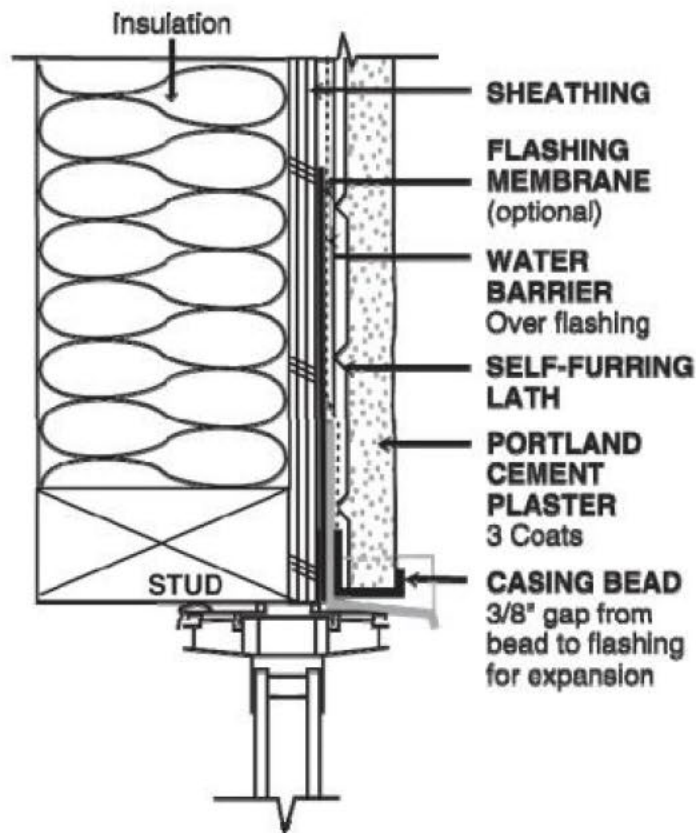
No header flashings are installed above the window and door openings in the stucco cladding as required by IRC 703.8, ASTM E-2112, and AAMA 2400.

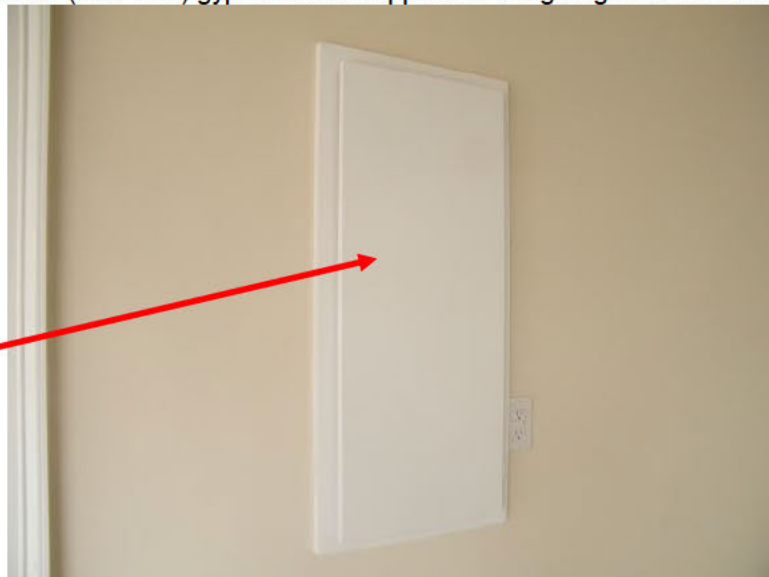
The access panel door for the fire-suppression sprinkler system in the west wall of the main garage does not meet the requirement for a fire separation. Lack of proper firestopping at utility penetrations in the garage walls voids the fire rating required by IRC R309.2: Separation required. The garage shall be separated from the residence and its attic area by not less than 1/2-inch (12.7 mm) gypsum board applied to the garage side. board or equivalent.

Not fire-separation compliant.

The 3/4" panel door does not have the equivalent flame- and smoke-spread rating as does 1/2" drywall. 3/4" plywood is rated at 120-140 while 1/2" drywall is rated at 10-15.

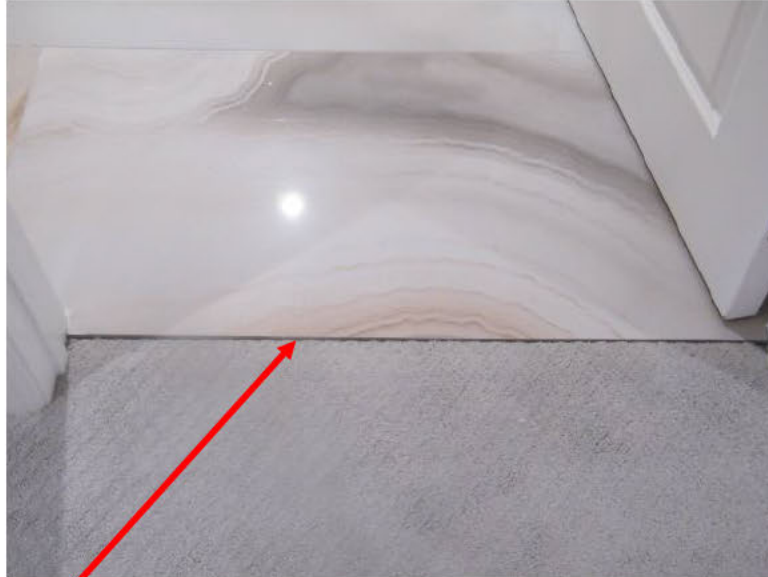
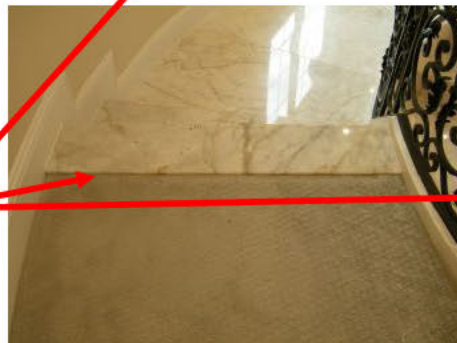
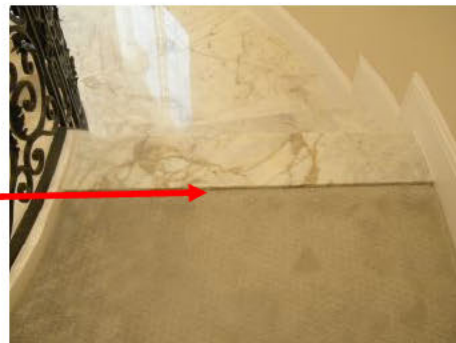
Carpet reducer strip is needed in the doorway of the second floor northeast hall bathroom and at the heads of the main stairs.

Transition
strip
needed.

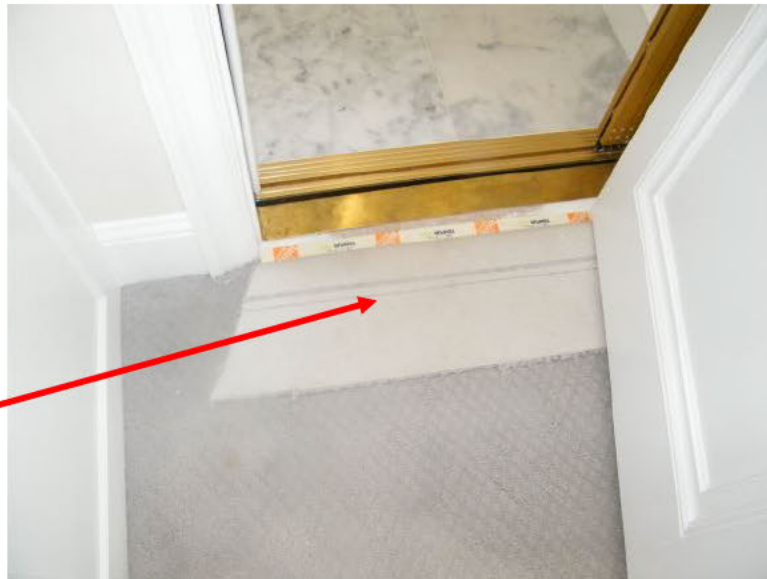
The carpet in the game room is incompletely installed at the elevator door.

Carpet
incompletely
installed.

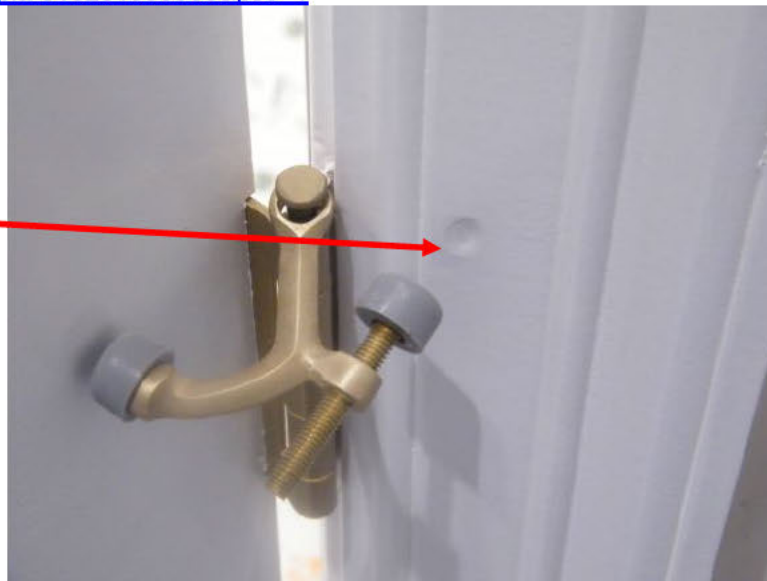
Stops
damage
trim.

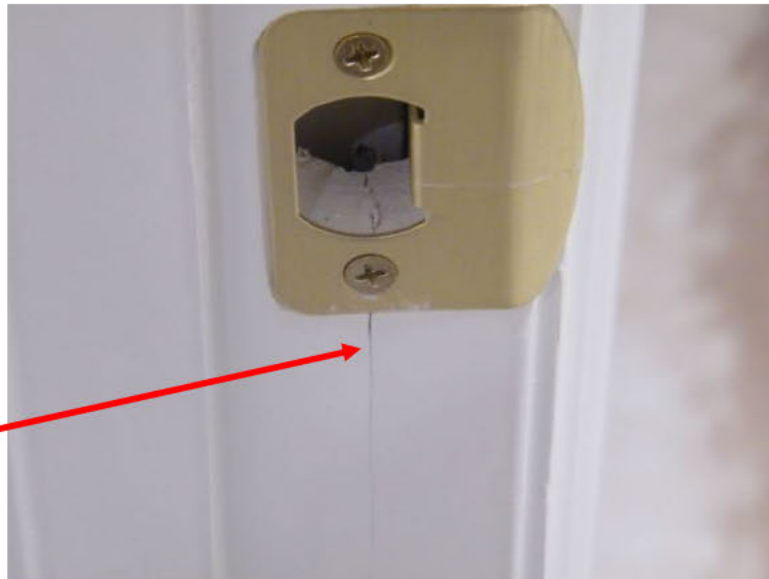
The strike jamb is split on the door to the second floor southeast hall bathroom due to failure of the installer to pre-drill the screw holes.

Jamb split.

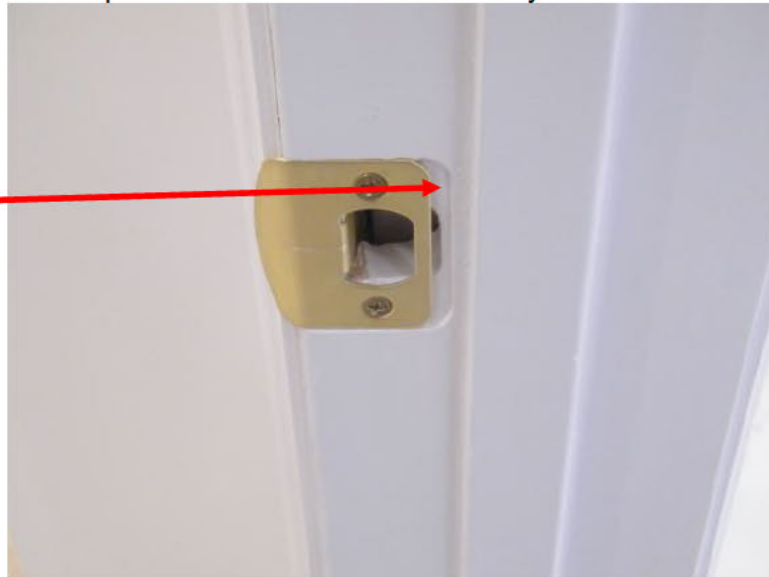
The strike plate mortises are oversized at many of the interior doors.

Jamb over
mortised for
strike plate.

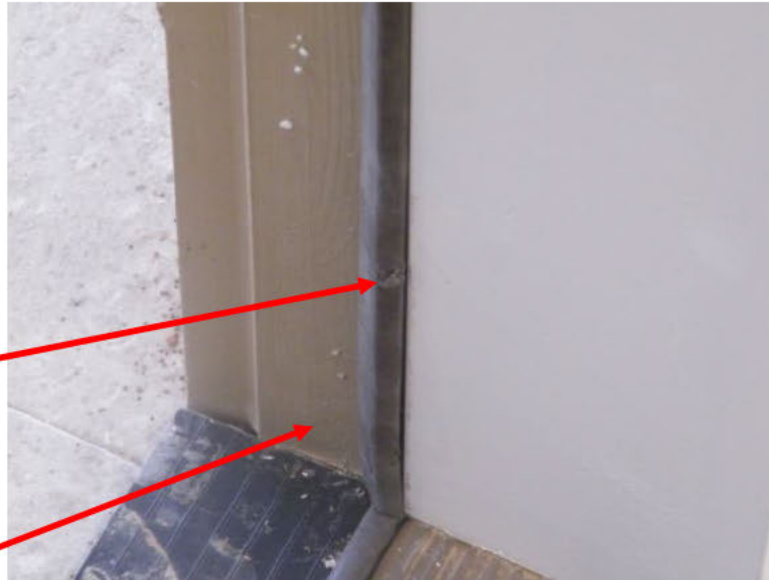
Weather
strip
damaged.

Seal pad
missing.

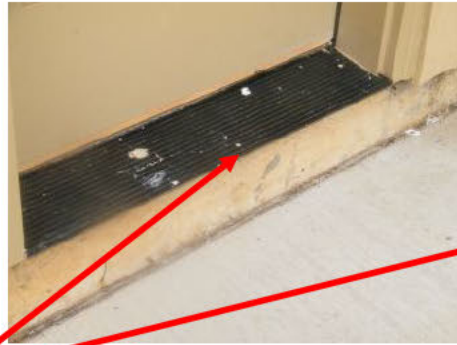
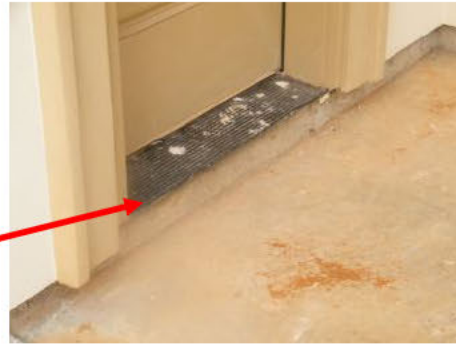
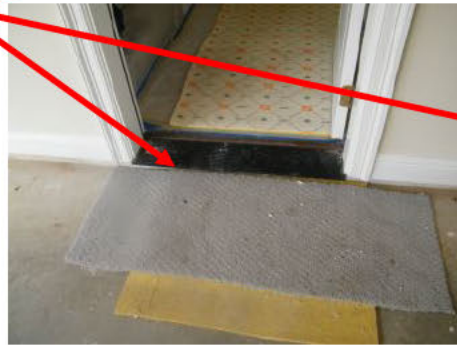
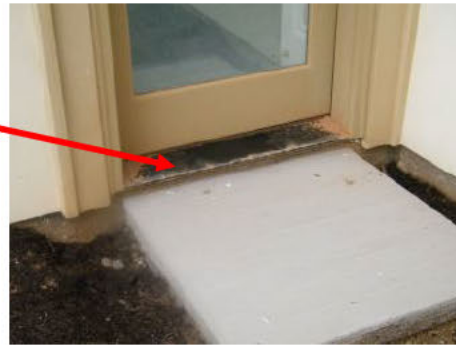
Support thresholds.

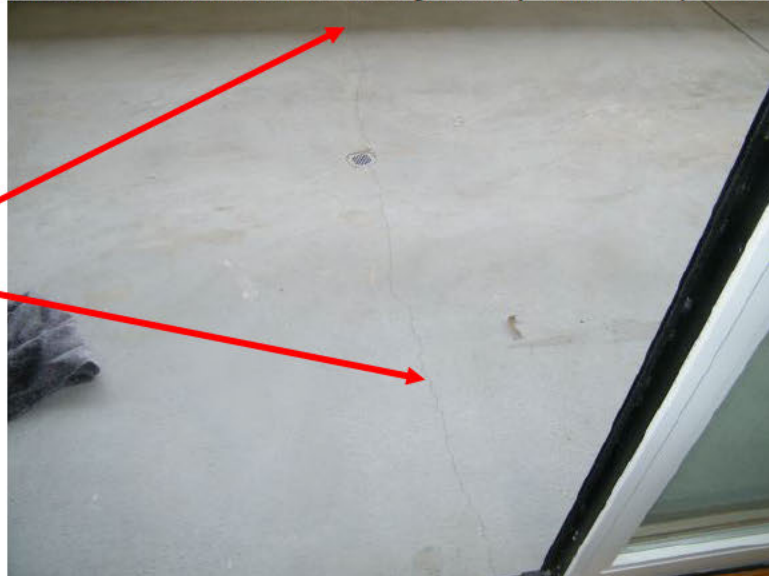
Rear
balcony
cracked.

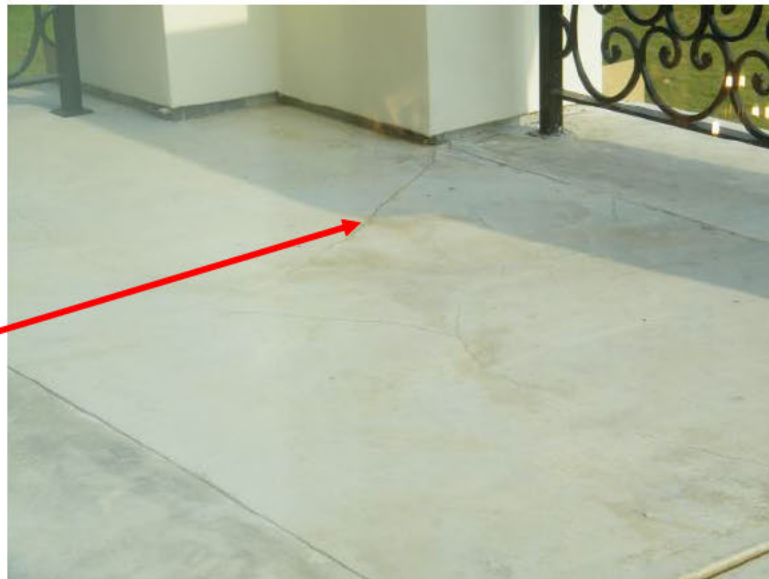
Front
balcony
cracked.

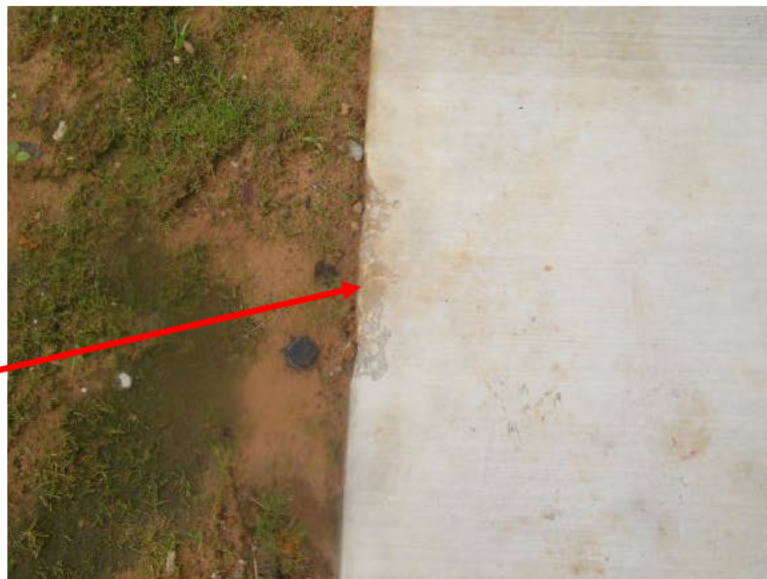
Driveway
edge
damaged.

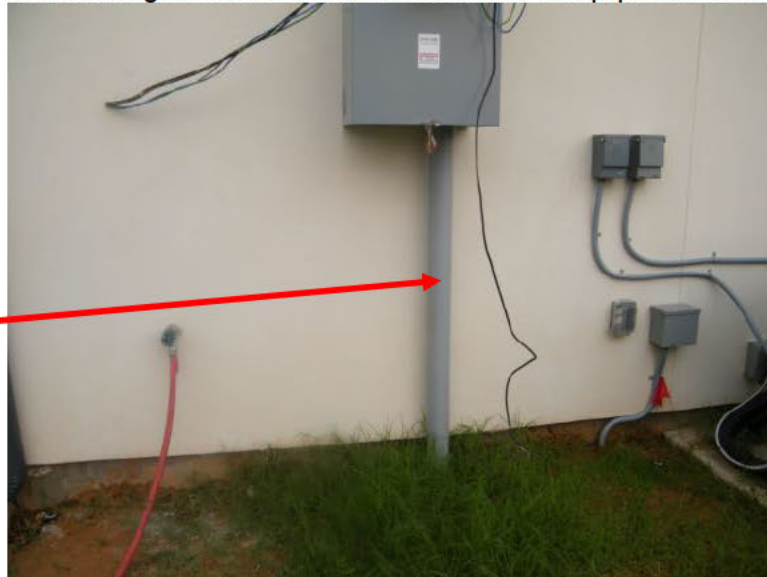
A (meter) slip riser is required in the electrical service conduit as per NEC 300.5(J) Earth Movement. Where direct-buried conductors, raceways, or cables are subject to movement by settlement or frost, direct-buried conductors, raceways, or cables shall be arranged so as to prevent damage to the enclosed conductors or to equipment connected to the raceways.

Slip riser
required.

Your builder, municipal inspector, or even a representative of the electric utility company may attempt to convince you that the slip riser is not required. This is not the case.

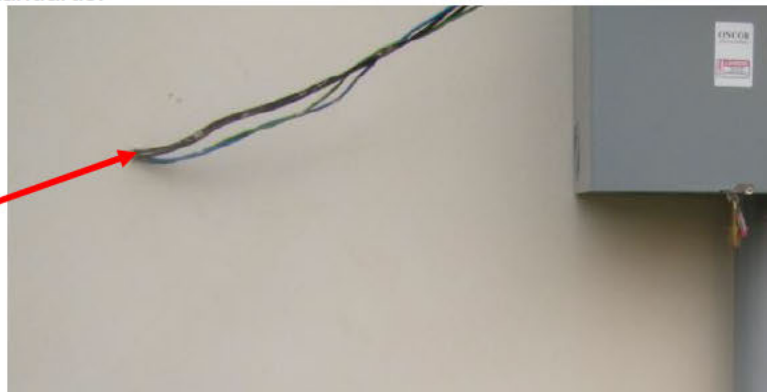
Fiber optic cables were observed to be incorrectly installed in contact with the stucco. This is not allowed by NEC 720.24, Note No. 3. Also see ANSI/NECA/BICSI 568-2006, Standard for Installing Commercial Building Telecommunications Cabling; ANSI/NECA/FOA 301-2009, Standard for Installing and Testing Fiber Optic Cables; and other ANSI-approved installation standards.

Conduit required.

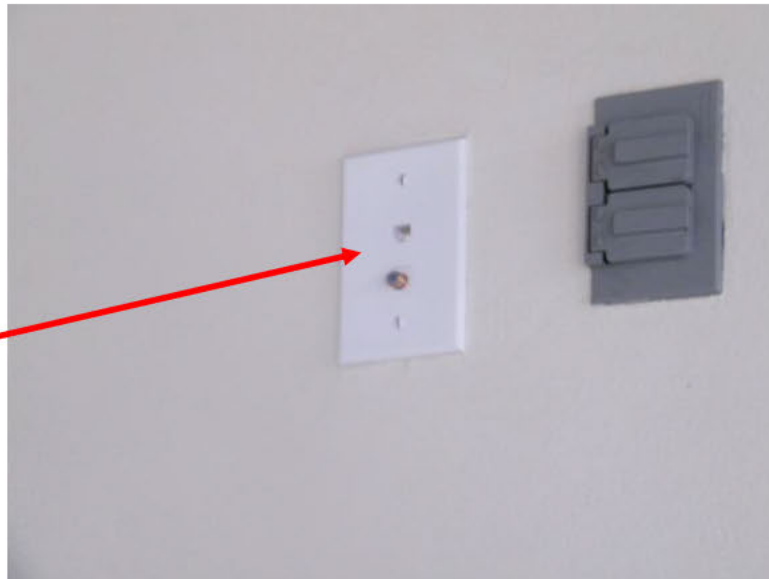
The communications cable outlet and cover plate (audio/visual jack wall plate assembly) at the patio are not listed or labeled for use in damp or wet locations as required by NEC 314.15 Damp or Wet Locations In damp or wet locations, boxes, conduit bodies, and fittings shall be placed or equipped so as to prevent moisture from entering or accumulating within the box, conduit body, or fitting. Boxes, conduit bodies, and fittings installed in wet locations shall be listed for use in wet locations.

Weatherproof
cover plate
required.

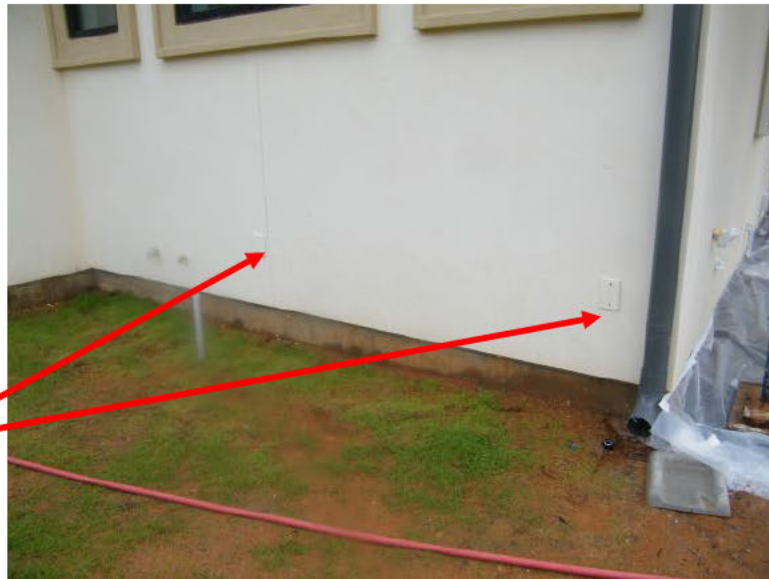
Weatherproof
cover plates
required in all
locations
outside.

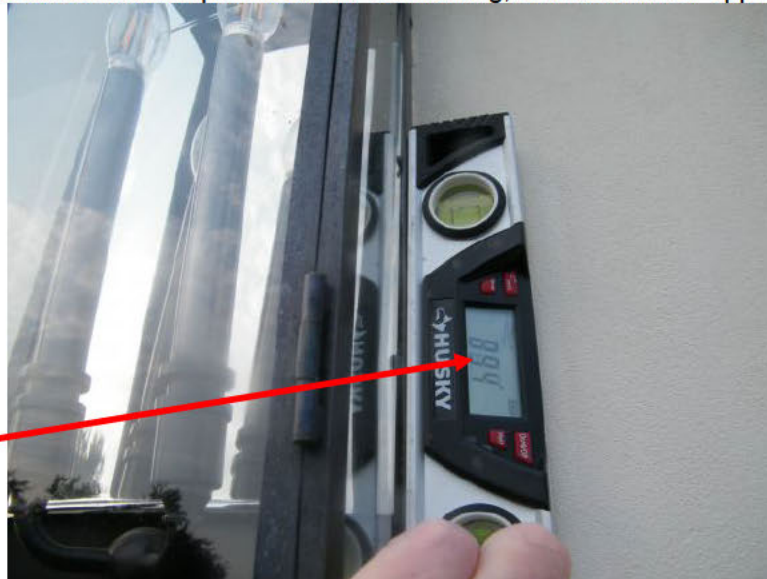
Fixture not level.

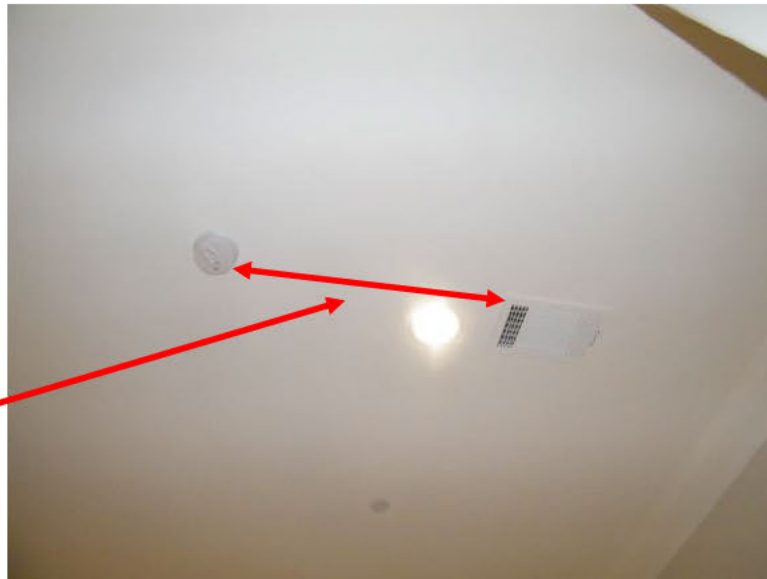
Less than
36"
clearance.

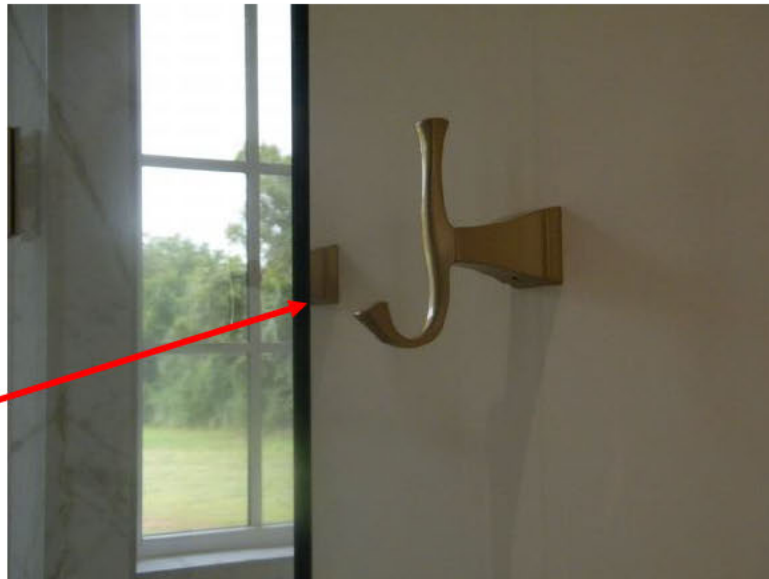
Install stop
to prevent
door
breakage.

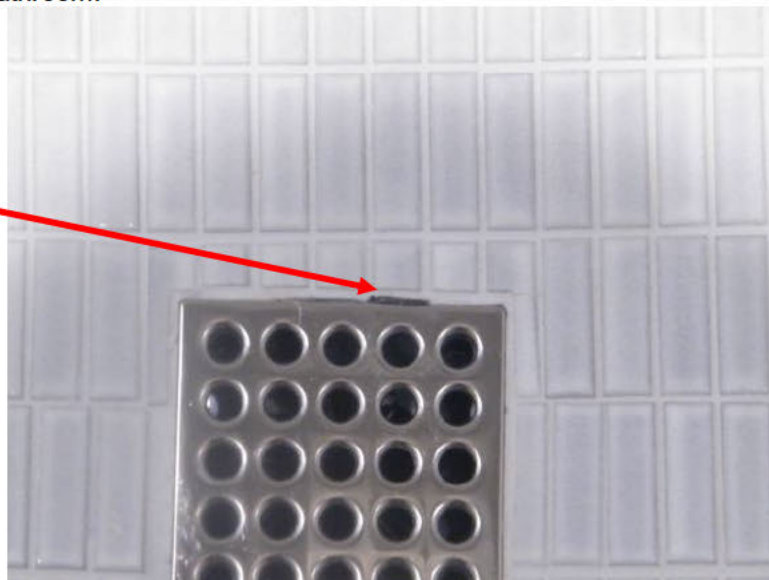
The grout is incompletely installed at the drain grate in the second floor northeast ensuite bathroom.

Improve
grout here.

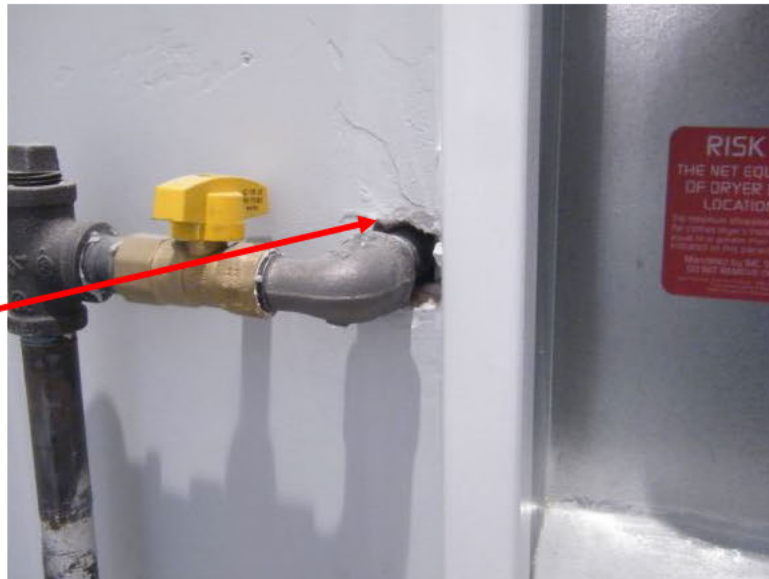
Add
escutcheon
plate.

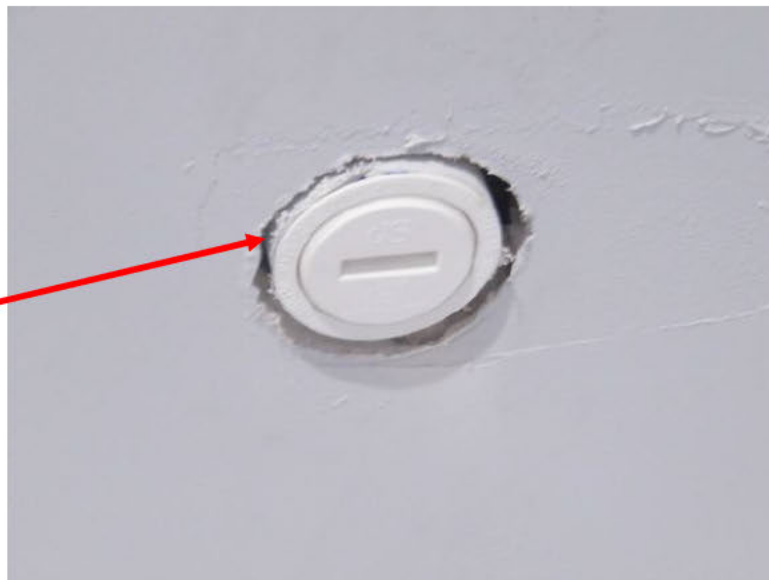
Seal around
cleanout.

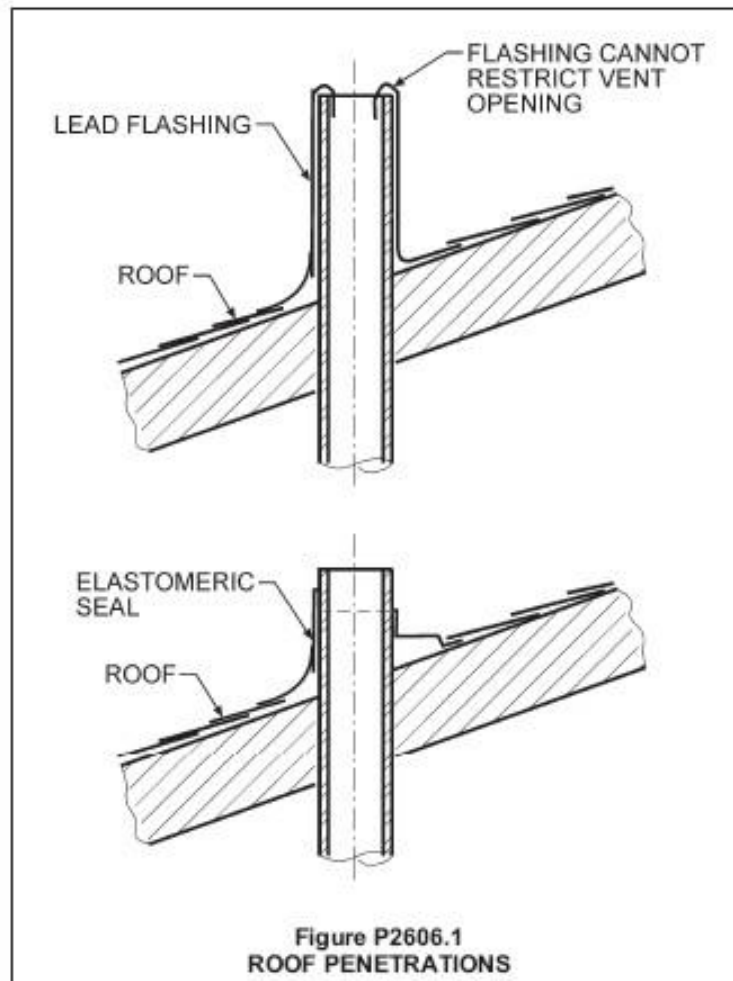
The lead flashing for the plumbing vent piping that penetrates the roof surface is folded over into the top of the vent(s) and is obstructing the vent opening. This is not allowed by IRC 2606.1. Repair is required.

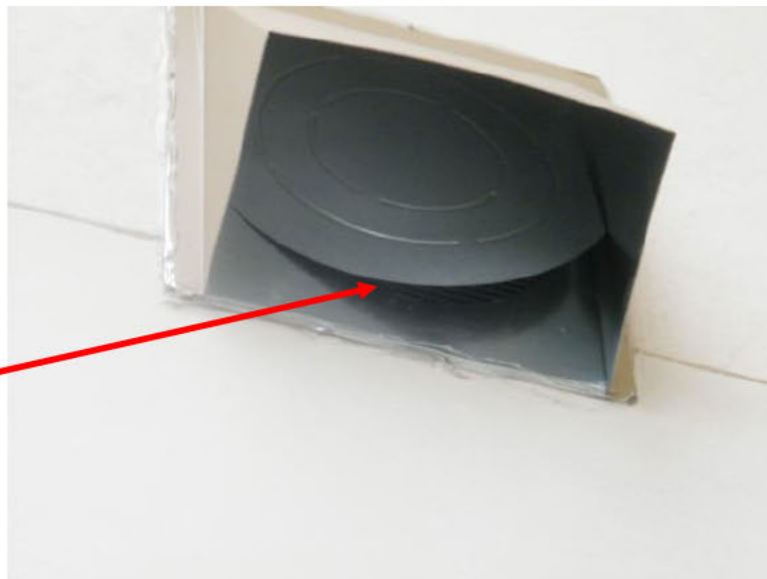
Damper
does not
close.

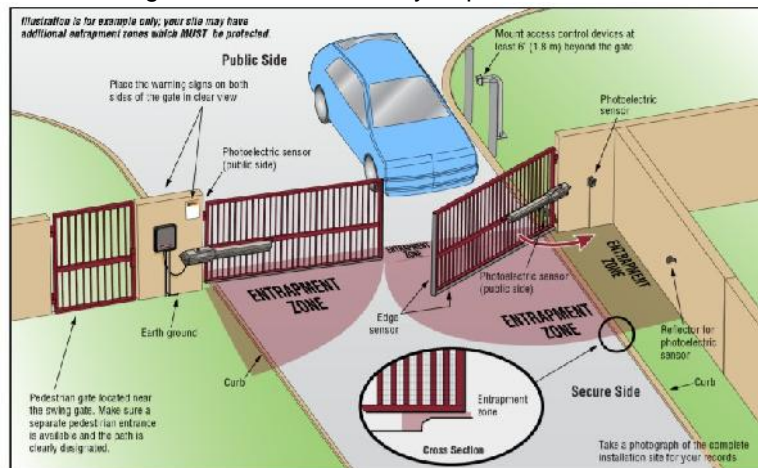
The vehicular gate operator is not installed in strict accordance with the [manufacturer's installation instructions](#), 2016 UL325, ASTM F2200 or IRC 102.4. Signs of this improper installation include, but are not limited to a lack of sensors of both sides of the gate and a lack of entrapment signage where required. This gate is unsafe as is and should not be used until it has been brought into minimum safety requirements.
