TEXAS INSPECTOR

PROPERTY INSPECTION REPORT

A. Foundations

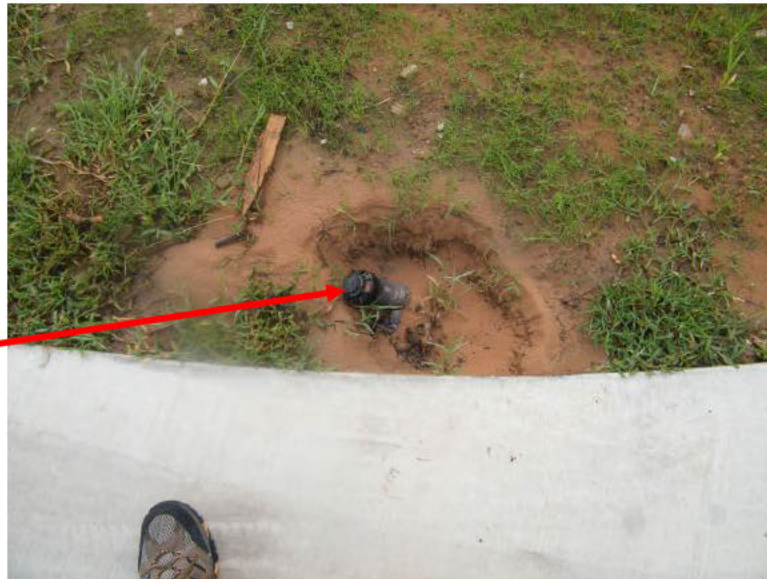
A sprinkler head has been damaged by vehicular traffic at the interior radius of the driveway on the north side of the house.

Head
damaged by
vehicle.

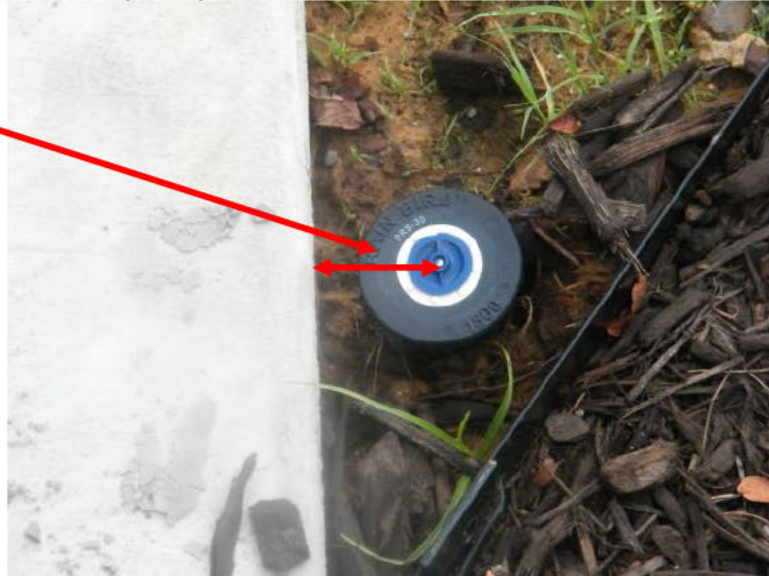
<4" to
hardscape.
