FW: Request for Assistance

References below are from the 2021 IRC:

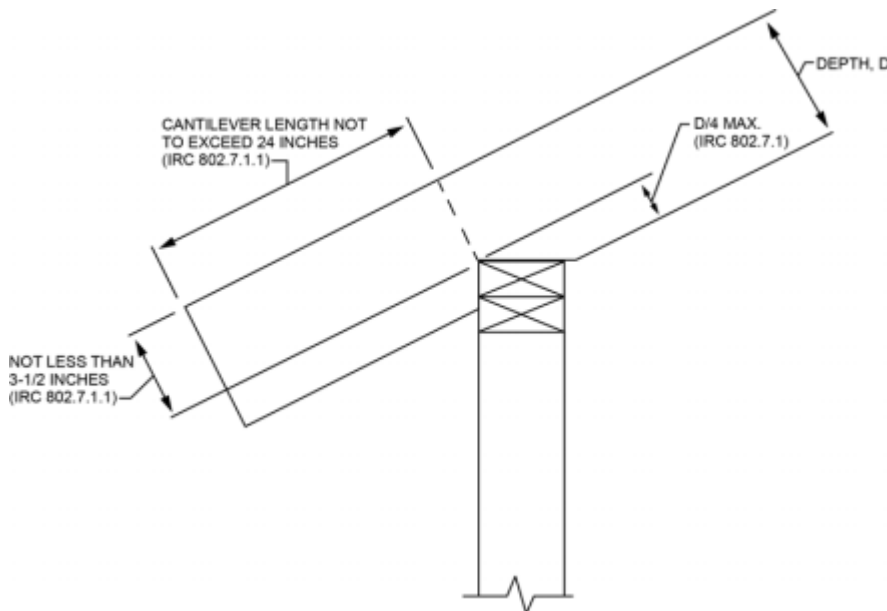
IRC Figure R802.7.1.1 shows what is commonly referred to as a “birds-mouth” notch. Note that the taper cut on the bottom of the rafter does not extend beyond the inside face of the top plate for the reasons stated above.

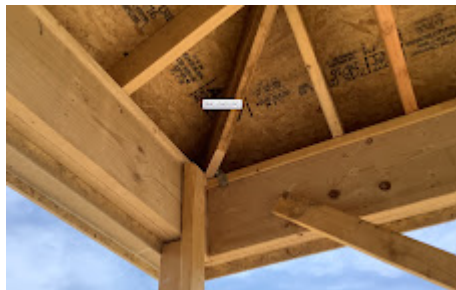
3.jpg
598K

These limits are intended to maintain the strength of rafters at their bearing. The taper cuts shown on the bottom of the rafters in the photos you provided will induce significant shear stresses on the rafter where it bears at the inside face of the top plate. A split will likely form at that location compromising the load-carrying capacity of the rafter. This is particularly problematic for what appears to be a hip rafter in at least one photo.

I am an independent code inspector in the DFW, Texas area. Often I come across hip and valley rafters improperly supported by the top plate, as shown in the attached photos. I am at my wits end trying to find anything in the I-Codes that addresses this. I have also attempted to contact folks at the American Wood Council, to no avail.
