FLOOR SQUEAKS: CAUSES, SOLUTIONS AND PREVENTION

Number C468N

April 2002

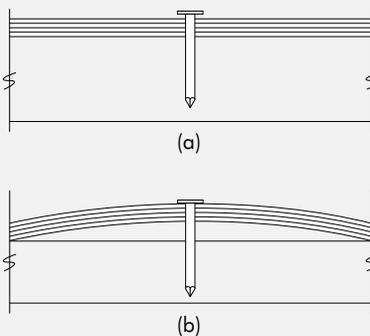
FIGURE 2

**LUMBER USED TO ELIMINATE
FLOOR SQUEAKS DUE TO
NAIL POP.**

Solution – Floor Joist Accessible: Regardless of the floor covering, if there is access to the joist space under the floor, the squeak can be corrected. This is done by using a 2- or 3-ft.-long piece of lumber or metal

angle (see Fig. 2). The piece is predrilled so that it can be fastened with screws to both the panel and the joist. Drill holes in the piece slightly larger than the largest outside diameter of the screw. Apply construction adhesive to the edges which will come in contact with the floor and joist. If possible push the floor down against joist. Fasten to both with screws. (Sheet metal screws are recommended since they normally have greater holding power than wood screws of equivalent size.) Screw length should be selected to maximize penetration into the floor panel without penetrating the top surface of the underlayment.

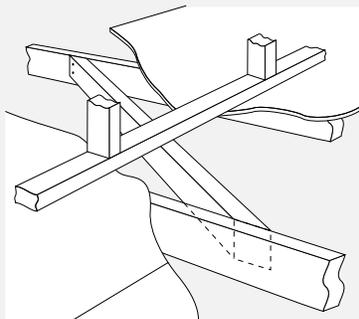
FIGURE 3

plate and the floor. It is common practice to nail the lower plate of the interior wall partition to the panel subfloor rather than to the joists. Floor panels will deflect slightly under load. When this occurs, the subfloor can rub on the nail shank and thus cause a squeak.

**DIAGONAL BLOCKING
USED TO ELIMINATE FLOOR
SQUEAKS BELOW INTERIOR
PARTITION WALLS.**

Solution – Clinch nails which penetrate the panel subfloor. If this does not correct the problem, screws can be driven up through the subfloor into the lower plate, or diagonal blocking can be inserted under the partition, as shown in Figure 3.

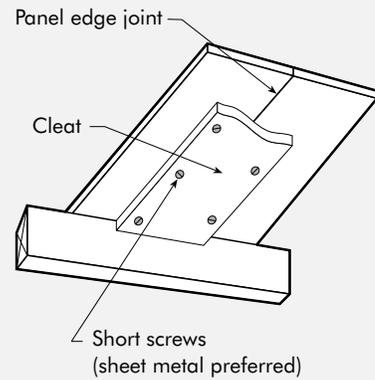
FIGURE 4

Normally T&G joints fit tightly together and are completely silent. In rare cases, often due to damage during construction, the fit between the grooved panel and the tongue of the adjacent panel may be slightly loose. When these panels flex under traffic they may emit a squeak or popping sound.

Solution – To silence a T&G-related squeak the blocking and bridging method described in Cause 5 will probably stop the sound if there is access to the underside of the floor. Another solution is to attach panel blocking to the underside of the joint with construction adhesive and with screws long enough to provide maximum penetration of the floor panel without protruding through the panel surface. See Figure 4.
