FPE Panels – Hazard or Hype?

by Douglas Hansen

This article focuses on the controversy over inspecting and reporting Federal Pacific panels. It has been published in the magazine for the California Real Estate Inspection Association and in other technical journals.

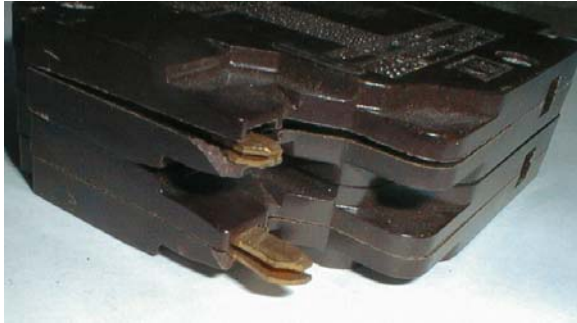
Figure 8 – Damaged “E” type breaker

Not only do “E” breakers make poor connection to “F” sockets, forcing them into the socket can damage them. The breaker may split when shoved into the slot, with the bus stab receding inside the breaker (figure 7). Since it is now making a very loose contact to the bus, the breaker might fall right out when the deadfront cover is removed (figure 9). Inspectors can be forewarned of this condition before taking off the cover. Simply look at the label for the panel to see where the “E” slots are located and whether any “E” breakers have been inserted into “F” slots. When finding that situation, there is no need to remove the cover to know that the breaker is in the wrong position.
