Safety Glazing, by Douglas Hansen

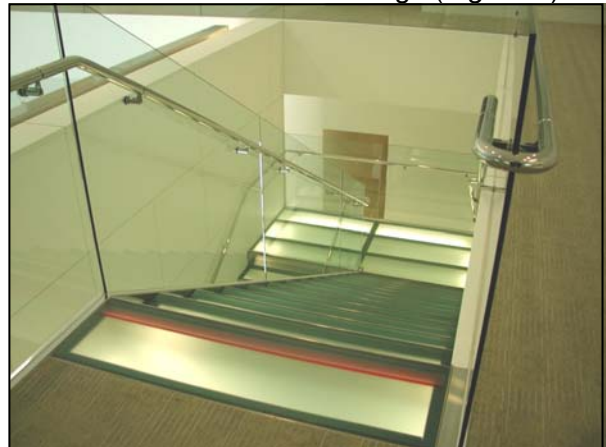
Laminated glass has two separate pieces of annealed, heat-strengthened, or tempered glass sandwiched around a layer of clear polyvinyl butaryl (PVB). The layers are bonded under high pressure. In the United States, it is used in car windshields. It is a safety glass product. One side can shatter from impact without the other side shattering, and when the glass shatters it does not delaminate into shards. Laminated glass is often used for frameless railings (*Figure 3*).

Figure 3 – Laminated Glass Railing

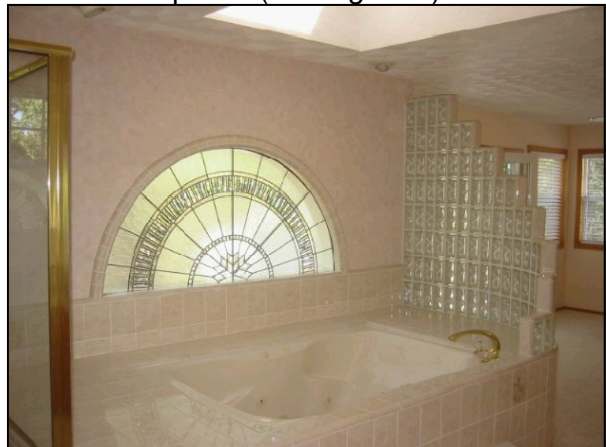
Figure 6 – Shower and Tub Enclosures
In this example, the shower enclosure at the left contained tempered safety glass, and the glass blocks at the end of the tub are exempt. The leaded glass next to the tub is not allowed; any windows in that area must be safety glass.

Jalousie windows are exempt. Their edges must be smooth, and they must be at least 3/16 inches thick. Finally, there is an overall exemption for glass blocks (*figure 6*) when they are properly installed in accordance with the rules for that form of masonry.

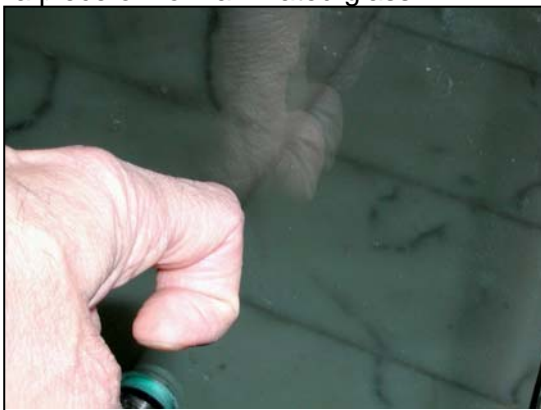
Laminated glass is sometimes labeled, though most codes do not require it. Laminated glass can be identified by its reflection — if you hold your hand to it, you will see multiple reflections (see Figure 8). With a little practice, these are readily distinguishable from the two reflections you might see from the inner and outer surfaces of a piece of non-laminated glass.

Figure 8 – Identifying Laminated Glass
