# Validation of Installation Methods for CSST Gas Piping to Mitigate Lightning Related Damage

## Phase 1

***Final Report***

# Final report for Validation of Installation Methods for CSST Gas Piping to Mitigate Lightning Related Damage

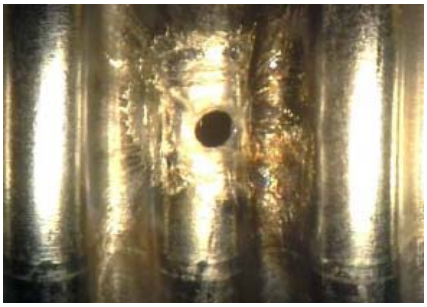
**Example of Arcing Damage observed after the Test**

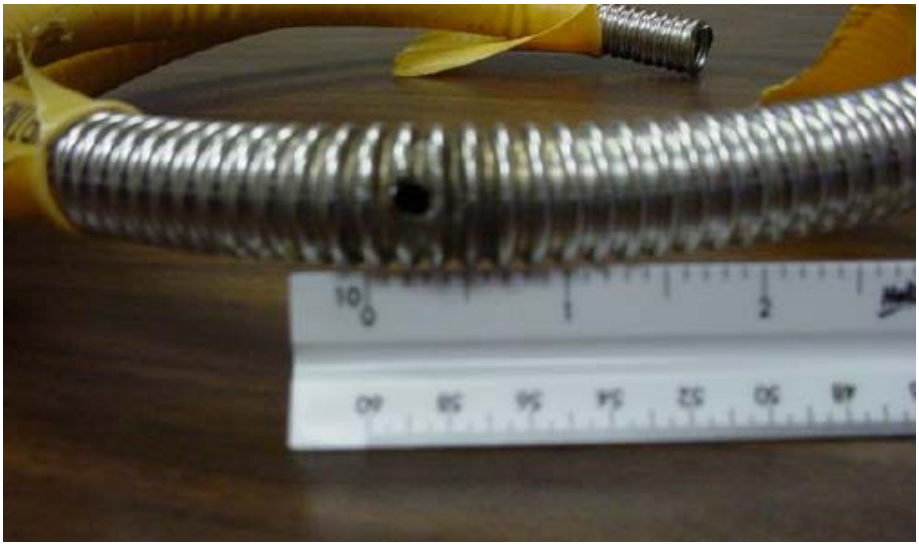
Damage caused by a lightning strike to a CSST system can be described as small puncture of the tubing wall. This type of damage is caused by an arc of energy "jumping" from a pathway of higher potential to a pathway of lower potential in an effort to find a lower impedance pathway to ground. This type of damage appears to be consistent around the country.

**Example of Damage to CSST**

Recently updated CSST manufacturer's installation instructions now include the requirement to directly bond the CSST system to the electrical system grounding system. The bonding attachment must be near the service entrance to the building and the connection must be made with a #6 AWG copper wire. This method of bonding will provide additional protection to the CSST system when it is energized by an indirect lightning strike. All CSST manufacturers have issued either Technical Bulletins or other documents to describe the new requirements. Although similar, these bonding requirements are currently not identical between the manufacturers. Manufacturers' installation instructions have undergone a series of changes since 1996 to reflect the impact of the prevalent construction practices at the time of their printing including modifications to the bonding requirements."

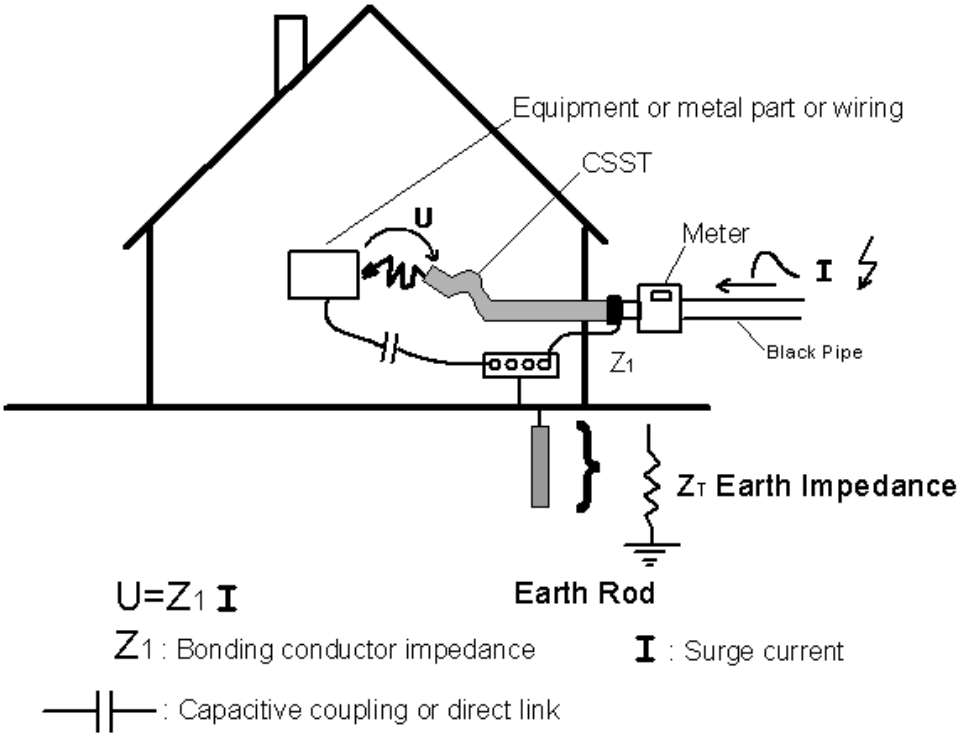
**Scenario a)**

This is the typical arrangement covered by NFPA 54. A metallic pipe supplies gas to the house. The CCST installation starts at the entrance point. Bonding to the electrical supply ground is achieved by a link of impedance Z1 (lightning is both high frequency—up to 1 MHz—and low frequency; high frequency creates the sparkovers and overvoltages, while low frequency is related to energy. Thus any component should be characterized by impedance and not only resistance). The earth rod has an earth impedance. Many metal parts and conductors are connected to the grounding electrode, but some of them are only related to this grounding electrode by capacitive coupling. In any case, they have a voltage determined by the grounding electrode one way or another. Bonding the CSST helps to decrease the stress and its efficiency is related to its capacity to conduct the lightning current I, as well as maintain CCST voltage near the ground rod voltage. A bonding conductor of 6 AWG is what is required by IEC 62305 for equipotential bonding, and is therefore adequate to handle the lightning energy. If the bonding conductor is too long, CCST will then be at a high voltage $U = Z_1 I$ and can sparkover to a grounded metal part in the vicinity. Acceptable separation distance depends on voltage U and thus on current I and impedance $Z_1$. If the length of the bonding conductor increases, the separation distance must increase accordingly. Multiple bonding will help reduce the stress very efficiently. If we assume that the bonding conductor is mainly an inductance (typical value of 1µH/m) and that the front of the current impulse waveform is 20 kA/µs (see table copied from IEC 62305 already discussed), we get a voltage U = L di/dt, and for 1 m of bonding conductor this equals 20 kV. If the bonding conductor is long enough, this can lead to a sparkover between CCST and a metal element in the vicinity.

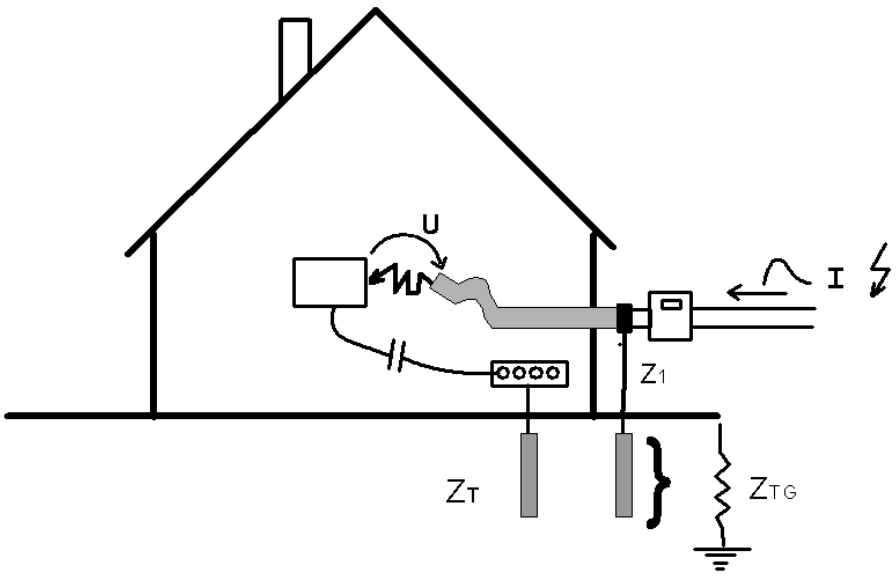
Scenario b)

$U = (Z_1 + Z_{TG})\,I$

$Z_1$ : Bonding conductor impedance  $I$ : Surge current

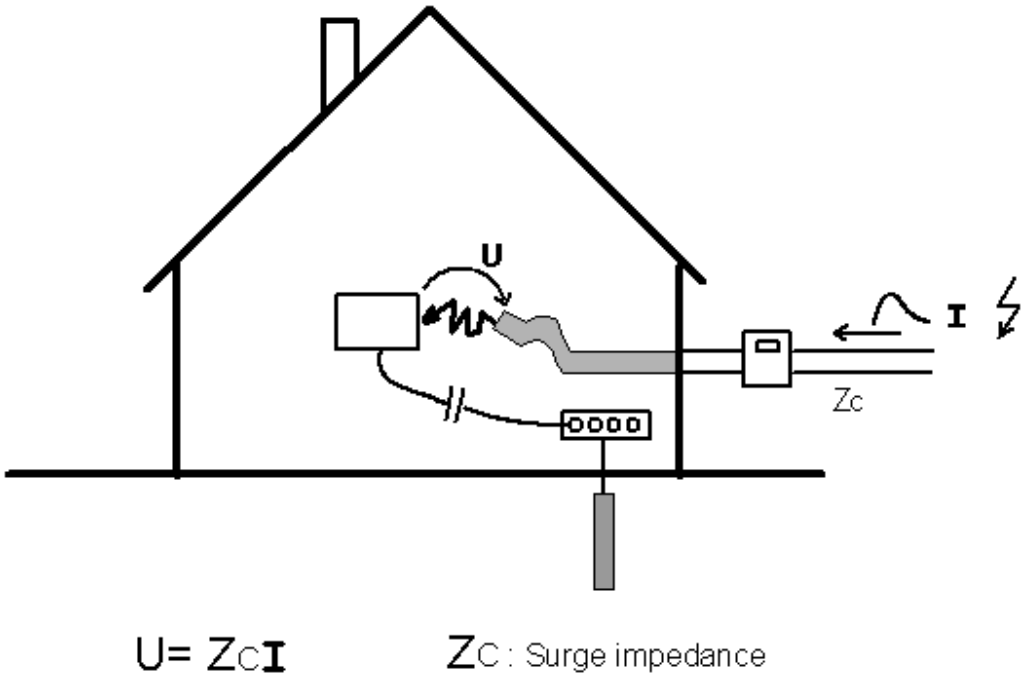
**Scenario c)**

Scenario c is similar to a) and b), but in this case there is no CSST bonding at all.

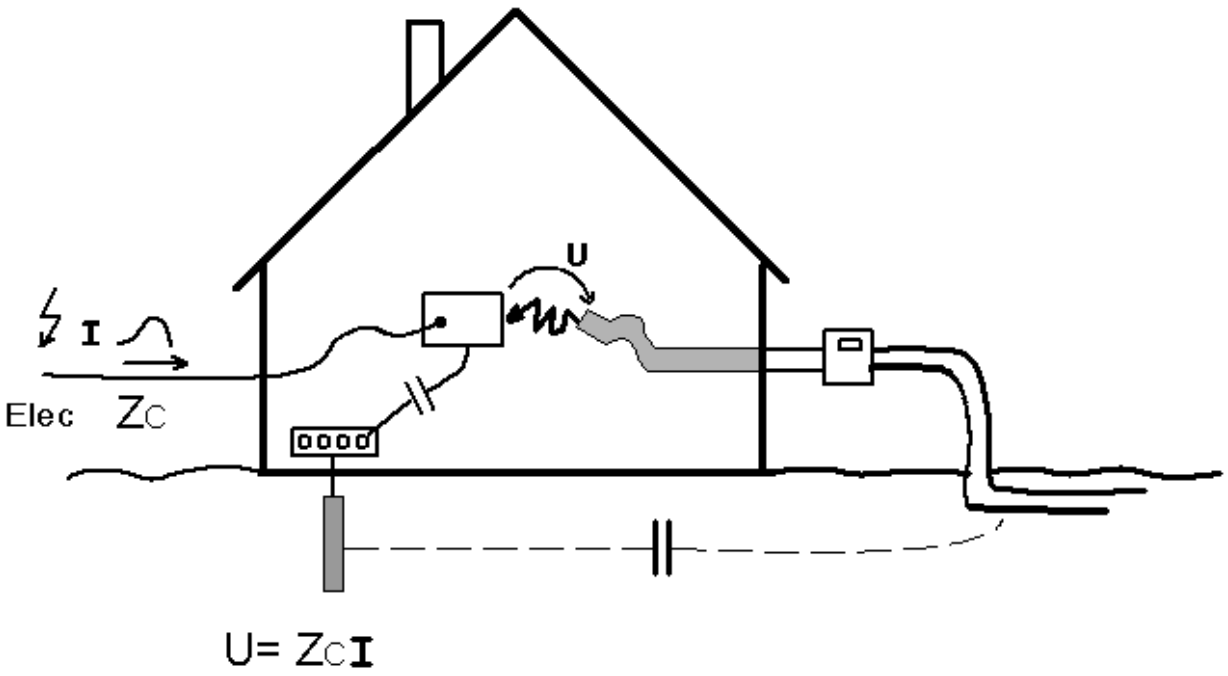
**Scenario d)**

In this scenario, the threat is coming from the electrical line. If we assume a 300 ohm surge impedance we get a voltage U = 300 kV for a 1 kA surge current. This can lead to a sparkover between the electrical conductors and the CSST. The arc created

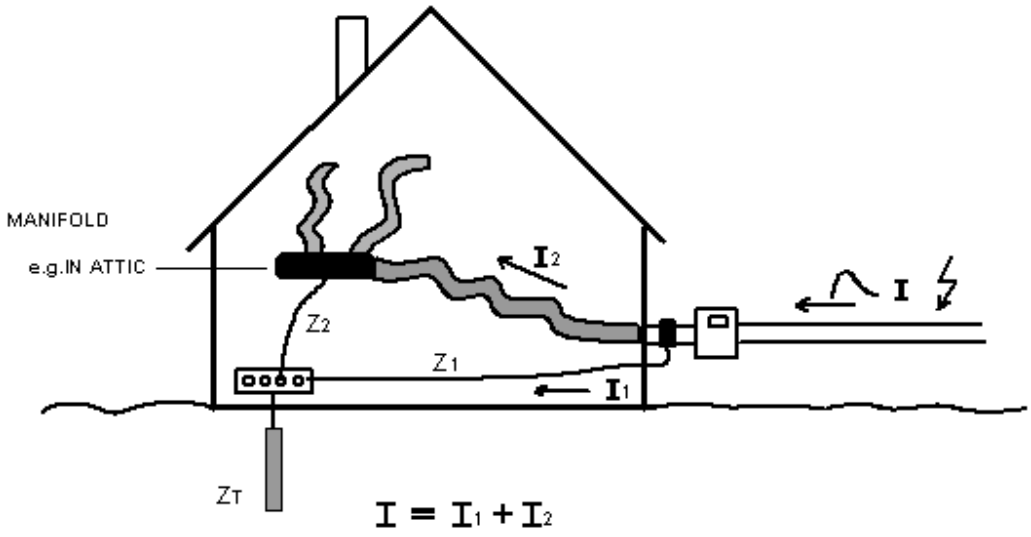
**Scenario e)**

Scenario e) is based on scenario a), but another bonding conductor exists elsewhere in the installation (in the above figure, the additional bonding is at the manifold; this has been seen in some real cases).

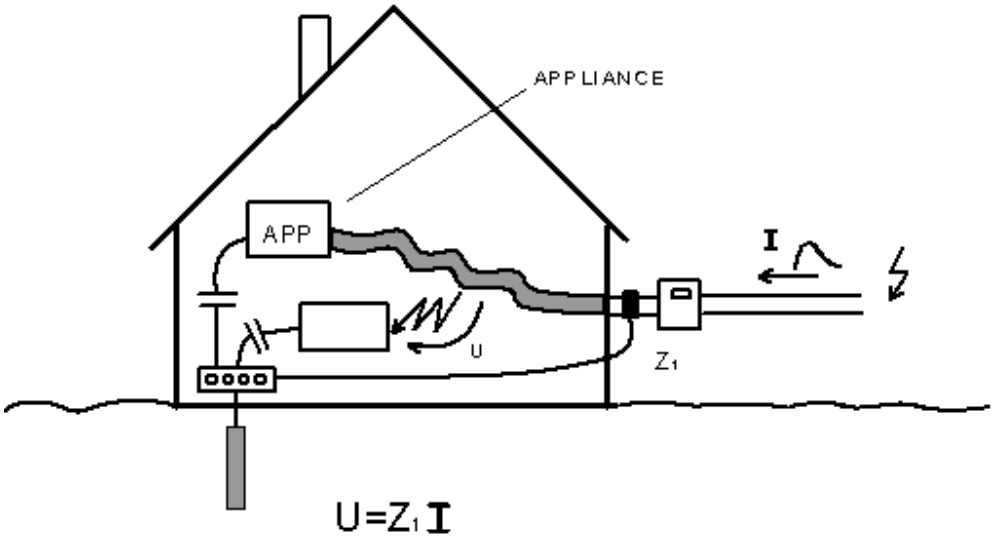
**Scenario f)**

Scenario f) is close to previous scenarios [especially a) and e)], but the CSST connection to an appliance is also involved. If this appliance is grounded, the scenario is equivalent to scenario e). If the appliance is grounded through a different circuit, the scenario is closer to scenario a).

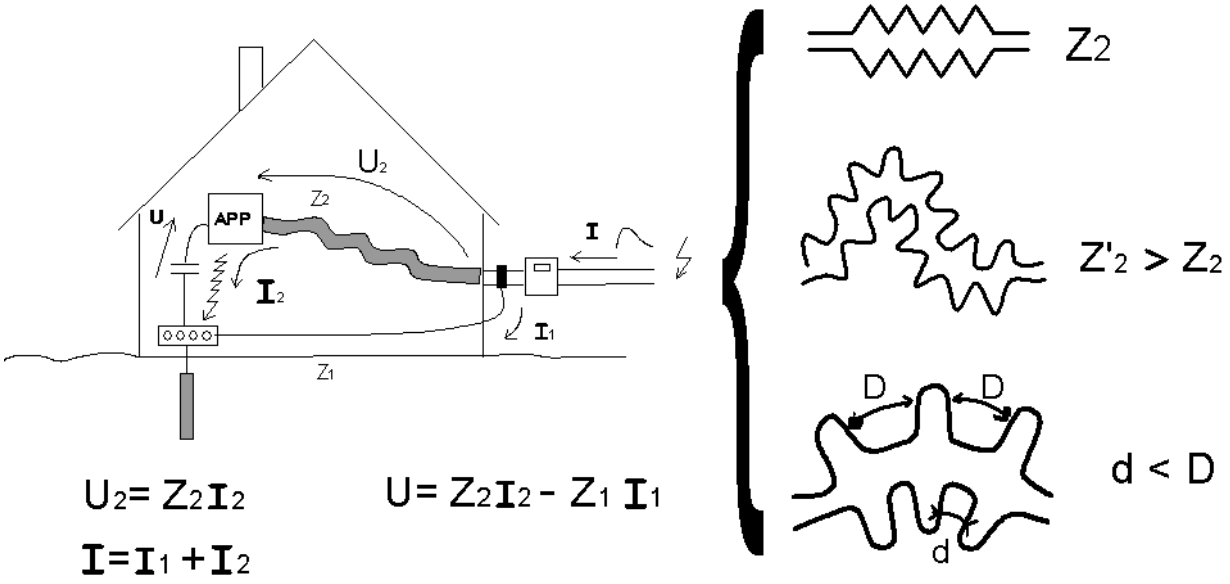
**Scenario g)**

This scenario emphasizes the effect of the CSST impedance. It is based on scenario e). Whatever the inductance $Z_2$ of CSST may be, it is clear that the impedance will be slightly more when a bend exists ($Z'_2$). **Tests to determine CSST impedance should incorporate maximum bending radii as given in technical brochures.**

**The effect of bends should be investigated**. There are cases where multiple holes have been found on CSST without clear explanation (when a sparkover exists somewhere, this normally drops the voltage and reduces the probability another sparkover will occur, especially in close vicinity). The bending effect—where some ridges of the CSST (inside the bend) are nearer than other parts (outside the bend) — could be an explanation that needs to be investigated. Apparently, around 50% of the cases where this occurred were related to direct lightning strikes and we have already

said that direct lightning withstand can probably be disregarded (this should be within the scope of NFPA 780). Cases were reported where adjacent holes occurred without a direct strike to the house, and cases were reported where a hole was found far from any metal part.

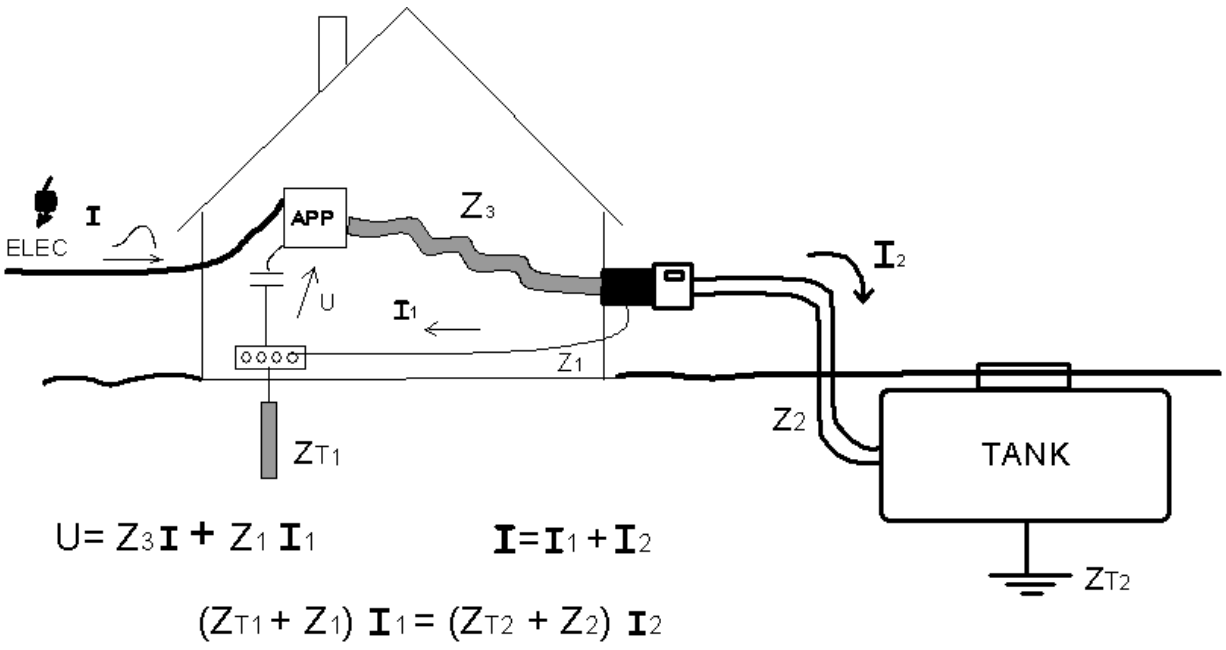
**Scenario h)**

In this scenario, the surge current comes from the power supply. The gas supply is an underground tank as observed in a few cases described to us. This gas tank has a natural earth impedance $Z_{T2}$ . Flashover may occur inside the powered appliance and the surge current then flows to both groundings (power supply rod and gas tank). The

phenomenon involved is similar for black pipe and CSST as it is for appliance damage. The solution in that case is probably an SPD on the power line.

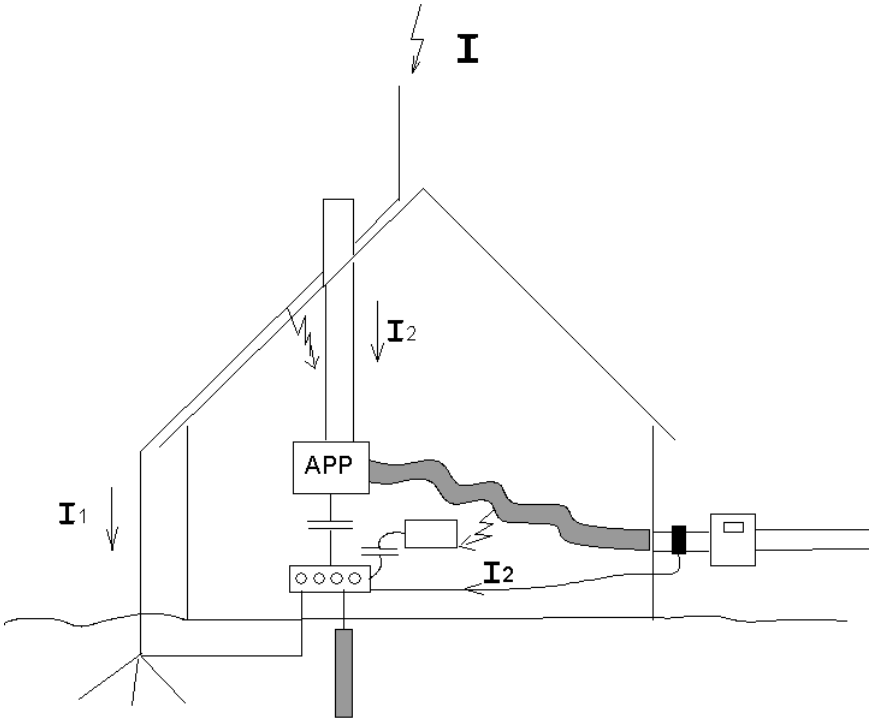
**Scenario i)**

Scenario i) considers a house equipped with a lightning protection system (LPS). In case of lightning strike on the LPS, the current I flowing along the down-conductor creates a high voltage at the house top that may lead to a sparkover at roof level, to a

metal chimney for example. A part of the surge current I will then flow along the metal chimney, then inside the appliance, leading to a partial current flowing along CSST. Once again in that scenario, the damage is likely to occur inside the appliance. The current flowing along CSST can also create a sparkover somewhere where distance between CSST and a grounded metal part is smallest. The solution in this case is global equipotential bonding, but this should fall under the rules of NFPA 780. This is basically a matter to be resolved by mutual information sharing between the CSST and LPS contractors to ensure that this additional stress on CSST installation remains under control.

The flow of partial lightning current along CSST is not completely covered by tests published so far.

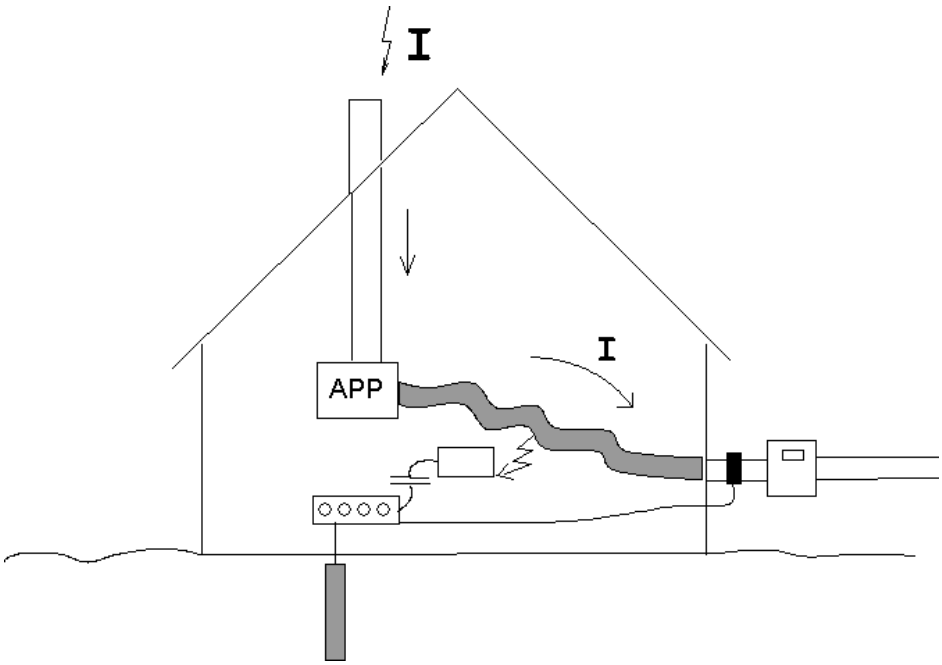
**Scenario j)**

In this scenario, there is also a direct strike to the building, but no LPS is present. The chimney on the roof is struck by lightning, and current flows through an appliance and then through CSST. It is likely that this will create damage at the appliance, but a sparkover can occur between CSST and a metal part in the vicinity. However, why CSST should withstand this stress when the complete house is in danger due to the direct lightning hit itself is in question. To be sure that CSST can withstand such a stress, an LPS is needed on the house, or at least rules for equipotential bonding given in NFPA 780 should be applied to CSST whether an LPS is present or not.
We do not suggest performing tests to cover such a scenario.

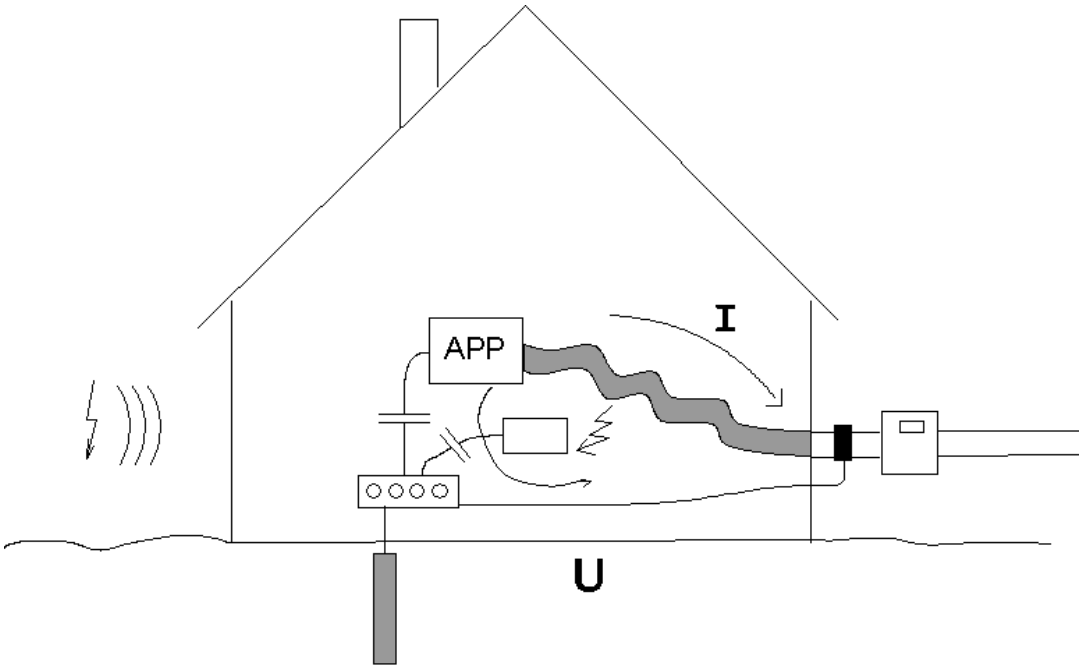
**Scenario k)**

Scenario k) covers the case of a lightning strike in the vicinity of the house, close enough to create a high voltage on the CSST installation (which is a loop). When the voltage is high enough, a sparkover will occur somewhere and an induced current will flow in the CSST circuit. According to IEC 62305-2, a dangerous spark can only occur when the lightning strike is less than 250 m from the house. In such a case, the best way to protect CSST is to create bonding on the CSST to decrease the size of the loop. Bonding at CSST, at manifold, and if possible at appliances would be a good solution, since it would reduce the size of the loop. One expert declared that the non-systematic equipotential bonding approach was the cause of the problem. Scenario k) supports his position. **Tests should however be performed with 8/20 impulses** (representing induced surges) to determine whether these impulses can damage CSST if multiple bonding is not provided.

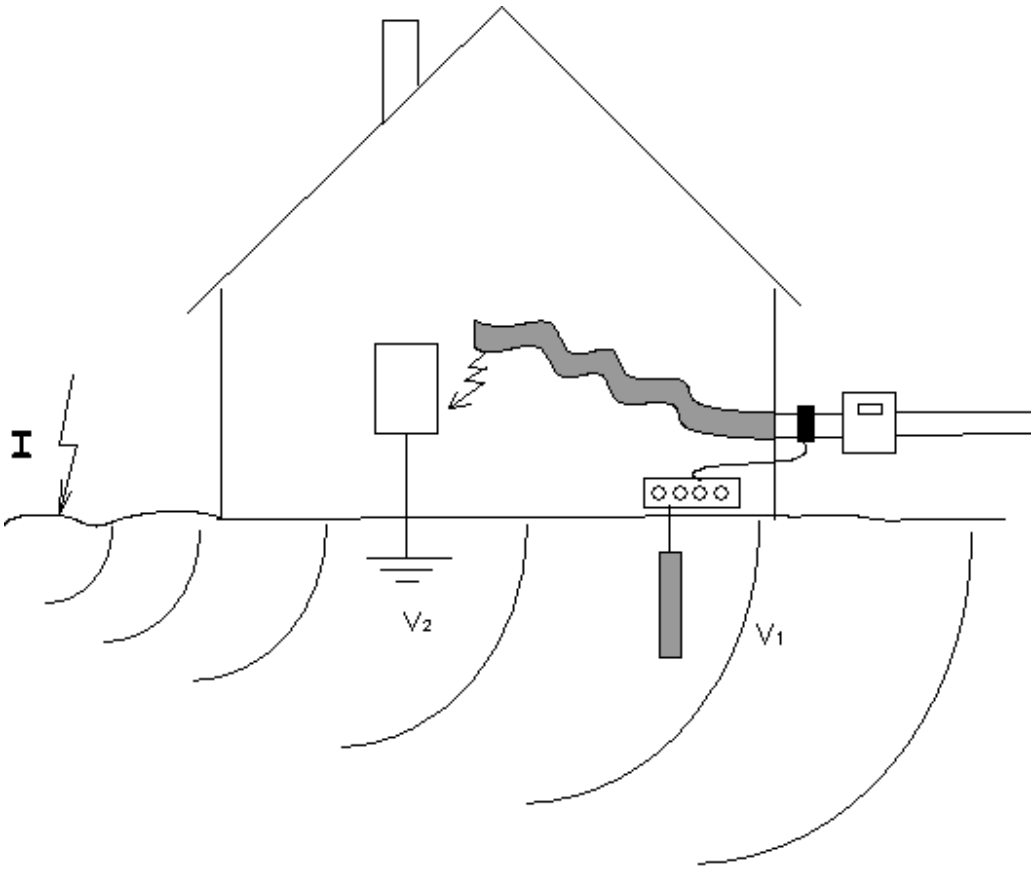
**Scenario l)**

Scenario l) represents the case of a direct strike to the ground or a grounded structure (such as a tree or a pole) in the vicinity of the house. The lightning current creates equipotential spheres in the soil, which leads to different soil voltages at different locations (this helps explain the well known step voltage problem leading to many cows' deaths when lightning occurs). If metal parts of the house (for example columns, steel beam, or concrete walls) are in contact with the soil, we will experience a voltage V2 that may be different from the voltage at the gas installation (or electrical ground rod). This voltage can be high enough to create a sparkover between this metal part and the CSST. A partial lightning current is then flowing through the arc and the CSST.

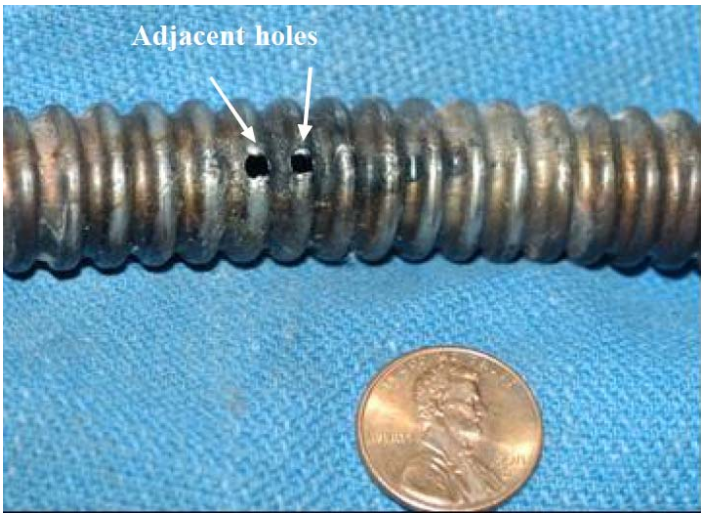
| **Comment** | Good example of multiple holes on CSST. |

| **Detailed investigation:** | The fire occurred in the wood framed chimney space that had a metal chimney insert. CSST ran through the chimney space to feed the gas igniter. **Four** perforations were found in the CSST, ranging in size from a pinhole to a hole about 125 mils along its major axis. A lightning report showed that 4 hits within 0.1 mile of the house were recorded. |

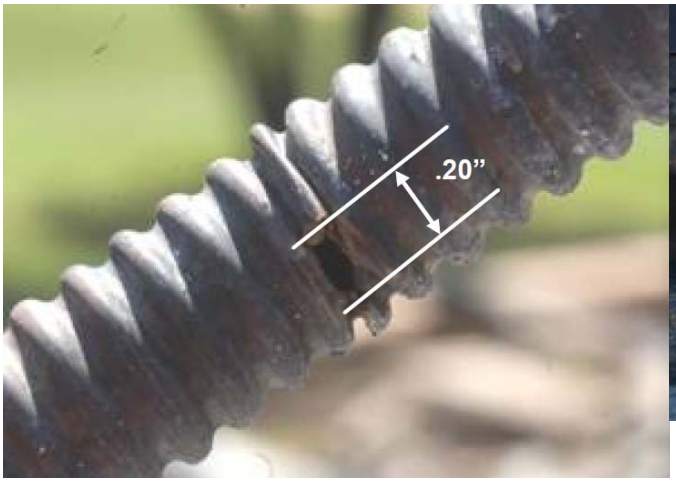
| **Detailed investigation:** | The fire occurred in (construction not finished) a 2 story house, and plumbed with approximately 95% black pipe. Two runs of CSST, each serving a fireplace, comprised the CSST piping in the house. A perforation with its major axis measuring approximately 200 mils was found in one run of the CSST. An interview with a neighbor confirmed that the audible and visual components of the strike were sensed simultaneously. A positive lightning report was obtained, showing 11 strikes within 0.5 mile. Regrettably, the house was razed before the investigation was complete. |

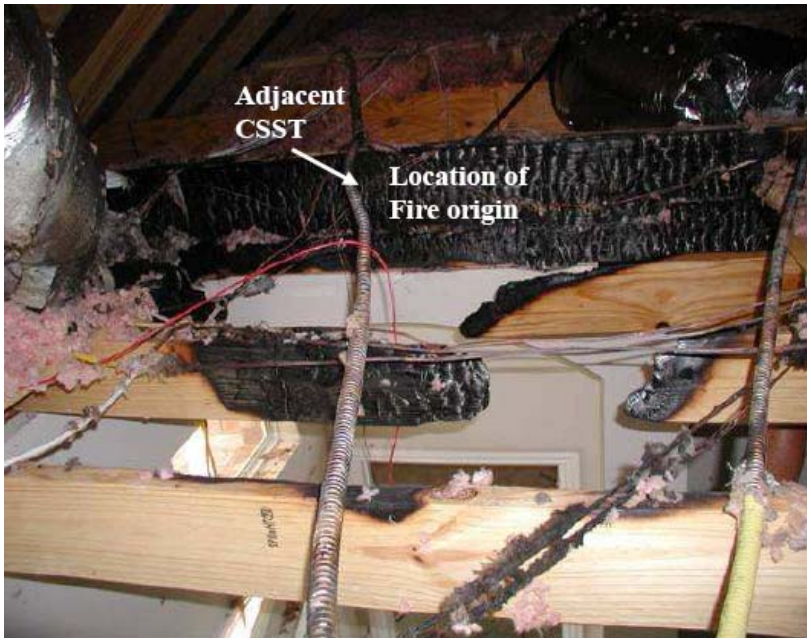
| **Detailed investigation:** | The fire occurred within the attic space of a home, which included several runs of CSST. The CSST runs went to a fireplace, furnace, range, and water heater. During a lightning storm, the CSST run serving the fireplace leaked and the resultant fire then destroyed a section of the attic. A perforation measuring 95 mils along its major diameter was found in the pipe. A lightning report showed that there were approximately 5 strikes within 0.3 mile of the house. The fire was contained within the attic, but subjected the house to extensive smoke damage. |

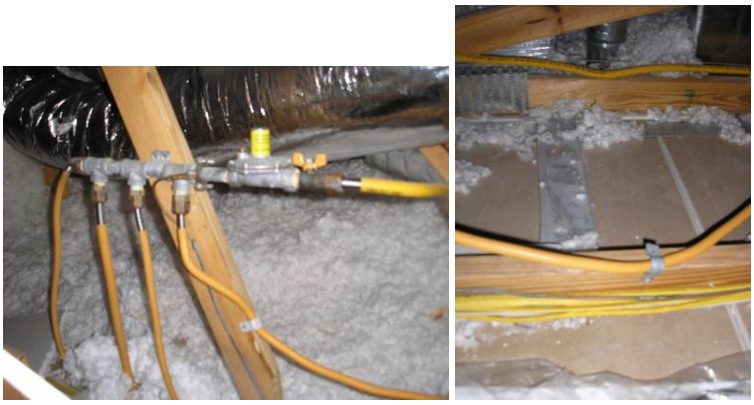
The NFIRS report indicates that there was a gas leak from a gas line in the attic and flame showing from the leak. The fire was extinguished by turning off gas.

**Bonding Only at Manifold (left), and Location of Incident (right)**

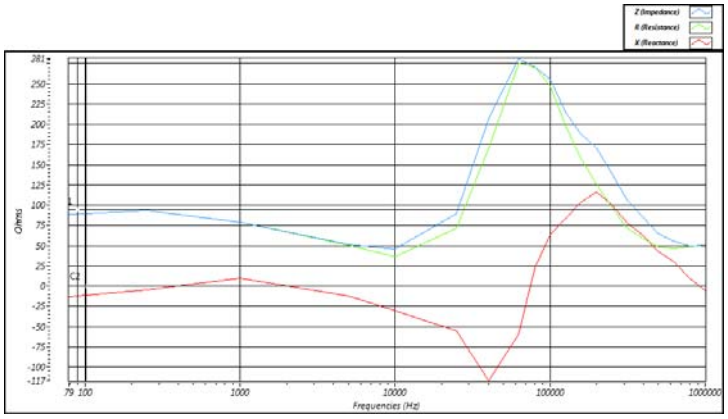
**Impedance versus Frequency for Gas Line at Service Entry Point for the second case investigated at the Villages**

The low frequency value is found to be approximately 89 ohms. The average high frequency impedance of the gas line at the service entrance was found to be 148.8 ohms; a significant capacitive effect at frequencies above 100 kHz which dropped the impedance at 1MHz to 49.6 ohms.

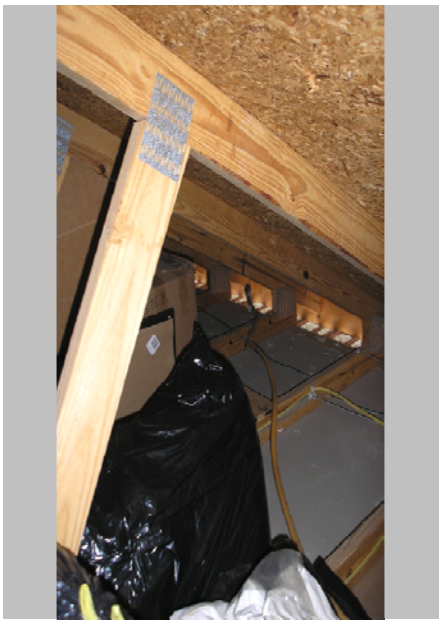
**Routing of Incoming CSST Piping**

Electrical testing was performed on 3 September, 2010. For Case 1, identified as receiving a direct strike, it is unclear as to whether there was an eyewitness to the event but the homeowner was home at the time and indicated he heard experienced very loud and close thunder. The NFIRS report for the incident indicated that firefighters responding to a resulting fire call found a hole in the ridge vent of approximately 2 inches by 2 inches. No StrikeFax was obtained for this incident. The result of the event was small fires in the attic above the garage and in the master bathroom ceiling. In both these areas, NFIRS indicated the fire resulted in a 3-inch by 3-inch burned area with indication of the presence of a gas line with plastic coating melted in the location above the garage. No such indication was noted for the fire in the master bathroom ceiling. A week after the event a contractor working in the attic smelled gas and upon investigation found that the CSST line adjacent to the hot water heater vent was damaged. The figure above forwards a picture of the burned area and electrically-isolated hot water heater vent showing the repaired CSST piping. The damaged section of piping was removed, spliced as shown, and supported above the hot water heater vent. The incoming gas service is municipal and metered, enters the structure at the meter and rises to the attic area using galvanized piping. The transition to CSST is made at the entry point to the attic. The CSST coursing from the transition point to the manifold runs across and in close proximity to electrical wiring in the attic. The figure below shows the installation of the manifold and the solid #6 AWG copper wire used to ground the manifold through the electrical service ground rod. This appeared to be a common practice here, or at least it was a consistent technique found at the locations visited as a part of this survey. As you can see from this series of photos, the failure point in the CSST piping in Case 1 was in the section of CSST on the source side of the manifold and prior to the grounding of the CSST.

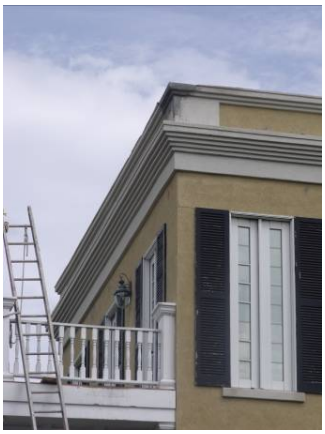
Eyewitnesses reported a direct strike to a 4-story residence located on the edge of a salt marsh. Municipal gas service was provided which transitioned to CSST throughout the structure. There was physical evidence of a direct strike to a corner of the structure with a resulting fire and significant electrical damage. There was no indication that CSST was a factor in the fire. The earth resistivity of the site was found to be a very low 2.09 ohm-m and the resistance to earth was found to be only 2.1 ohms.

**Direct Strike at Corner of Building**
