PROPERTY INSPECTION REPORT

Concerning: 1234 Final Lane
(Address or Other Identification of Inspected Property)

By: Aaron D. Miller, ACI, CEI, CMI, CRI, MTI, RCI
Certified Master Inspector,
ICC Residential Combination Inspector R-5,
ICC Residential Building Inspector B-1,
ICC Residential Electrical Inspector E-1,
ICC Residential Mechanical Inspector M-1,
ICC Residential Plumbing Inspector P-1,
HUD 203K Consultant D0981
PTI Level 1 PT Installer 320054833
TREC Professional Inspector 4336
TDA SPCS 11379/40247 Certified Applicator
TRCC Registered Builder 16229
TRCC Dispute Resolution Inspector 1350
ASHI Certified Inspector 203652

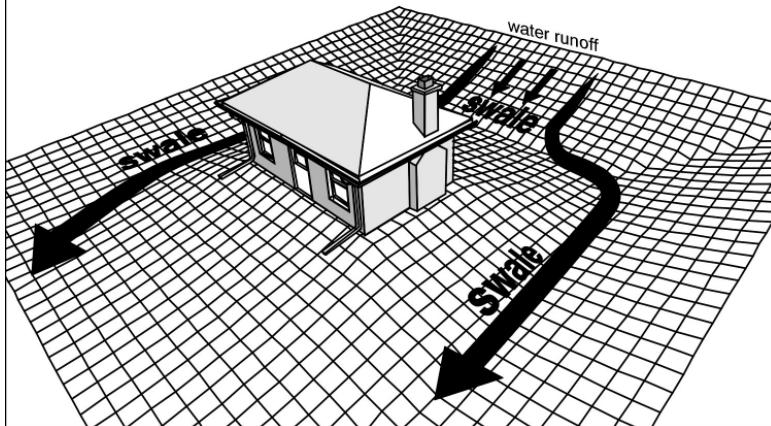
**SOIL**

The soil level on both sides of the front porch is too high in relation to the foundation elevation. IRC R404.1.6 requires a minimum of 4" clearance from grade to the bottom row of bricks or stone and 6" minimum clearance from grade to the bottom row of any other exterior cladding.

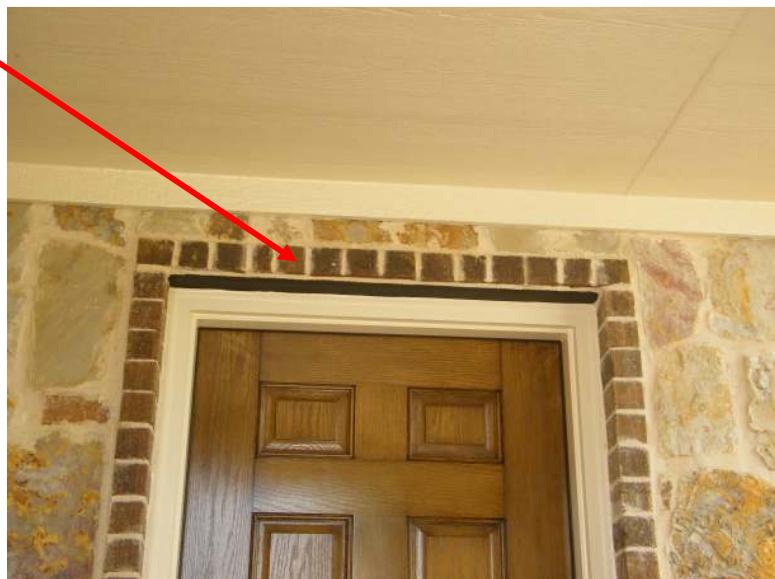
Weep holes
required @
33" o.c.

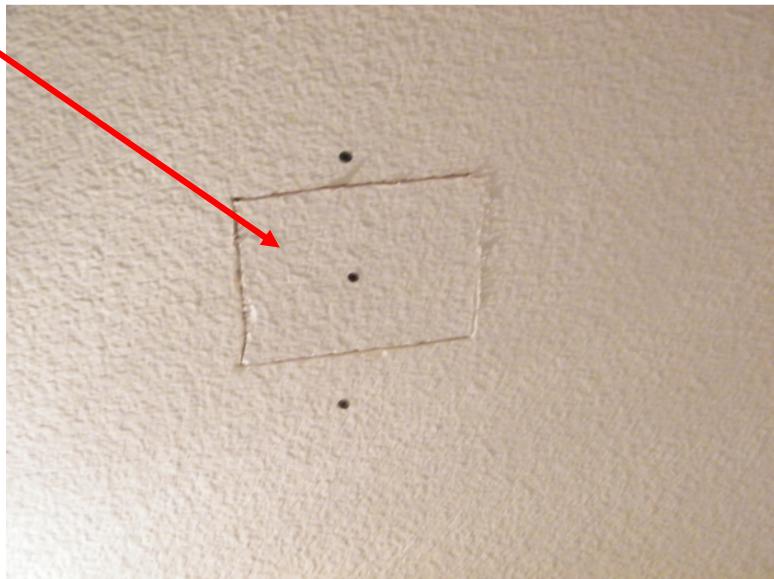
Drywall
repair
required.

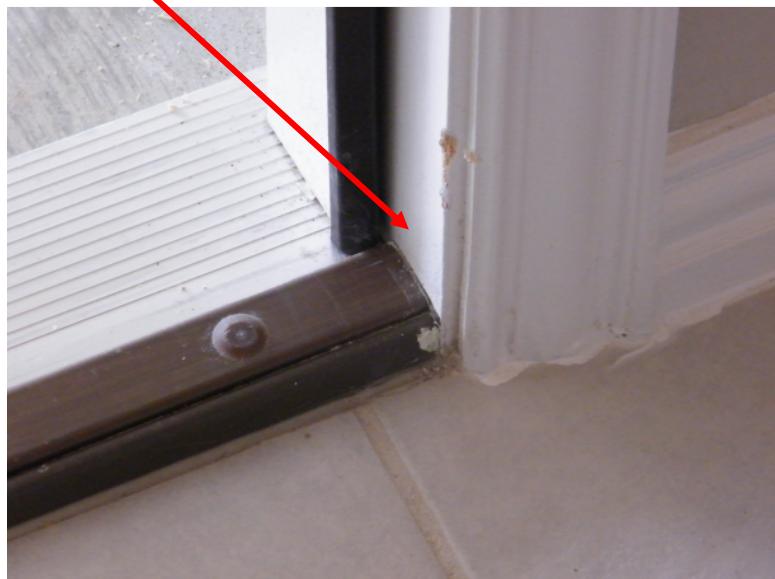
Light visible
due to no
seal pad.
