# TEXAS INSPECTOR

## PROPERTY INSPECTION REPORT

### A. Foundations

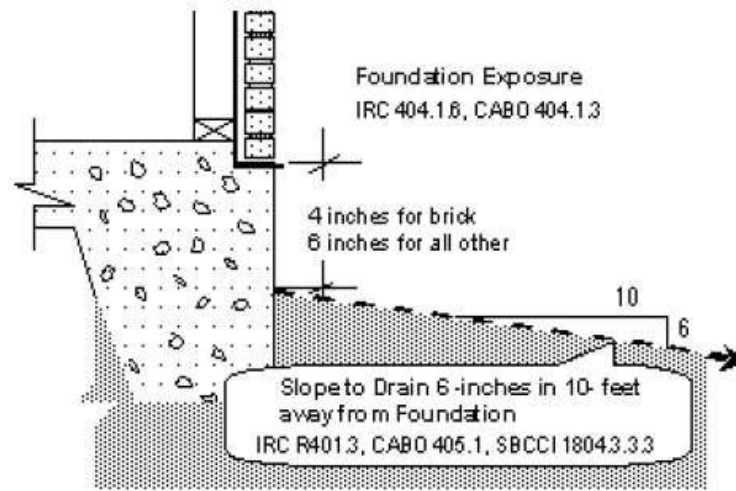
R 401.3 is not the only place in the code requiring this drainage provision. R506.1, and R 403.1.8 instruct builders slab-on-grade residential buildings on expansive clay soils to adhere to an even stricter commercial building code, that of the International Building Code 1805.8.2, "Slab-on-ground foundations. Slab-on-ground, mat or raft foundations on expansive soils shall be designed and constructed in accordance with WRI/CRSI Design of Slab-on-Ground Foundations or PTI Design and Construction of Post-Tensioned Slabs-On-Ground." PTI Design is the Post-Tensioning Institute of which this inspector is both a member and a Level 1 Certificate holder. The home you are buying is built on an unbonded post-tensioned slab-on-grade foundation and must adhere to these specifications. The Post-Tensioning Institute's *Construction and Maintenance Procedures Manual for Post-Tensioned Slab-On-Grade Construction*, echoes this requirement.

Additionally, the engineer responsible for the foundation design specifies in the shop drawings and general notes therein what the grading should be in relation to this particular foundation. Industry standards again underscore the need for these improvements. Yards shall have grades and swales that provide for proper drainage away from the home in accordance with the Code or other governmental regulations. If the grades or swales fail to meet the industry standards, the builder shall take such action as is necessary to bring the variance within the standard.

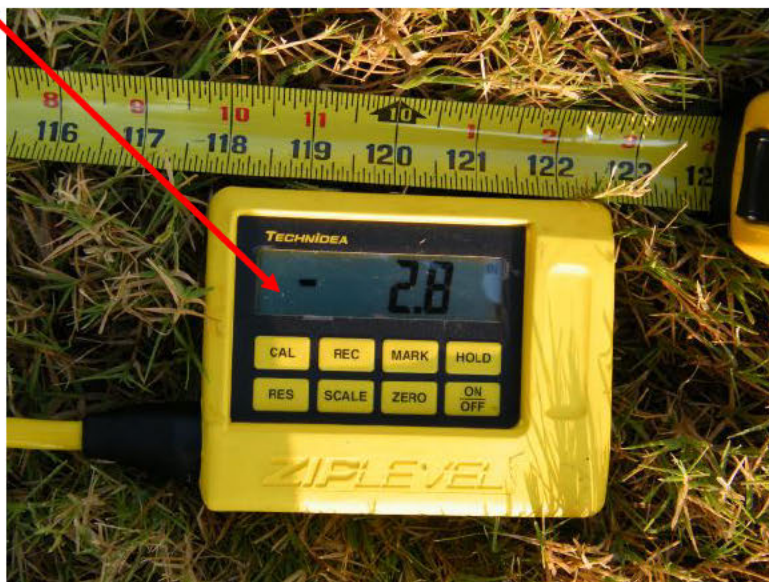
Grading  
west of  
patio is not  
code

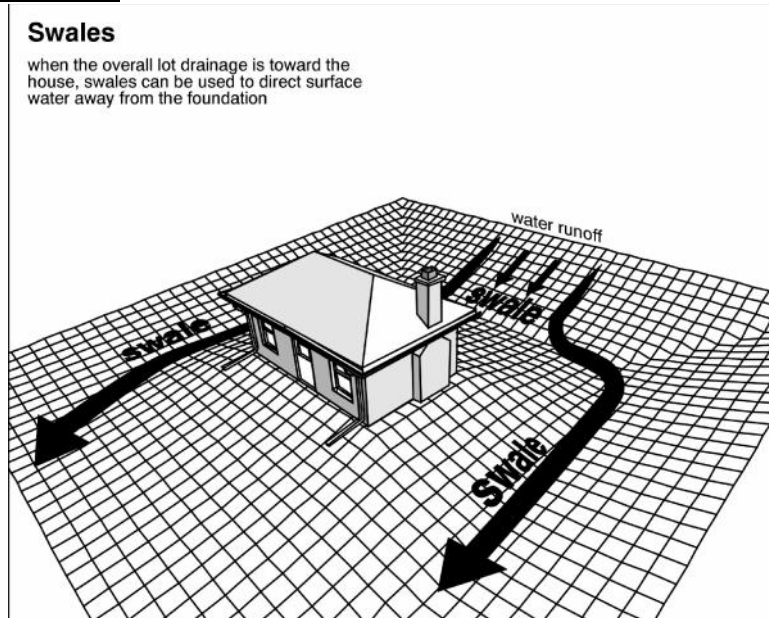
### 6.1.1.1 Site Grading

Site grading causes excess water to flow away from the foundation via surface sloping and drainage swales. Adequate surface drainage slopes are essential to minimize foundation movement and damage. Current International Residential Code requires 6" minimum fall the first 10' out from and perpendicular to building walls, and 2% minimum elsewhere to drain off lot. Because current building practices sometimes have homes built closer than 10' to the adjacent structure or lot line, it is necessary to have greater slopes so that the 6" minimum is maintained.

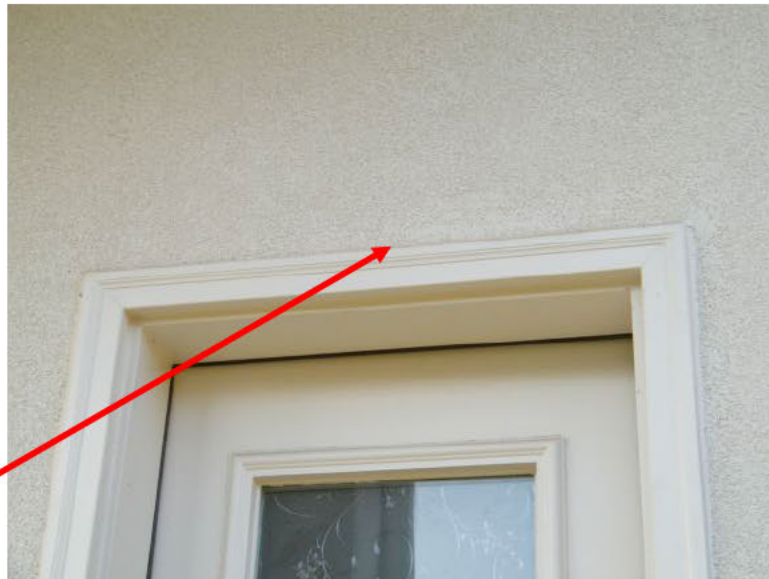
Header  
flashing  
required.
