# TEXAS INSPECTOR

## PROPERTY INSPECTION REPORT

**By:** Aaron D. Miller, ACI, CEI, CMI, CPI, CRI, MTI, RCI [REDACTED]

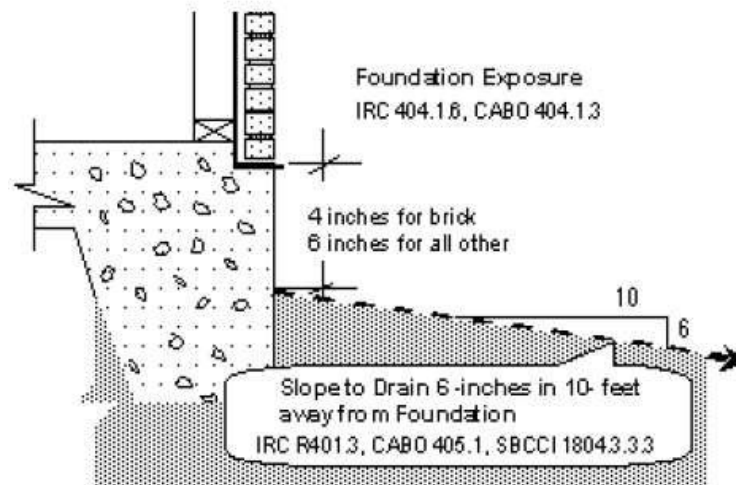
The grading around the perimeter of the foundation must be improved to promote the flow of storm water away from the house. Grading specifications are spelled out clearly in International Residential Code (IRC) R401.3, "Surface drainage shall be diverted to a storm sewer or other approved point of collection so as to not create a hazard. Lots shall be graded so as to drain surface water away from foundation walls. The grade away from foundation walls shall fall a minimum of 6 inches (152 mm) within the first 10 feet (3048)". This is equivalent to the 5% grade required by the foundation design firm's engineer. **FAILURE TO MAKE THESE IMPROVEMENTS MAY EFFECTIVELY VOID YOUR FOUNDATION WARRANTY!**

R 401.3 is not the only place in the code requiring this drainage provision. R506.1, and R 403.1.8 instruct builders slab-on-grade residential buildings on expansive clay soils to adhere to an even stricter commercial building code, that of the International Building Code 1805.8.2, "Slab-on-ground foundations. Slab-on-ground, mat or raft foundations on expansive soils shall be designed and constructed in accordance with WRI/CRSI Design of Slab-on-Ground Foundations or PTI Design and Construction of Post-Tensioned Slabs-On-Ground." PTI Design is the Post-Tensioning Institute of which this inspector is both a member and a Level 1 Certificate holder. The home you are buying is built on an unbonded post-tensioned slab-on-grade foundation and must adhere to these specifications. The Post-Tensioning Institute's *Construction and Maintenance Procedures Manual for Post-Tensioned Slab-On-Grade Construction*, echoes this requirement.

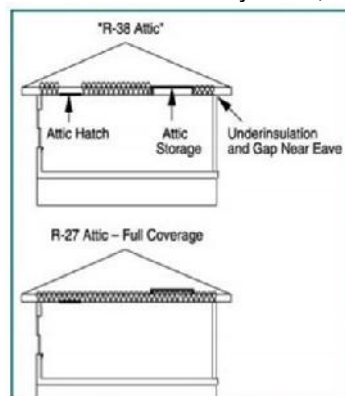
The hollow core side wall door at the second floor attic entrance is rated at R-2.17 while the surrounding walls are insulated to R-13. 2.17 does not equal 13.

Recent research by the U.S. Department of Energy shows that the lack of insulation in these places effectively decreases the R-value of the entire attic by as much as 30%. So this attic R-value is now effectively R-26, which is below the standard required by the 2009 IECC.

R-38 installed with 5% gaps or uninsulated areas yields the same heat loss as R-27 with full coverage - a 30% reduction!

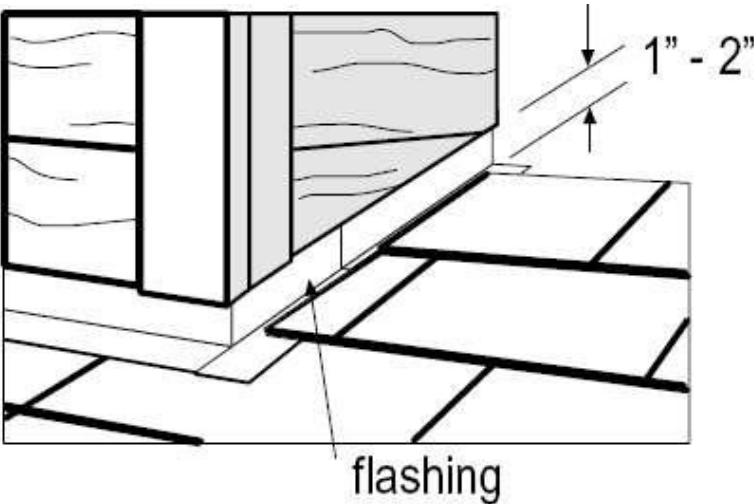
As indicated in the manufacturer's installation instructions, fiber-cement siding and trim material must be kept at least 1 - 2 inches above horizontal or sloped surfaces such as decks, balconies, porches, patios, sidewalks, driveways, and roofs. Most of today's manufactured siding, trim, decking, and roofing materials must be installed with spacing to permit expansion and to reduce the chance of wicking water.

Moisture will wick into the material on warm days during the winter. Then when temperatures drop, the water inside the fiber-cement material will freeze, expand, and crumble the material. In addition to the freeze-thaw-freeze problem, any salt (calcium chloride or sodium chloride) that you may have used to break up winter ice accumulations at driveways, porches, and patios will likely accelerate the damage.

The siding should not be in contact with the roof surface. It must be installed a minimum of 2" above the roofing surface. This voids the manufacturer's warranty.

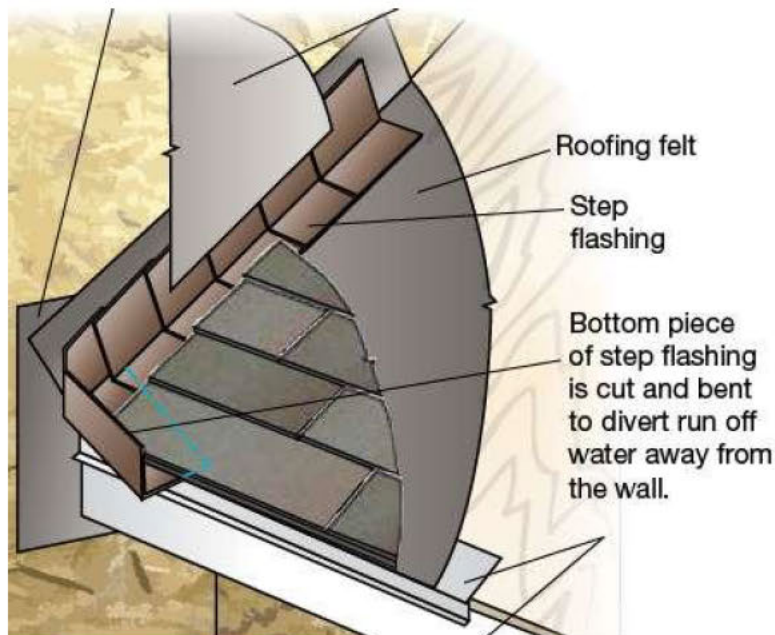
The siding must be spaced 1/8" from abutting perpendicular trim pieces and caulked as per the manufacturer's installation instructions. This installation voids the manufacturer's warranty.

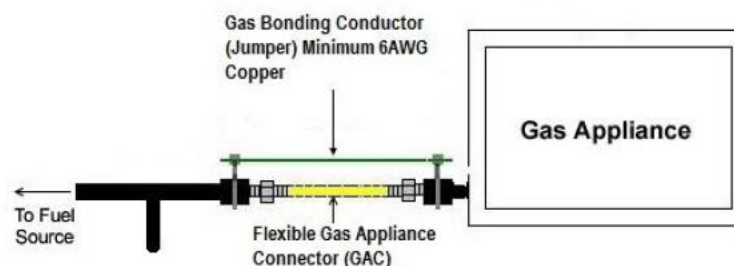
Solid copper bond jumpers from threaded steel gas piping to threaded steel gas piping at the cooktop(s), furnace(s) and water heater(s), et al., were not installed. The flexible gas appliance connectors are not designed or intended to be ground pathways and are not protected from “electrically induced fires”. A gas pipe shall not be used for grounding or as a grounding pathway as per NEC 250.104(B) and NEC 250.52(B). Flexible gas appliance connectors are similar in thickness and design to corrugated stainless steel tubing (CSST) gas piping material which is prone to damage from nearby (non-direct) lightning strikes which perforate the pipe and exacerbate fires. See “Google” - CSST litigation. See also “Electrically Induced Fires”, Fire Arson Investigator, July 1999 - [http://goodsonengineering.com/wp-content/uploads/2011/08/ElectricallyInducedFuelGasFires\\_web.pdf](http://goodsonengineering.com/wp-content/uploads/2011/08/ElectricallyInducedFuelGasFires_web.pdf)

**This is a fire and explosion hazard which requires immediate improvement!**

The flexible gas appliance connectors at the gas appliances do not appear to be properly bonded as required by NEC 250.104(B):

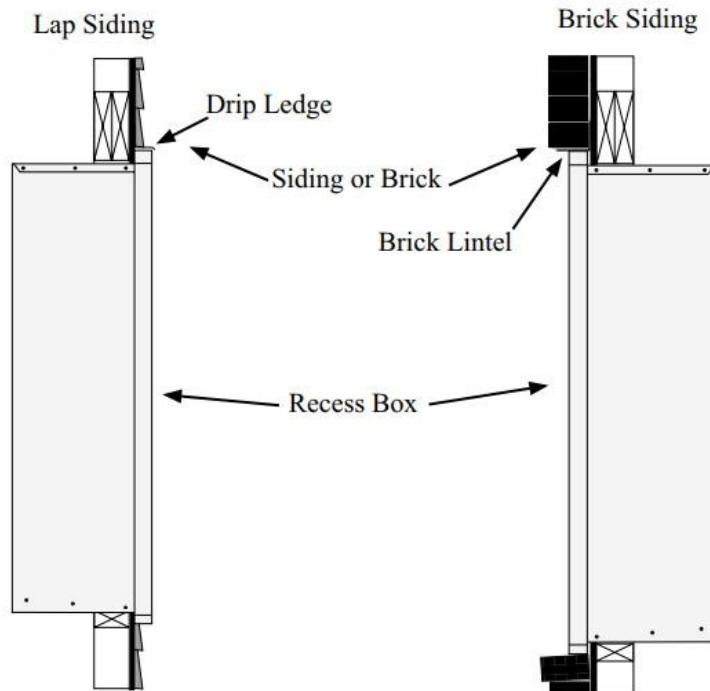
R703.8.3 Lintels. Masonry veneer shall not support any vertical load other than the dead load of the veneer above. Veneer above openings shall be supported on lintels of noncombustible materials. The lintels shall have a length of bearing not less than 4 inches (102 mm). Steel lintels shall be shop coated with a rust-inhibitive paint, except for lintels made of corrosion-resistant steel or steel treated with coatings to provide corrosion resistance. Construction of openings shall comply with either Section R703.8.3.1 or 703.8.3.2.

Masonry veneer, like all veneers, is a non-load-bearing wall covering. It is not intended to support any loads, except for the dead load of the masonry veneer above. A noncombustible lintel is required above an opening through the masonry veneer. The lintel must be protected from rust. Lintels must be sized and installed in accordance with Section R703.8.3.1 or R703.8.3.2.
